COLLEGE OF MARIN

TREE HEALTH PROJECT

KENTFIELD CAMPUS

JULY 10, 2014

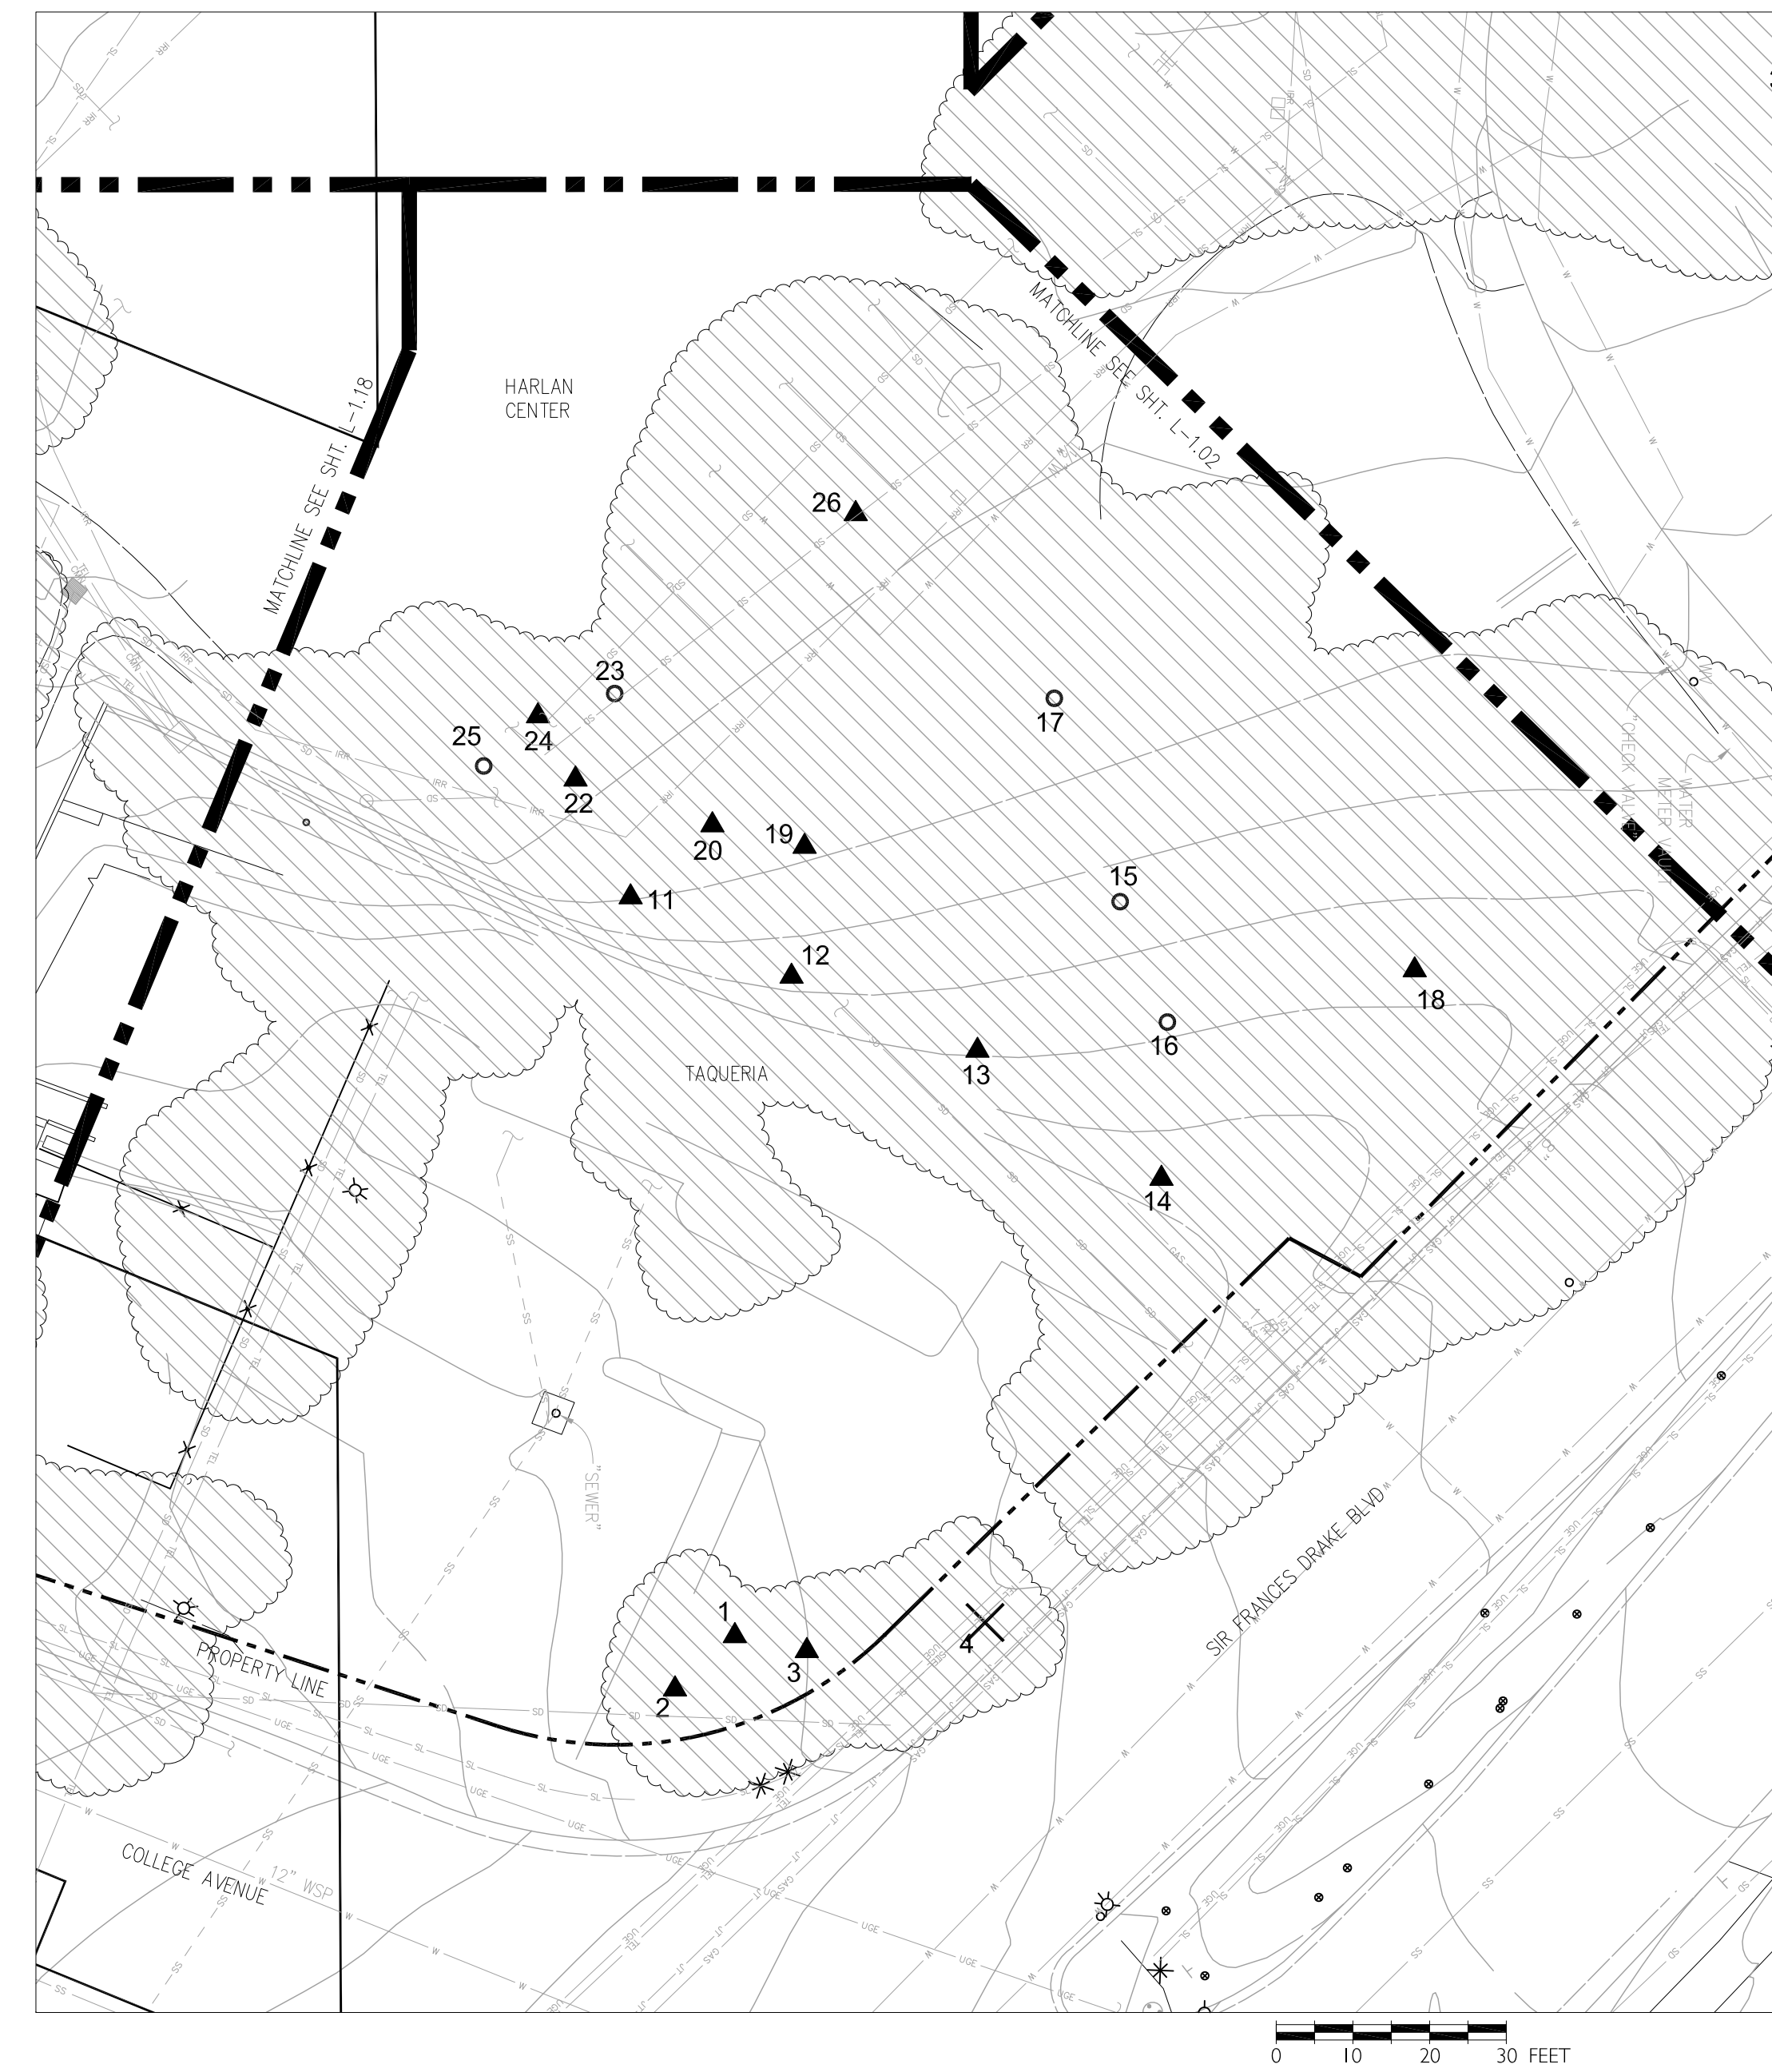
1 COLLEGE AVE. & SIR FRANCIS DRAKE BLVD. INTERSECTION (TREES 1-26)
1" = 20'. CONTOUR INTERVAL '1'

TREE ASSESSMENT									SCHEDULE OF WORK	
Tree #	Species (common)	Species (scientific)	Location	Size	Health	Structural Condition	Impacts to infrastructure	Conclusion	Recommendations	Priority
1	Coast Redwood	<i>Sequoia sempervirens</i>	Tree closest to the intersection of College Ave. and Sir Francis Drake.	18"	Good	Good	None		Prune branches and foliage up to 10' for visual clearance.	3
2	Coast Redwood	<i>Sequoia sempervirens</i>	Approximately 5' southeast of T-1. This tree is 11' northeast from one parking spot. It is 7' south of another parking spot. It is approximately 8.5' to the curb of the intersection of the sidewalk of Sir Francis Drake and College Ave.	12"	Good	Good	None		Prune branches and foliage up to 10' for visual clearance.	3
3	Coast Redwood	<i>Sequoia sempervirens</i>	North-most tree in the center parking lot island. This tree is approximately 2' northwest of a railroad tie for the asphalt parking space. The tree is 5' south of the intersection of the Sir Francis Drake and College Avenue sidewalks	12"	Good	Good	None		Prune branches and foliage up to 10' for visual clearance.	3

15	Coast Redwood	<i>Sequoia sempervirens</i>	Approximately 18-20' north/northwest of T-14	5'	Good; dominant.	Good	None		None	5
16	Coast Redwood	<i>Sequoia sempervirens</i>	Approximately 8' north/northwest of T-15	48"	Good	Good	None		None	5
17	Coast Redwood	<i>Sequoia sempervirens</i>	12' east-northeast of T-15	18"	Good	Good	None		None	5
18	Coast Redwood	<i>Sequoia sempervirens</i>	8-10' north/northeast of T-17	24"	Good; interior tree.	Good	None		Prune sprouts at base.	3
19	Coast Redwood	<i>Sequoia sempervirens</i>	Approximately 10-12' due east of T-18. This tree is 4.5' from the Taqueria wire fence	36"	Good; edge tree. Three feet from construction path.	Good	None		Prune sprouts. Monitor for stress post construction.	2
20	Coast Redwood	<i>Sequoia sempervirens</i>	8' north/northwest of T-19; approximately 8-10' south/southwest of T-18	30"	Good; ten feet from construction path.	Good	None		Prune sprouts. Monitor for stress post construction.	2

22	Coast Redwood	<i>Sequoia sempervirens</i>	15' north of T-20	30"	Good	Good to fair; asymmetrical canopy.	None		Prune sprouts for visual clearance.	3
23	Coast Redwood	<i>Sequoia sempervirens</i>	Approximately 10' south of T-22; approximately 4' from the wood border of the soil path	30"	Fair to good. Interior tree. Low LCR	Fair	None		None	5
24	Coast Redwood	<i>Sequoia sempervirens</i>	Approximately 6' west-northwest of T-23; 10' southeast of T-22	72"	Good; dominant tree in stand.	Good. Some over extending branches in lower canopy.	None		Consider reducing some lower branches to mitigate failure.	4
25	Coast Redwood	<i>Sequoia sempervirens</i>	Approximately 25' due west of T-15; adjacent to the lawn area	42"	Good	Good	None		None	5
26	Valley Oak	<i>Quercus lobata</i>	25' south of T-25; north of the humanities building	36"	Fair; mature. In TPZ	Fair; asymmetrical crown. Recently had crown cleaning.	None		Clear ivy from base. Monitor cables annually.	4

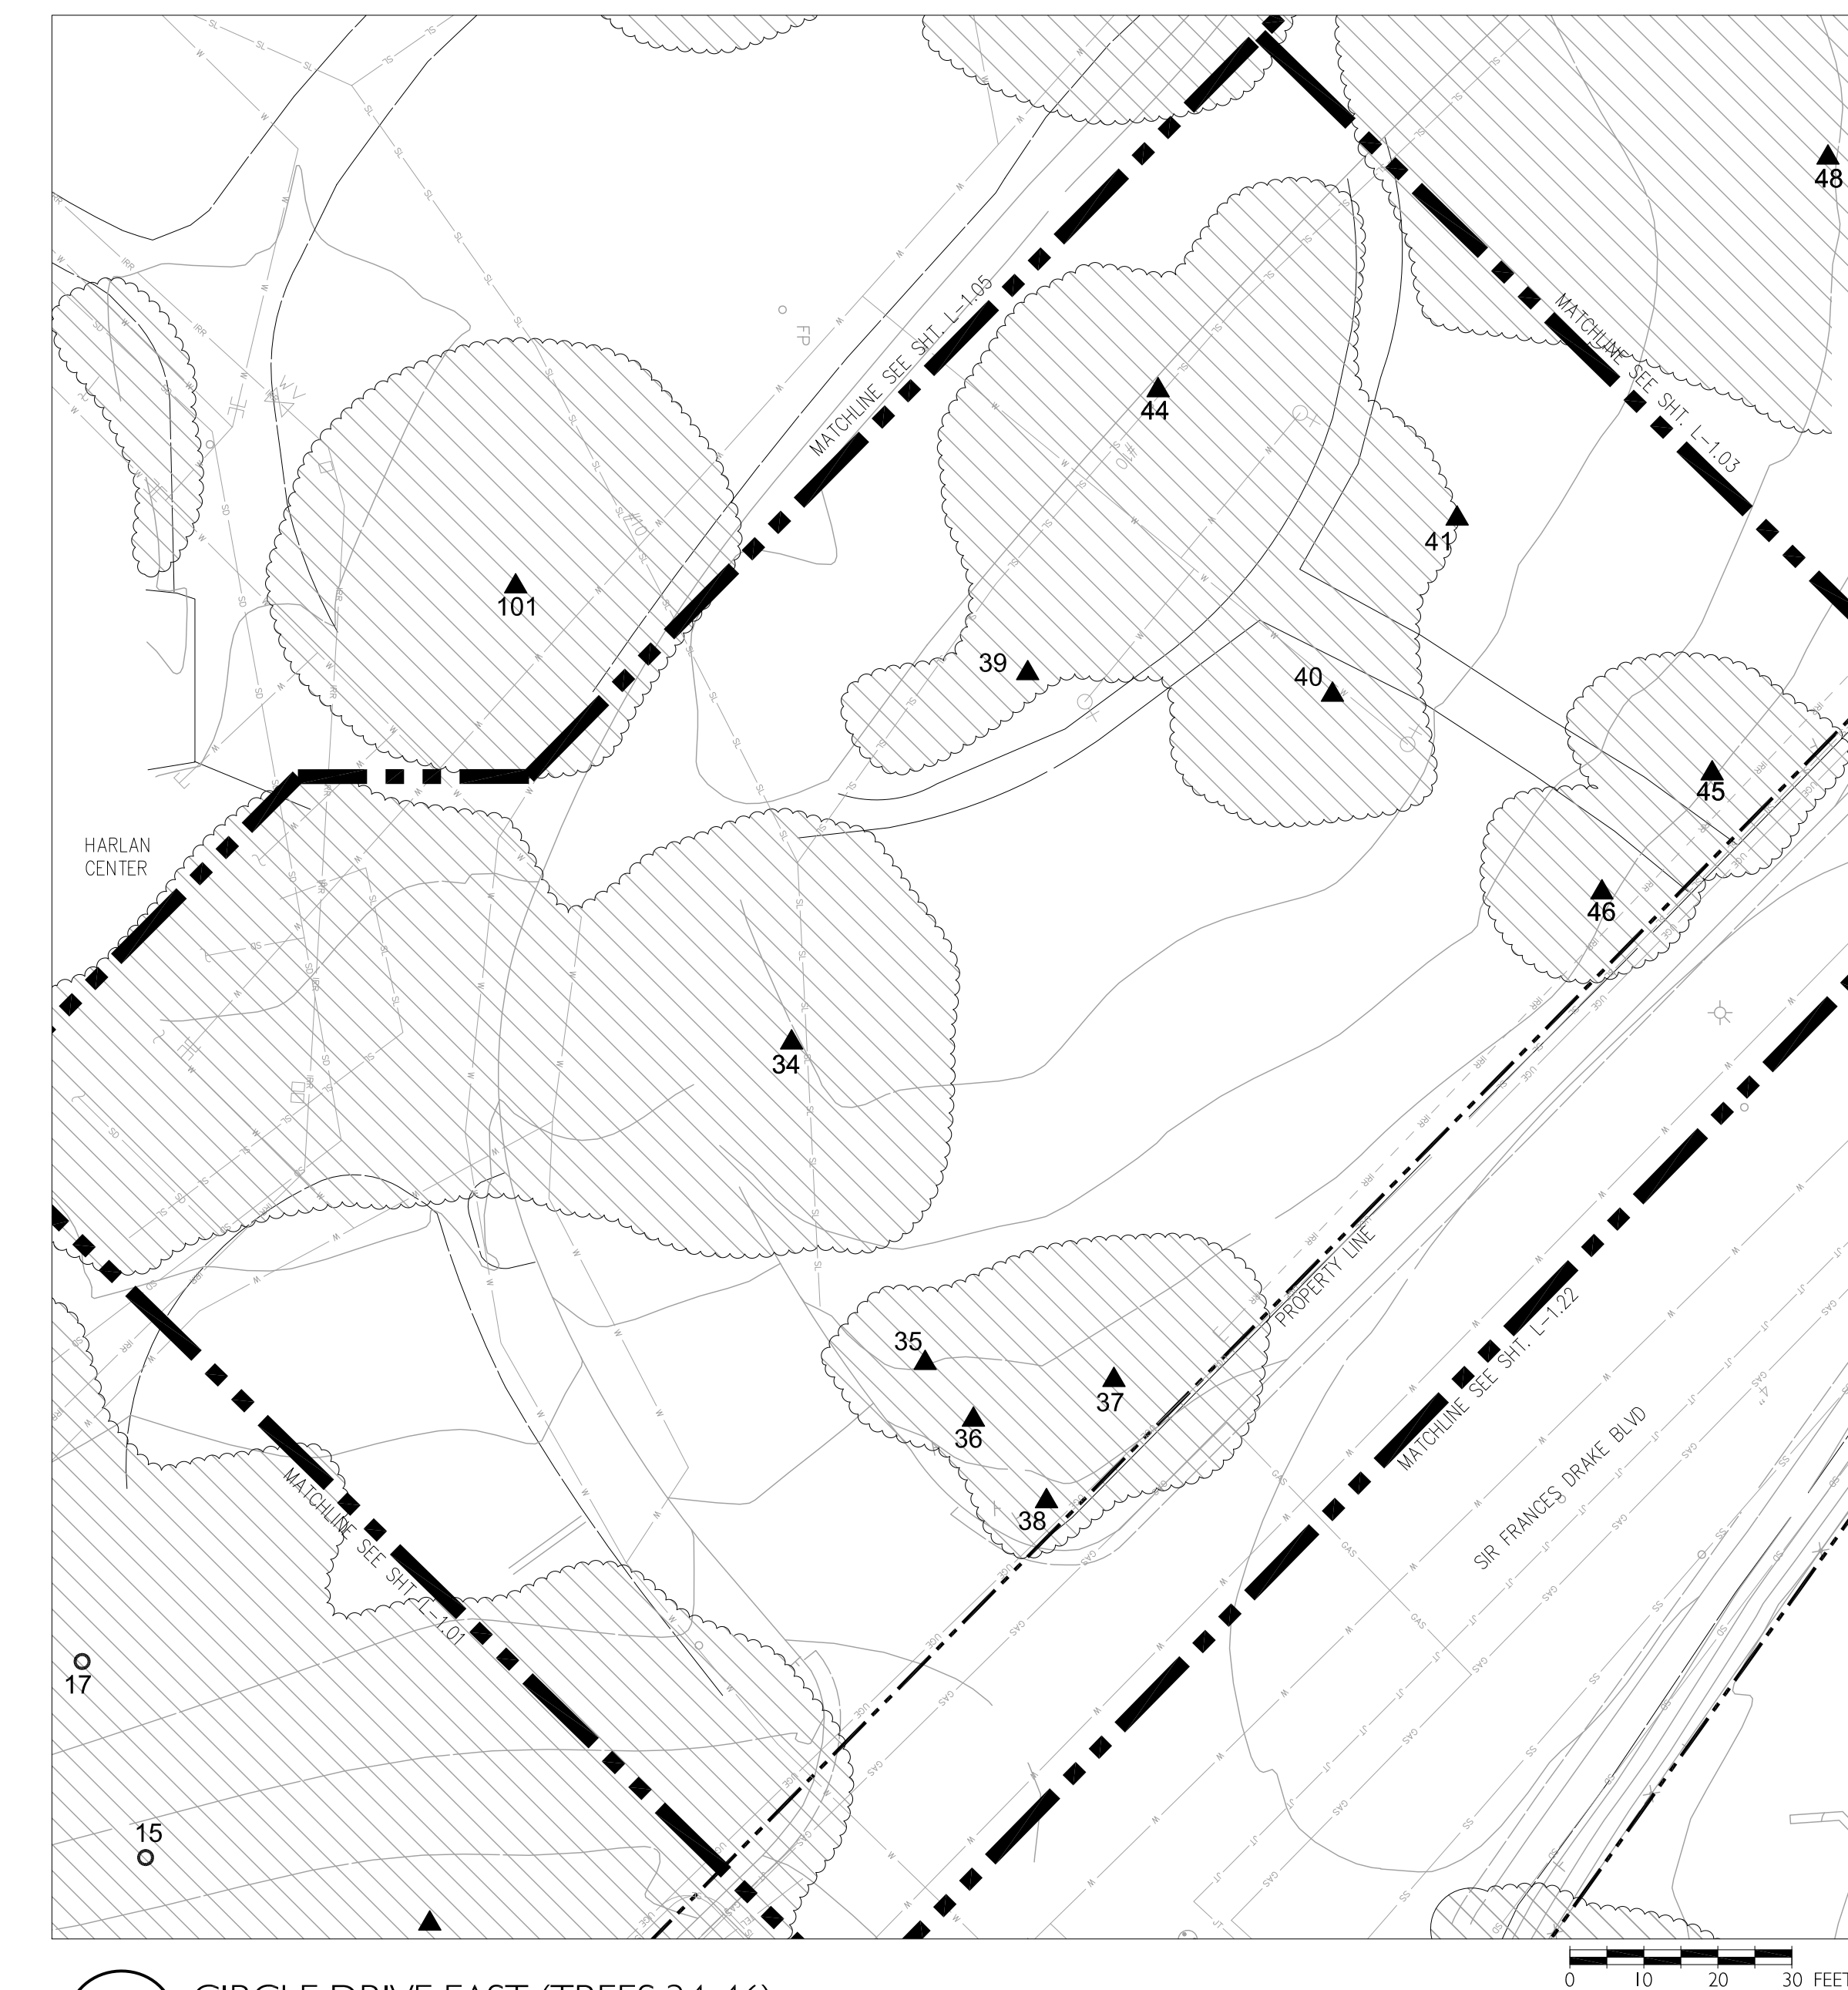
1 CIRCLE DRIVE EAST (TREES 34-46)
1" = 20', CONTOUR INTERVAL = 1'

TREE ASSESSMENT									SCHEDULE OF WORK	
Tree #	Species (common)	Species (scientific)	Location	Size	Health	Structural Condition	Impacts to infrastructure	Conclusion	Recommendations	Priority
34	Giant Sequoia	<i>Sequoiadendron giganteum</i>	In southwestern part of Circle Dr. area; just south of lawn area; immediately adjacent to a cut stump to the east-northeast	72"	Good. Infected with seiridium canker.	Good. Some crossing branches and deadwood.	None		Pole prune for visibility to 10'. Prune or remove shrubs for visibility.	2
35	European White Birch	<i>Betula pendula</i>	In island of trees located to the northeast of the giant sequoia with three European White Birch; within a large juniper thicket; 9.7' south/southwest of the bus stop on Sir Francis Drake	24"	Good	Fair. Some evidence of branch loss.	None		Prune branches less than 2" diameter up to 10' for visual clearance. Prune or remove understory shrubs for visibility.	4

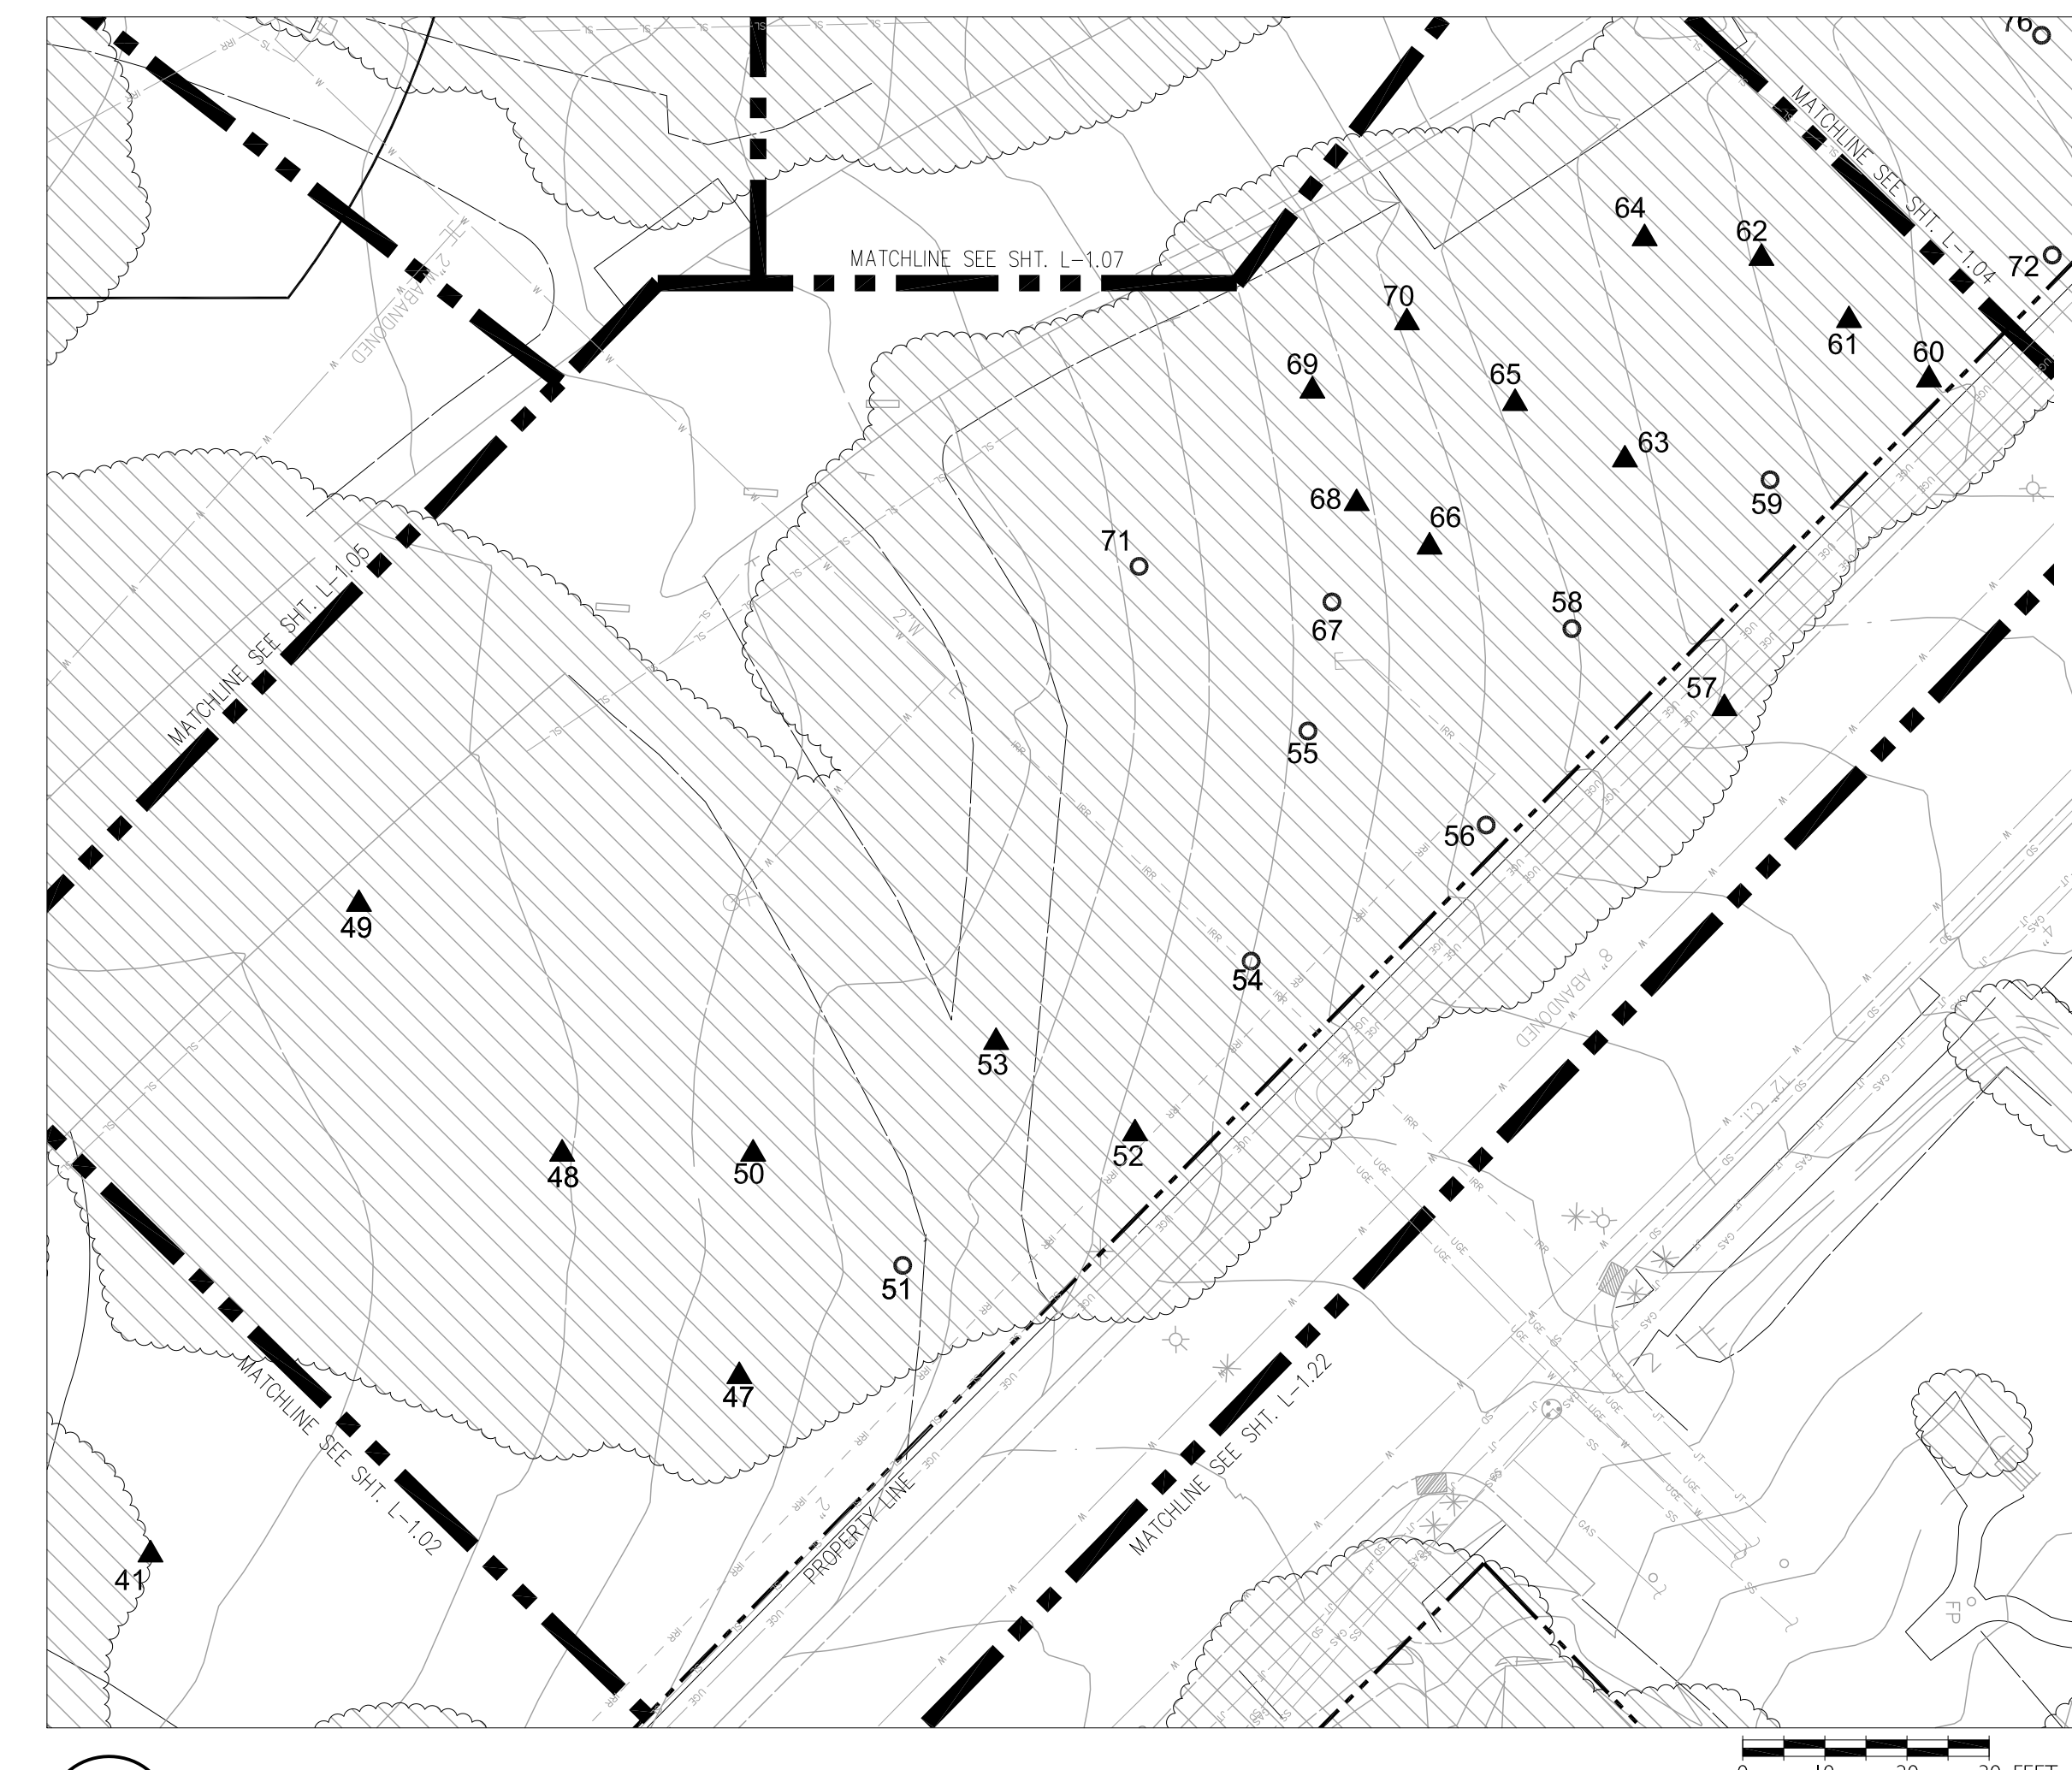
CIRCLE DRIVE MIDDLE (TREES 47-71)
1" = 20', CONTOUR INTERVAL = 1'

TREE ASSESSMENT									SCHEDULE OF WORK	
Tree #	Species (common)	Species (scientific)	Location	Size	Health	Structural Condition	Impacts to infrastructure	Conclusion	Recommendations	Priority
47	Incense Cedar	<i>Calocedrus decurrens</i>	Southeast of the sidewalk connecting with the Sir Francis Drake sidewalk and the crosswalk north across Sir Francis Drake	72"	Good	Poor to fair, 3 co-dominant stems.	None		Prune foliage up to 10' for visual clearance.	4
48	Coast Redwood	<i>Sequoia sempervirens</i>	Approximately 25' south of T-47 and midway between T-47 and T-49	60"	Good	Good	None.		Prune suckers for visibility.	3
49	Zelcova	<i>Zelcova serrata</i>	South of T-48.	60"	Good	Fair. Some odd pruning cuts in the past and some decay in the base.	None.	There are some dead branches over the parking area/road with defoliated bark that target cars and pedestrians.	Prune deadwood greater than 3" in diameter especially one ~10" limb over the road.	2

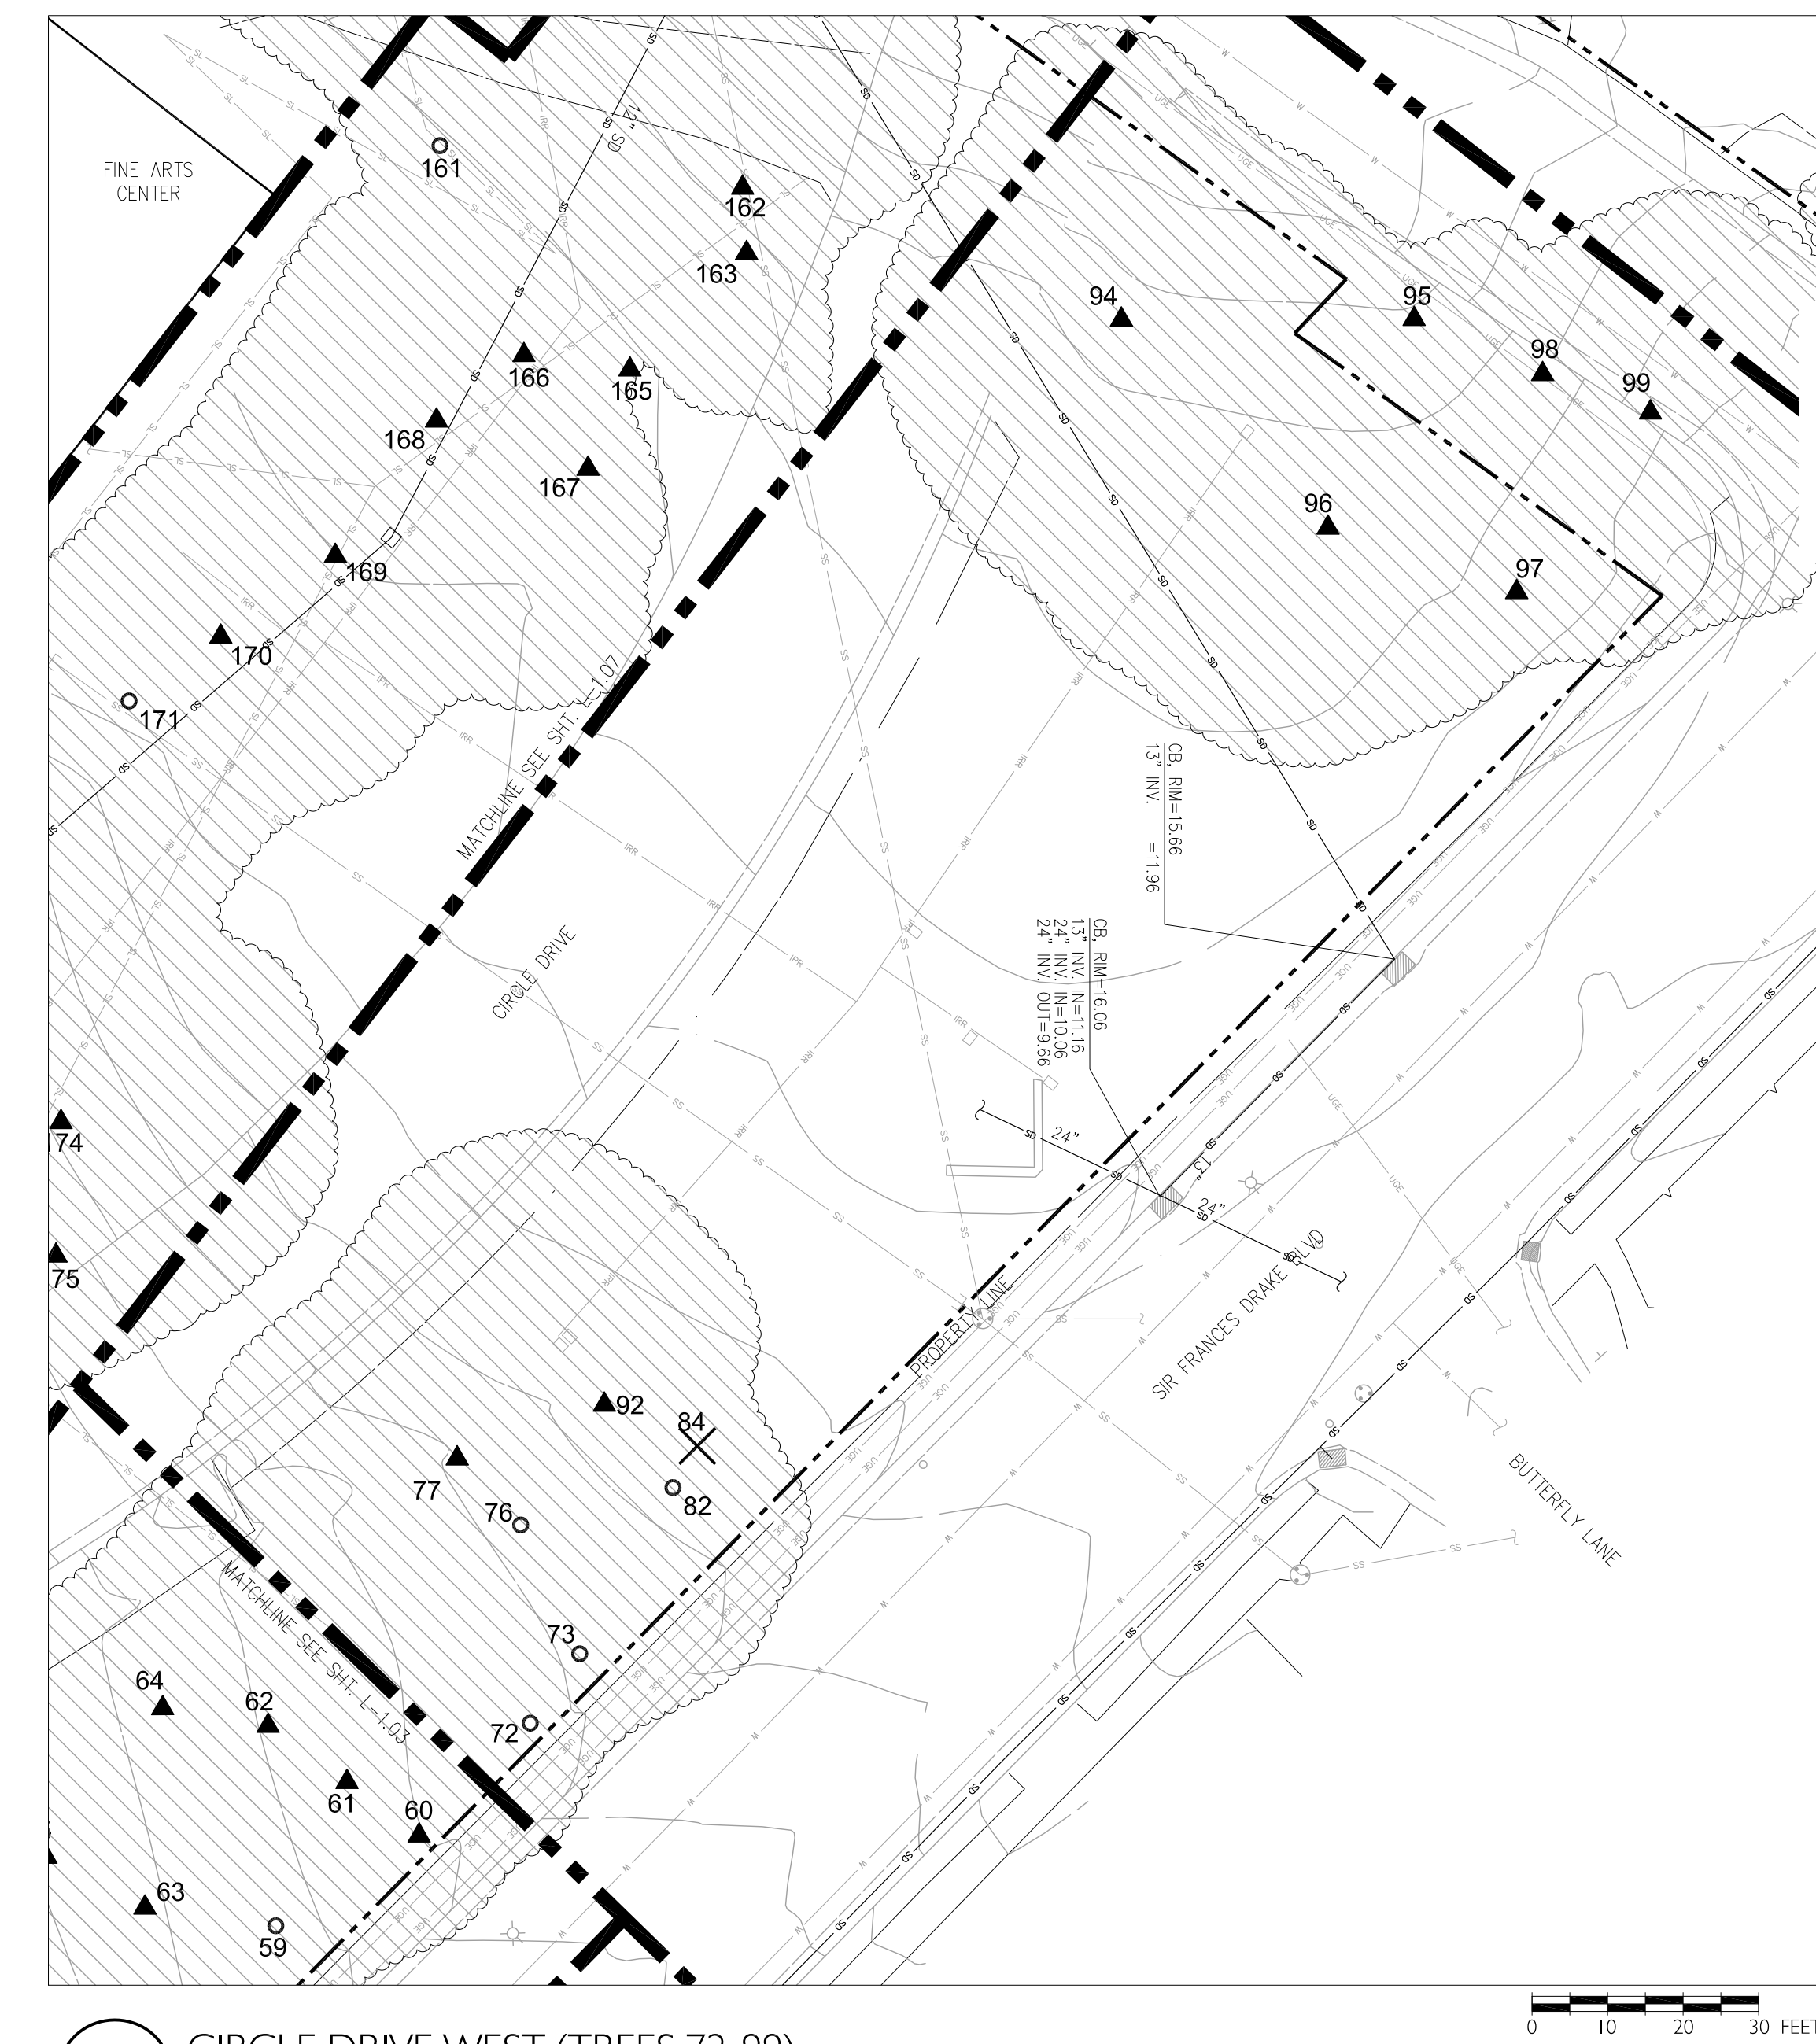
CIRCLE DRIVE WEST (TREES 72-99)
1" = 20', CONTOUR INTERVAL = 1'

TREE ASSESSMENT									SCHEDULE OF WORK	
Tree #	Species (common)	Species (scientific)	Location	Size	Health	Structural Condition	Impacts to infrastructure	Conclusion	Recommendations	Priority
72	European White Birch	<i>Betula pendula</i>	Approximately 10' south of the Sir Francis Drake sidewalk	16"	Fair. Some branch dieback.	Poor. Acute angle crotches and crossing branches.	None.	Deadwood is of a relatively small diameter and not a significant concern.	None	5
73	European White Birch	<i>Betula pendula</i>	Approximately 10' south of the sidewalk along Sir Francis Drake and 6' west of tree #72	12"	Fair. Some branch dieback.	Fair	None.		None.	5
76	European White Birch	<i>Betula pendula</i>	Approximately 6' east of black-top sidewalk	12"	Poor	Poor. Stunted growth and branch dieback.	None		None	5
77	Coast Redwood	<i>Sequoia sempervirens</i>	Approximately 6' south of T-76; approximately 7' east of the black-top sidewalk	24"	Good	Good	Slight lifting of sidewalk.		Prune sprouts at base. Prune branches and foliage up to 10' for visual clearance.	2

82	European White Birch	<i>Betula pendula</i>	Mid-grove to the west of the black top sidewalk; along the west edge of this grove	12"	Poor. Significant dieback.	Poor. Many stub cuts and broken branches.	None	This tree will continue to decline and will not recover.	None	5
84	European White Birch	<i>Betula pendula</i>	Approximately 8' north/northwest of a Coast Redwood which is close to the sidewalk along the parking area; one of the southernmost trees	12"	Very poor. Nearly dead.	Very poor. The base is covered with fungal fruiting bodies indicating sapwood decay and compromised structure.	None.	This tree could fall at any time.	Remove	1
92	Coast Redwood	<i>Sequoia sempervirens</i>	Less than 1' west of the black-top sidewalk that goes from the parking area to the sidewalk by Sir Francis Drake	24"	Good	Good	Slightly lifting black-top.		Prune sprouts at base. Prune branches and foliage up to 10' for visual clearance.	3

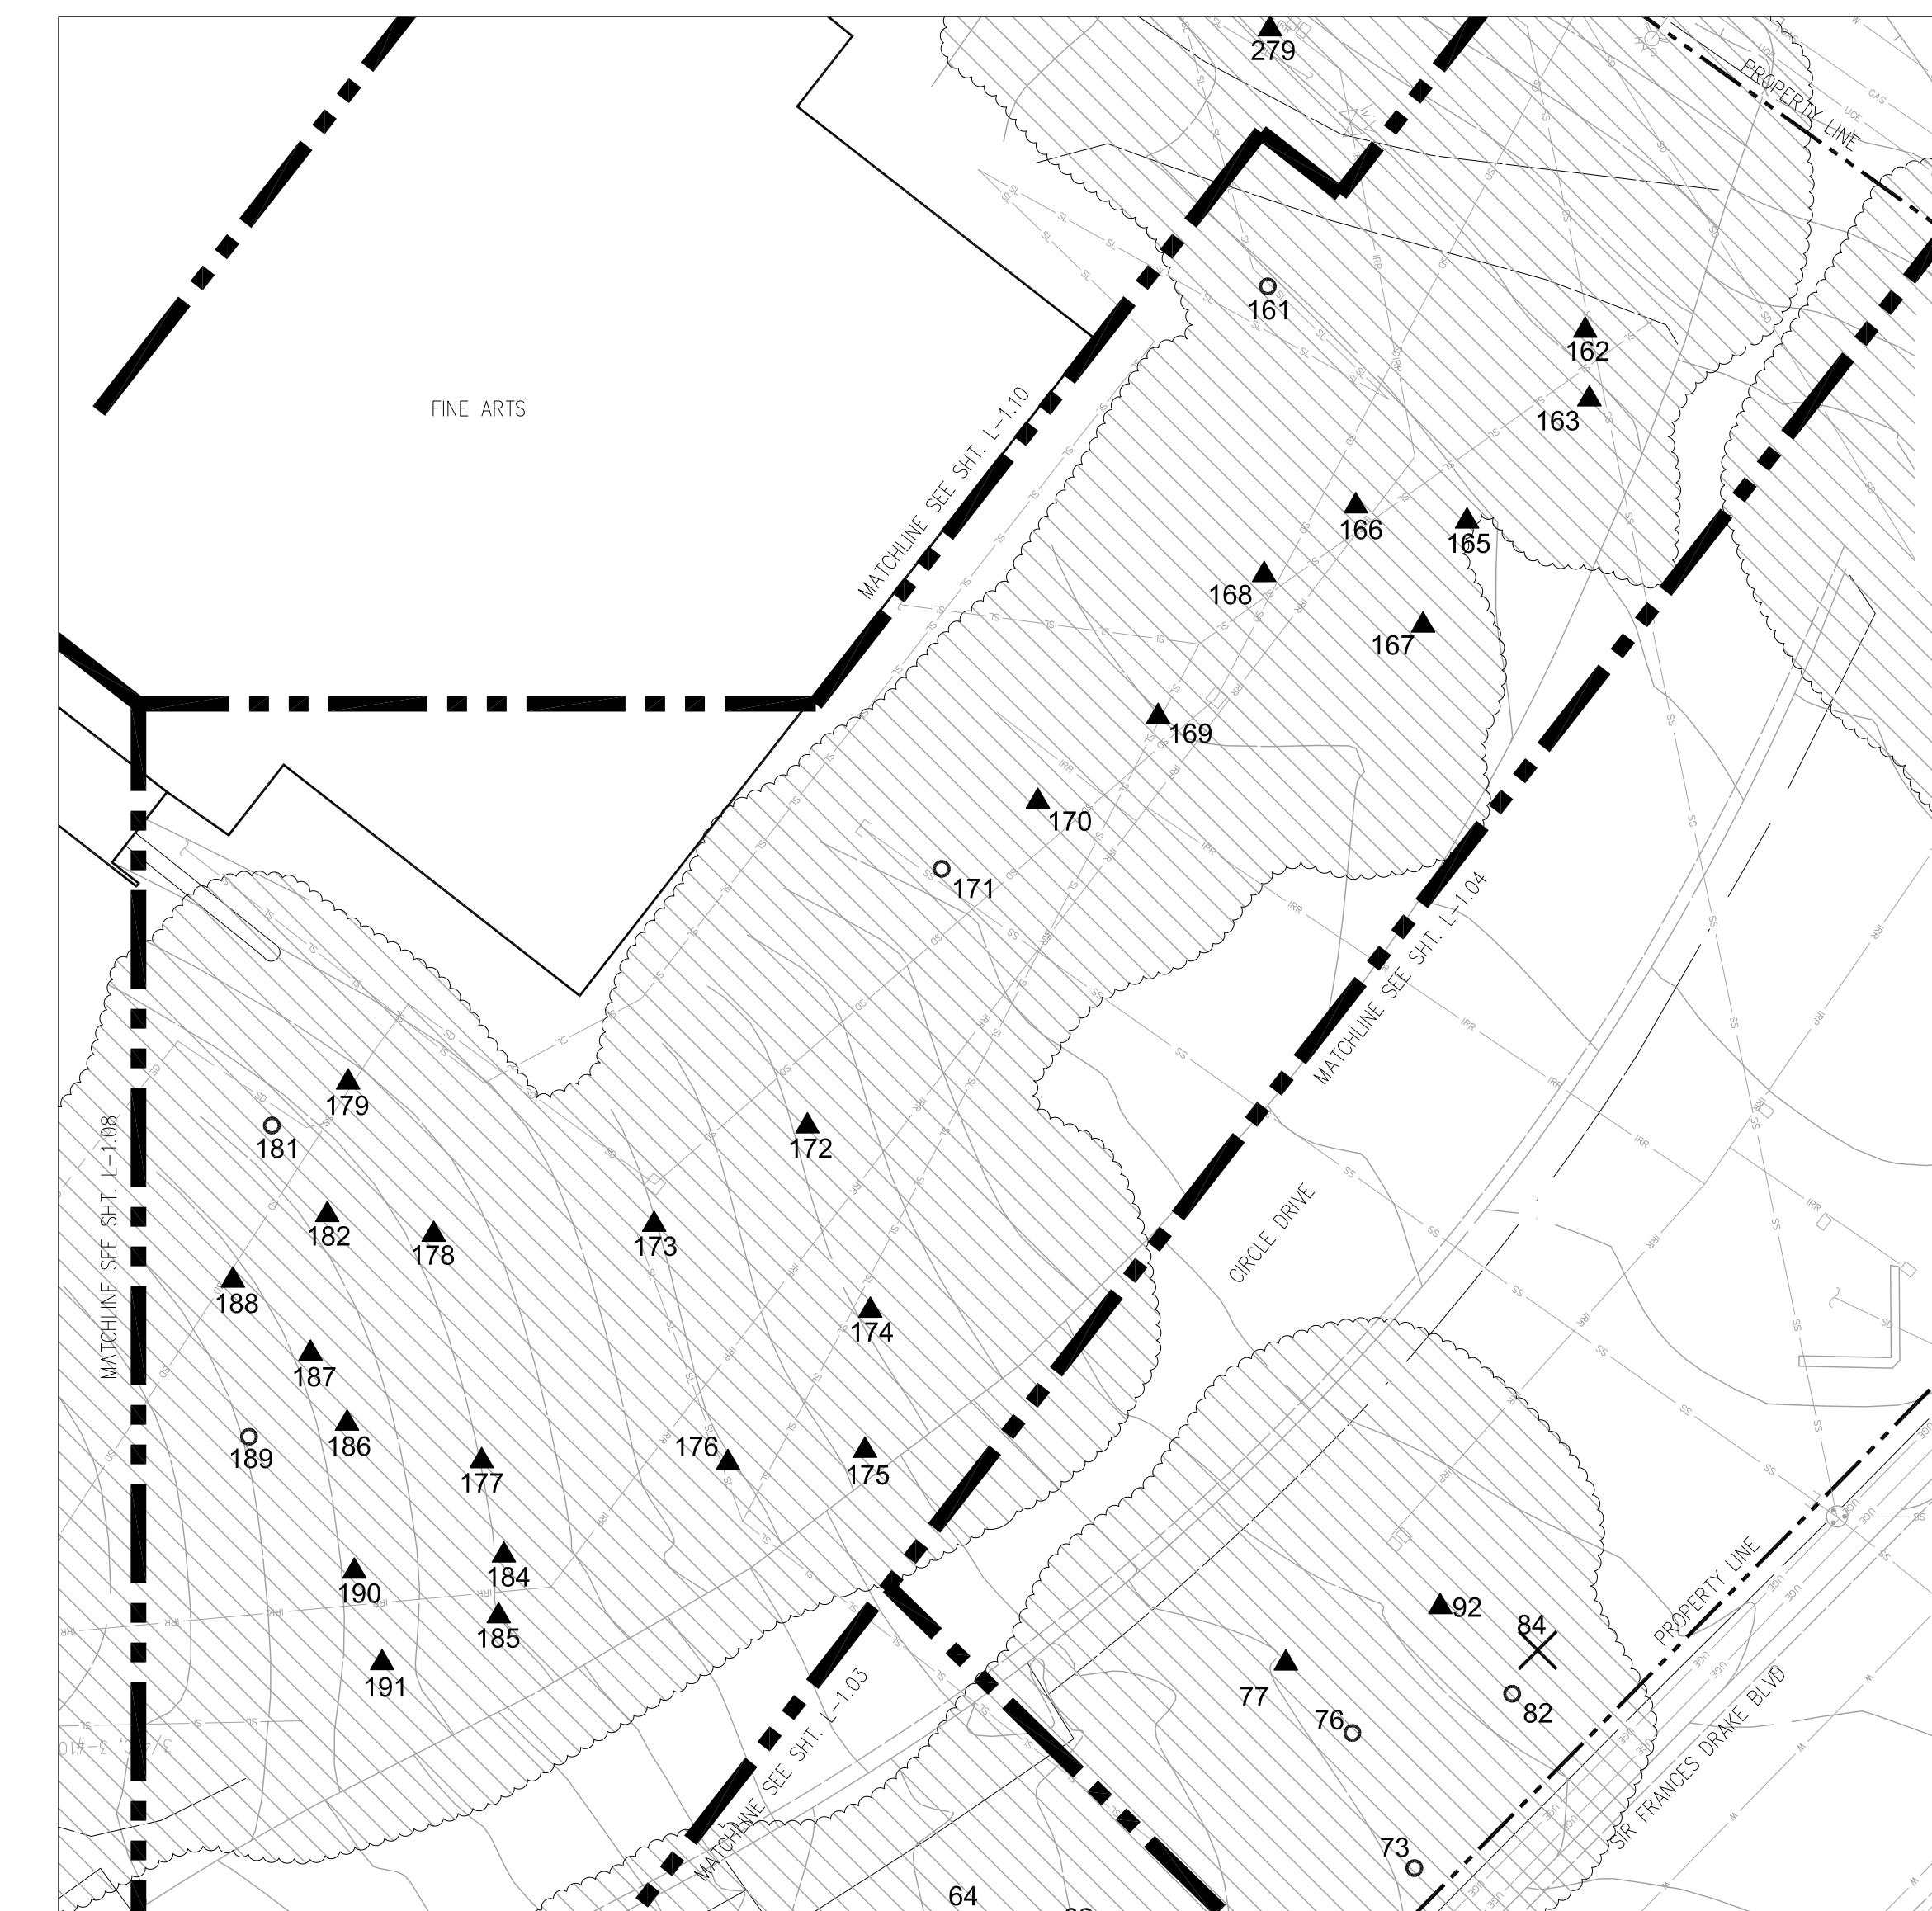
1 FINE ARTS NORTH (TREES 161-191)

Tree #	Species (common)	Species (scientific)	TREE ASSESSMENT						SCHEDULE OF WORK	
			Location	Size	Health	Structural Condition	Impacts to infrastructure	Conclusion	Recommendations	Priority
161	Coast Redwood	<i>Sequoia sempervirens</i>	4' south of the sidewalk north of the Fine Arts Center; approximately 5' from the sidewalk leading to the east entrance, next to the black-top driveway for this building	12"	Fair; sparse crown with competition on either side.	Good		None	None	5
162	Coast Redwood	<i>Sequoia sempervirens</i>	In a planter box between the driveway entrance to the Fine Arts Building and the sidewalk for the building; approx. 20' north/northeast of the northwest corner of the building; approximately 1.5' south from a cement retaining wall for the driveway and approximately 2' north of the cement walkway	20"	Good	Good		None	Limb up branches < 3" in diameter up to ten feet for visual clearance. Remove all sprouts down to grade.	3
