COLLEGE OF MARIN

TREE HEALTH PROJECT

KENTFIELD CAMPUS

JULY 10, 2014

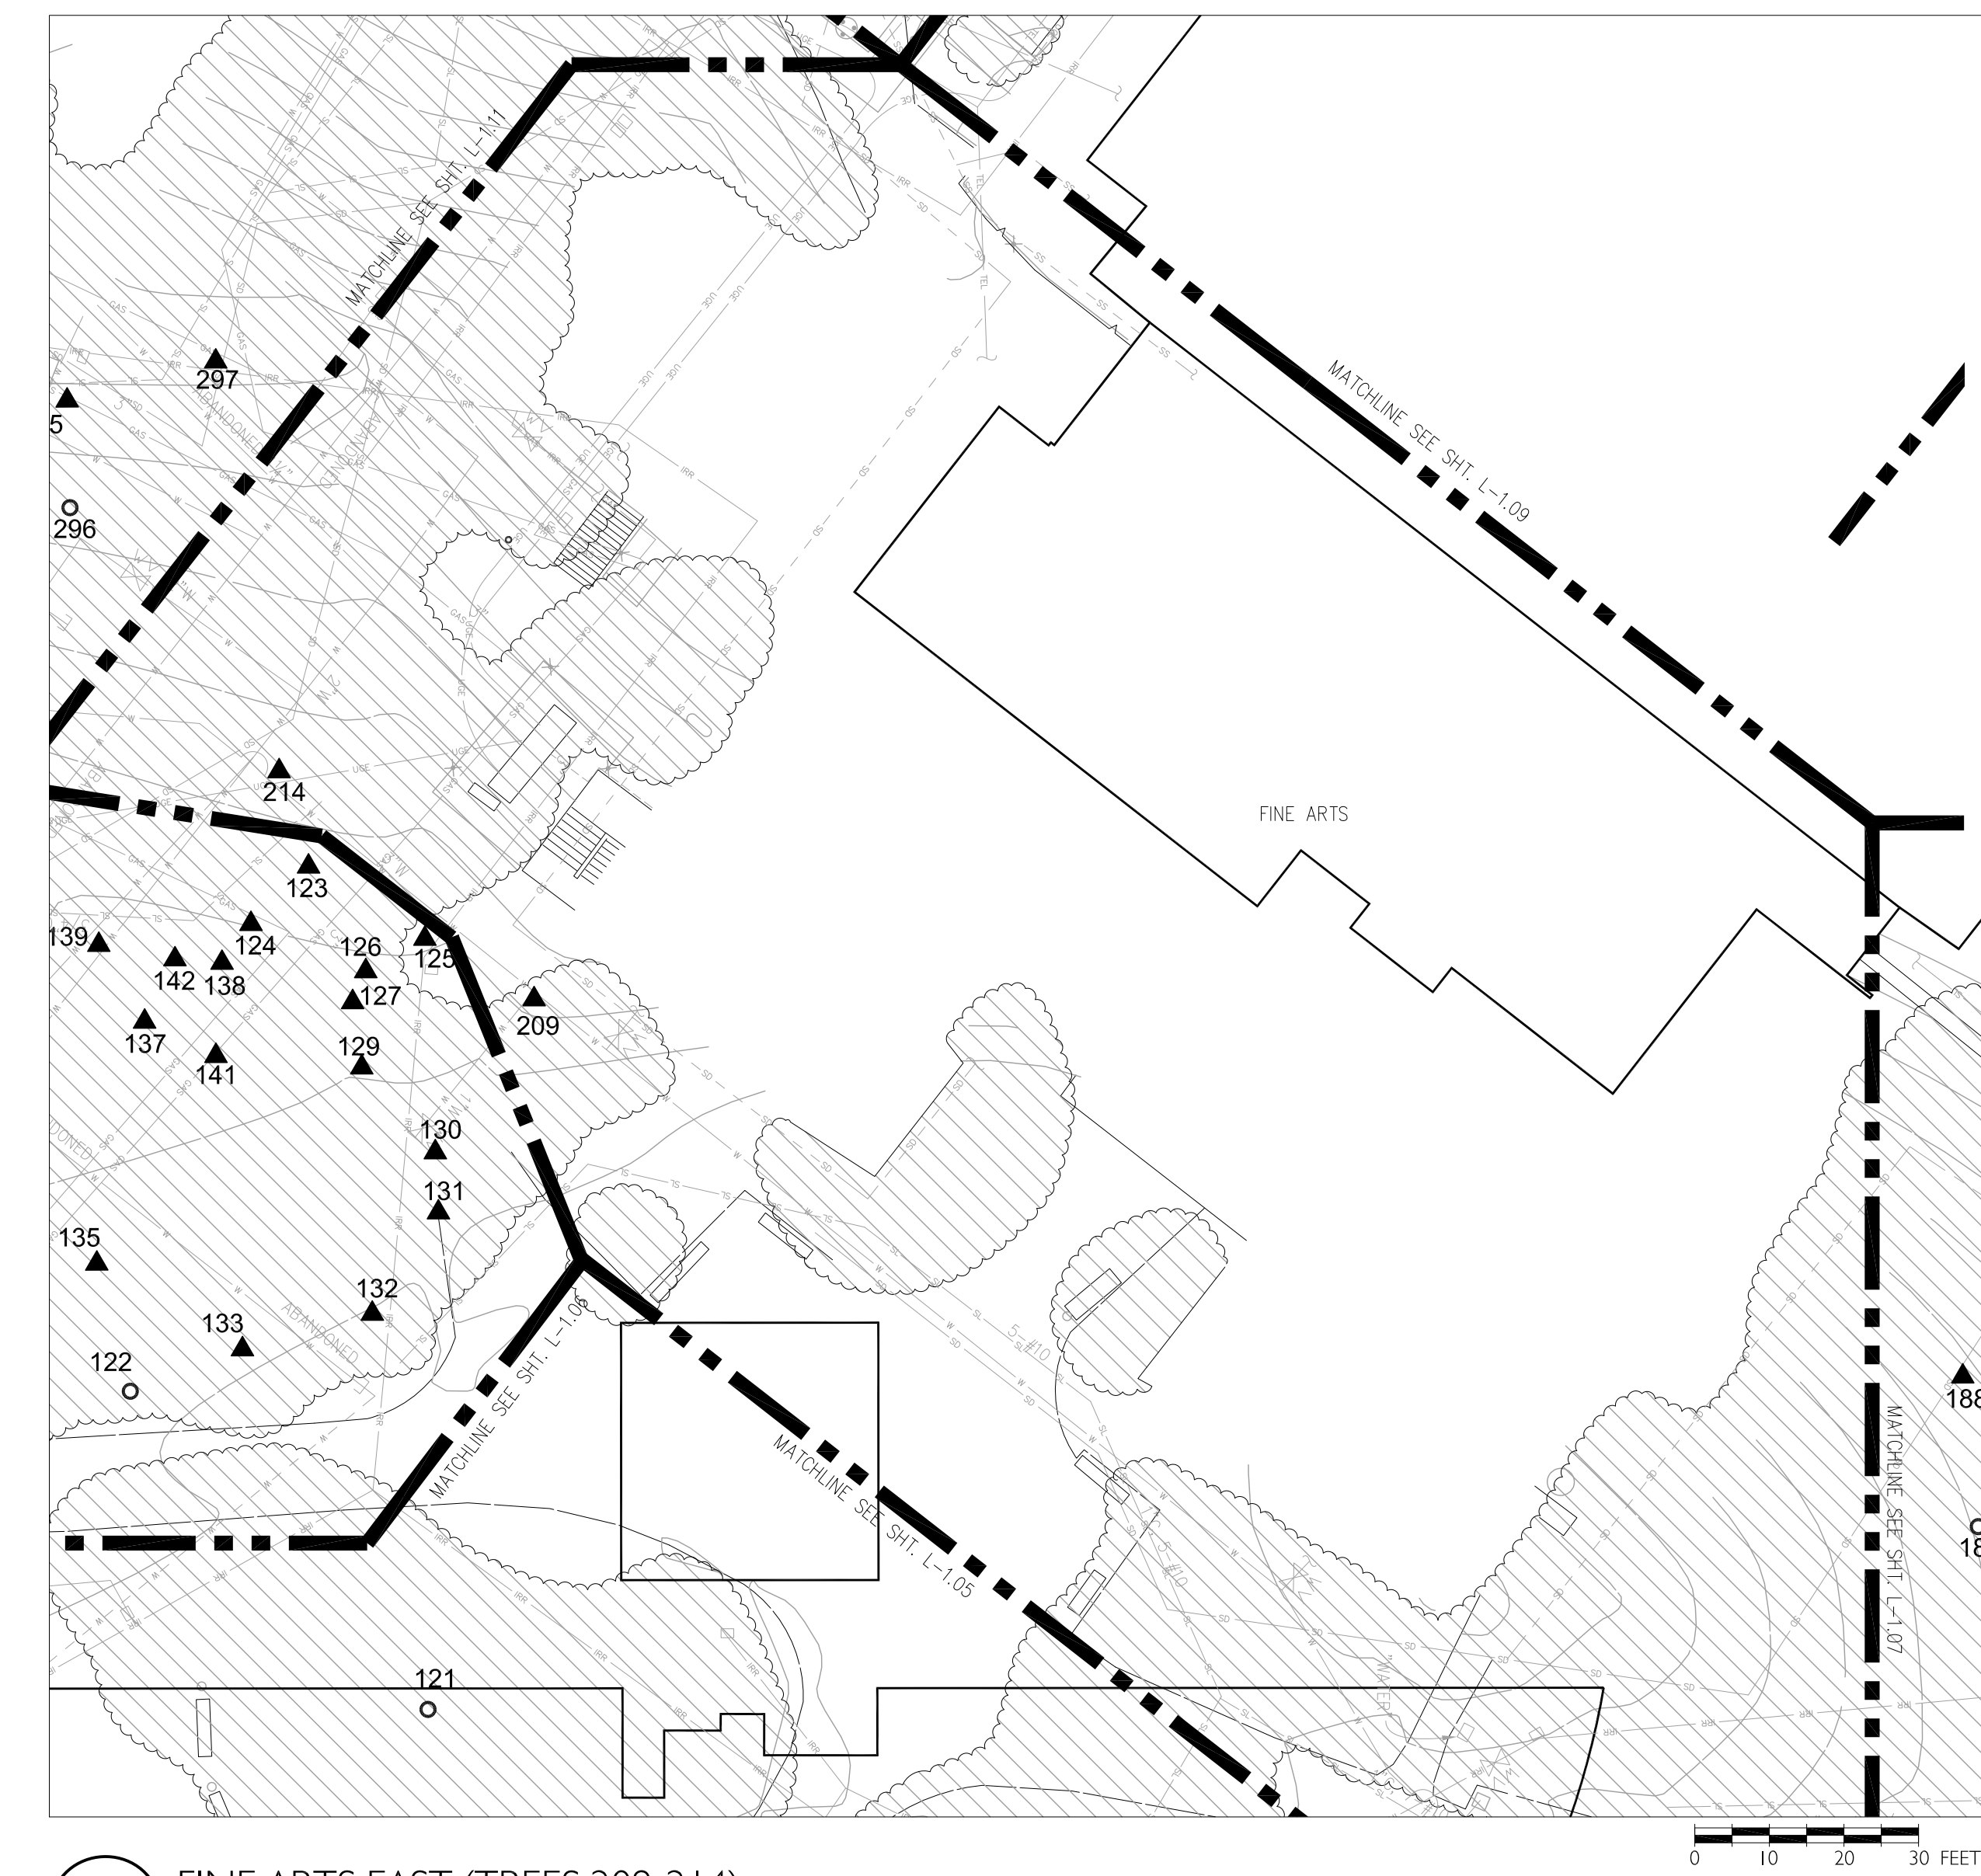
1 FINE ARTS EAST (TREES 209-214)
1" = 20', CONTOUR INTERVAL = 1'

TREE ASSESSMENT									SCHEDULE OF WORK	
Tree #	Species (common)	Species (scientific)	Location	Size	Health	Structural Condition	Impacts to infrastructure	Conclusion	Recommendations	Priority
209	American Persimmon	<i>Diospyros virginiana</i>	Opposite an equipment enclosure at the south end of the Fine Arts Building; within 4' of the black-top sidewalk	10"	Fair to poor; mature to over mature.	Fair; leggy structure. Has been directionally pruned away from pathway.	None		Reduce crown 15% and crown clean.	3
214	Coast Redwood	<i>Sequoia sempervirens</i>	In the middle of the black top sidewalk that descends to the west parking lot	24"	Good; some roots have been dug up to accommodate placement of rocks around a drainage grate.	Good	Good	Damage from digging probably won't cause significant damage.	Supply irrigation to mitigate root disturbance.	3

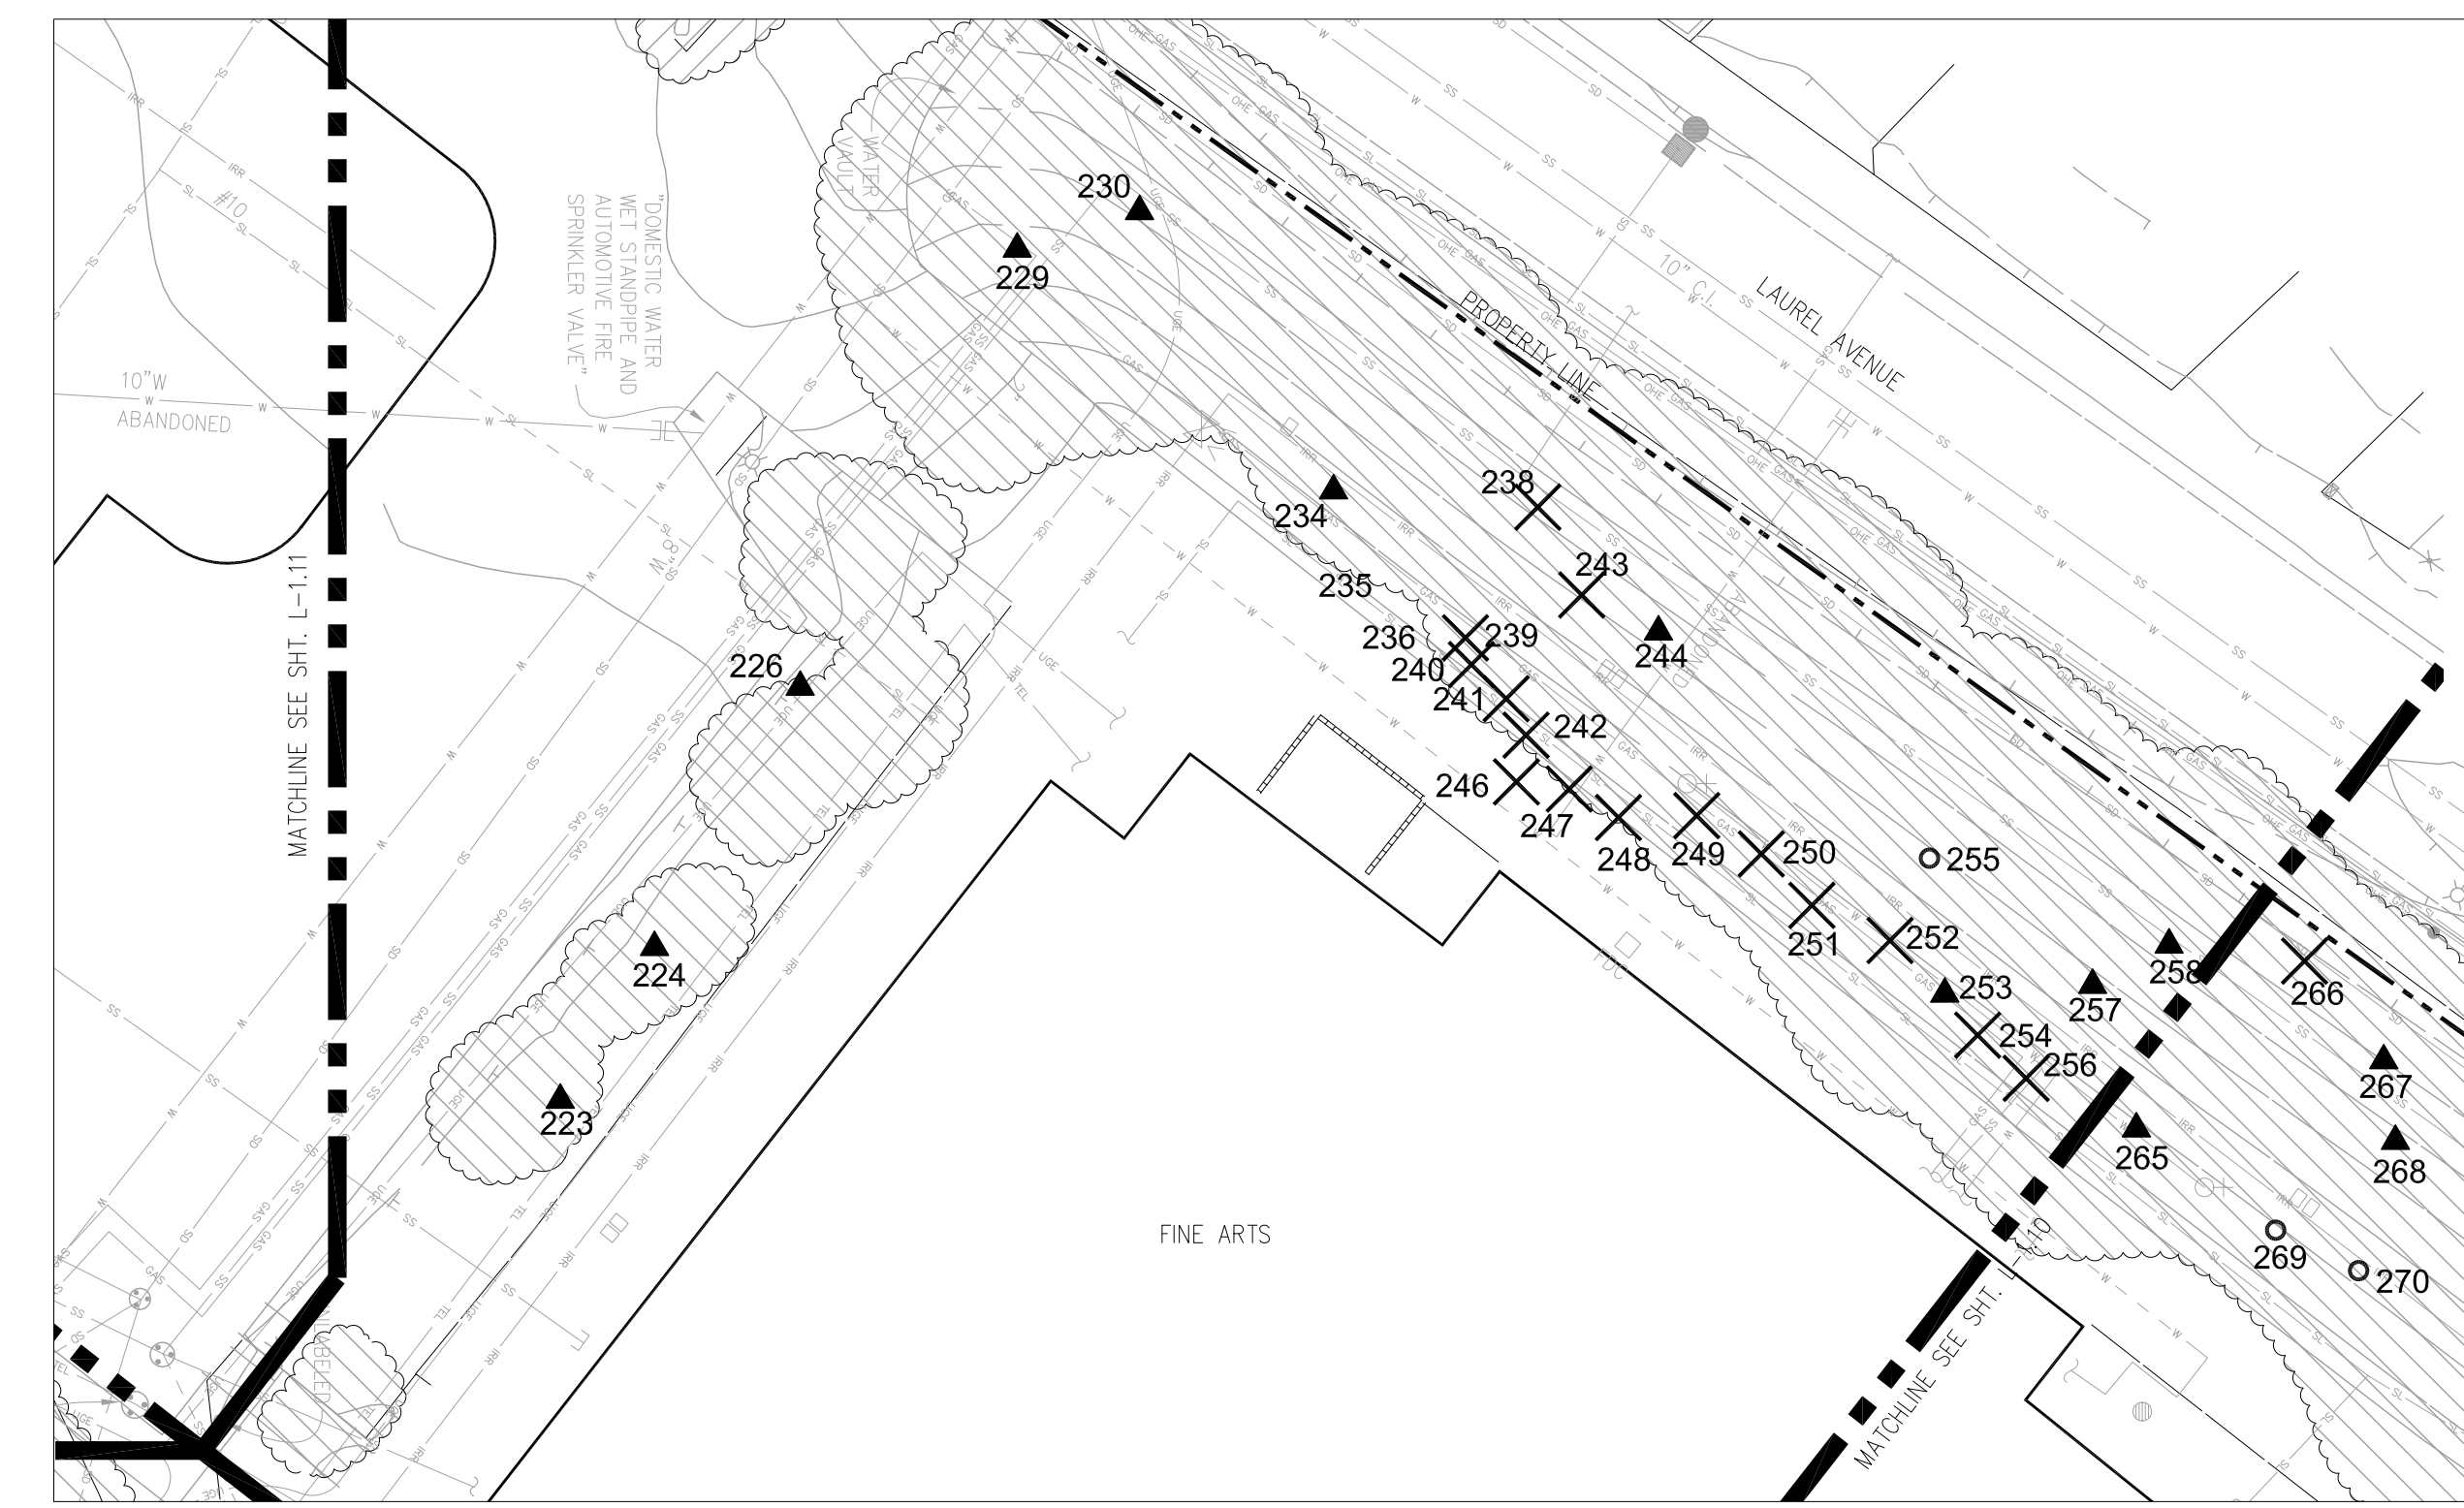
1 FINE ARTS SOUTH (TREES 222-258)
1" = 20', CONTOUR INTERVAL = 1'

Tree #	Species (common)	Species (scientific)	TREE ASSESSMENT					SCHEDULE OF WORK		
			Location	Size	Health	Structural Condition	Impacts to infrastructure	Conclusion	Recommendations	Priority
223	Coast Redwood	<i>Sequoia sempervirens</i>	Opposite the studio theater entrance; 10' south of the black-top sidewalk along the south side of the building; approximately 10' north of the west parking lot north curb	18"	Good	Good	None	None	Limb up branches < 3" in diameter up to 8' for visual clearance.	3
224	Coast Redwood	<i>Sequoia sempervirens</i>	Approximately 15' west of T-223 and approximately 8' south of the sidewalk along the south end of the building; toward the center of the building wall	8"	Good	Good	None	None	Limb up branches < 3" in diameter up to 8' for visual clearance.	3
226	Coast Redwood	<i>Sequoia sempervirens</i>	Approximately 7' south of the black-top sidewalk along the south side of the Fine Arts Theater; within 25' of the southwest corner of the building	10"	Good; top died out at one time and has come back with multiple sprouts.	Good	None	None	Prune top to select one dominant leader. Prune sprouts down to grade and raise canopy to 8'	3

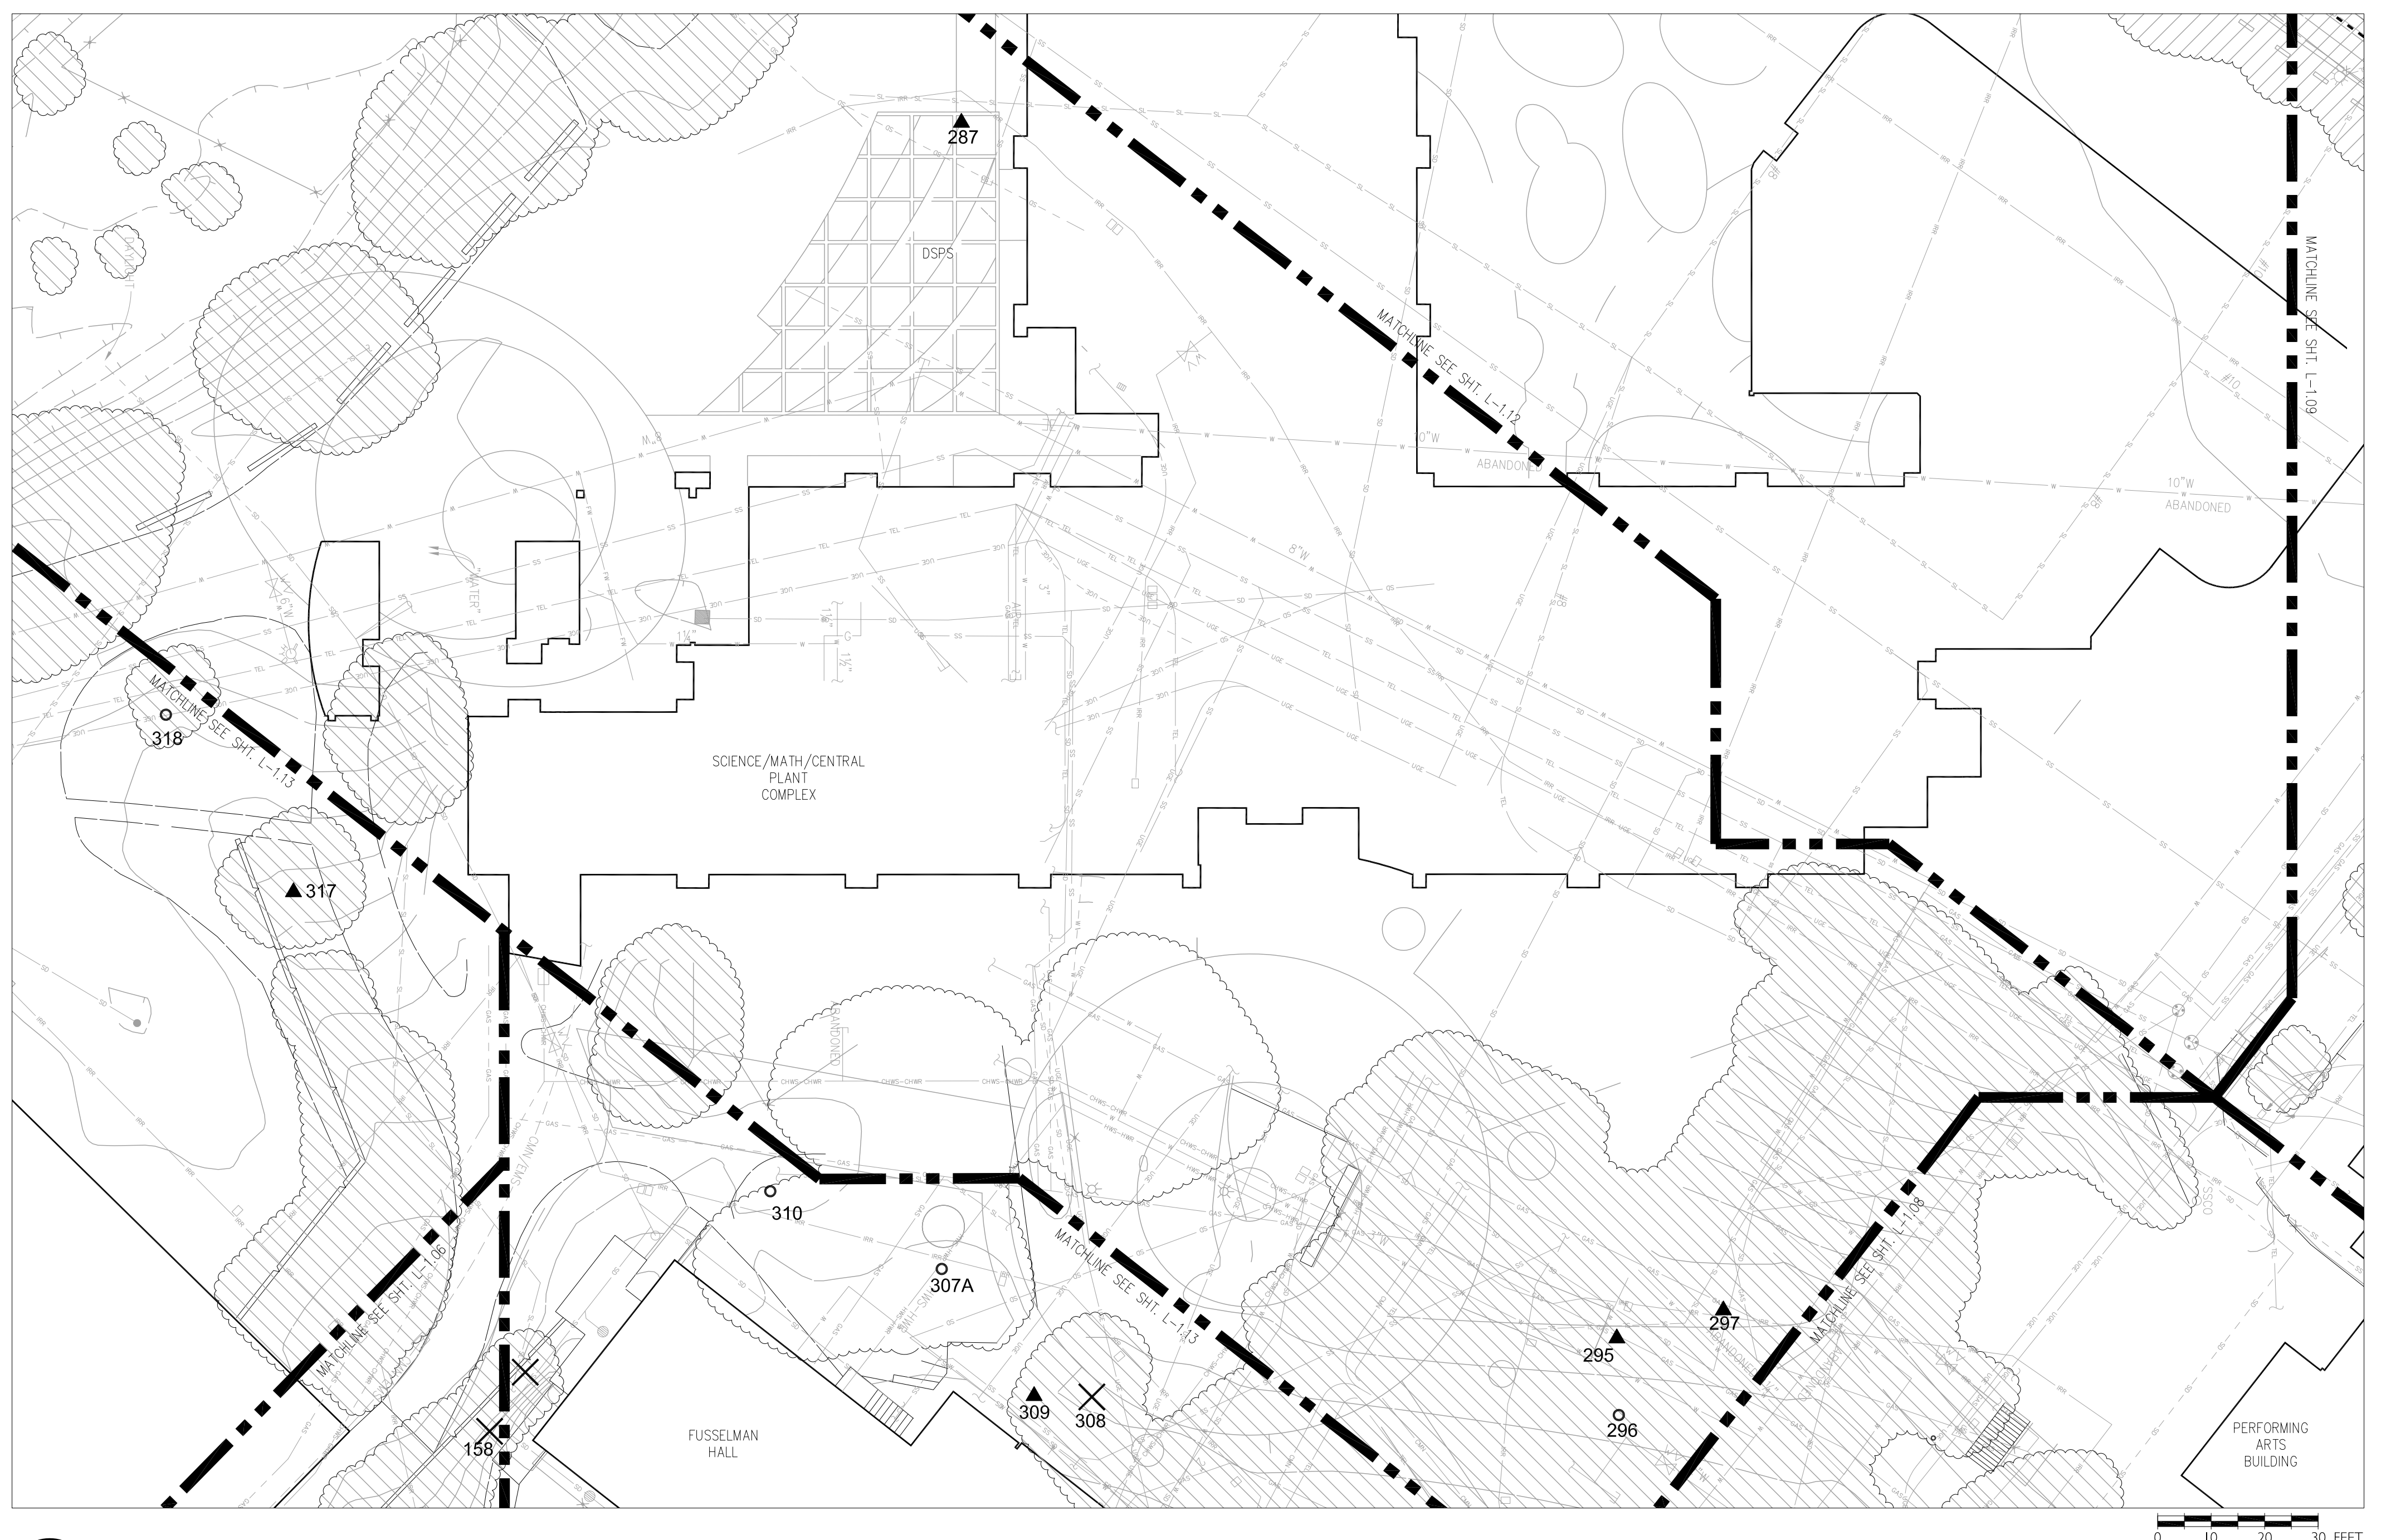
1 PARKING LOT #4/DICKSON HALL COMPLEX (TREES 287-297)
1" = 20', CONTOUR INTERVAL = 1'

Tree #	TREE ASSESSMENT								SCHEDULE OF WORK	
	Species (common)	Species (scientific)	Location	Size	Health	Structural Condition	Impacts to infrastructure	Conclusion	Recommendations	Priority
287	Southern Magnolia	<i>Magnolia grandiflora</i>	10' off the south side of the new Math and Science Building	12"	Fair to good; past wounds from vehicle traffic	Fair	None		Crown cleaning	4
295	Giant Sequoia	<i>Sequoiadendron giganteum</i>	In a planting island off of the northeast corner of Dickson Hall	5'	Fair; sleridium canker observed in upper and lower canopy	Good	None		Crown cleaning	4
296	Coast Redwood	<i>Sequoia sempervirens</i>	15-20' to the north of the Giant Sequoia; immediately adjacent to the black-top pathway that leads down between Dickson Hall and the Fine Arts Building; within 5' of the BBQ pit area	24"	Good	Good	None		None	5
297	Giant Sequoia	<i>Sequoiadendron giganteum</i>	Off of the northeast corner of Dickson Hall; 12' off of the northeast corner in a planting island that is between Dickson Hall and the Fine Arts Building	4.5'	Fair to good; sleridium canker present but not significant.	Fair; co-dominant leaders with included bark.	None	Cabling system is too low in canopy.	Have cabling system inspected by qualified arborist.	2

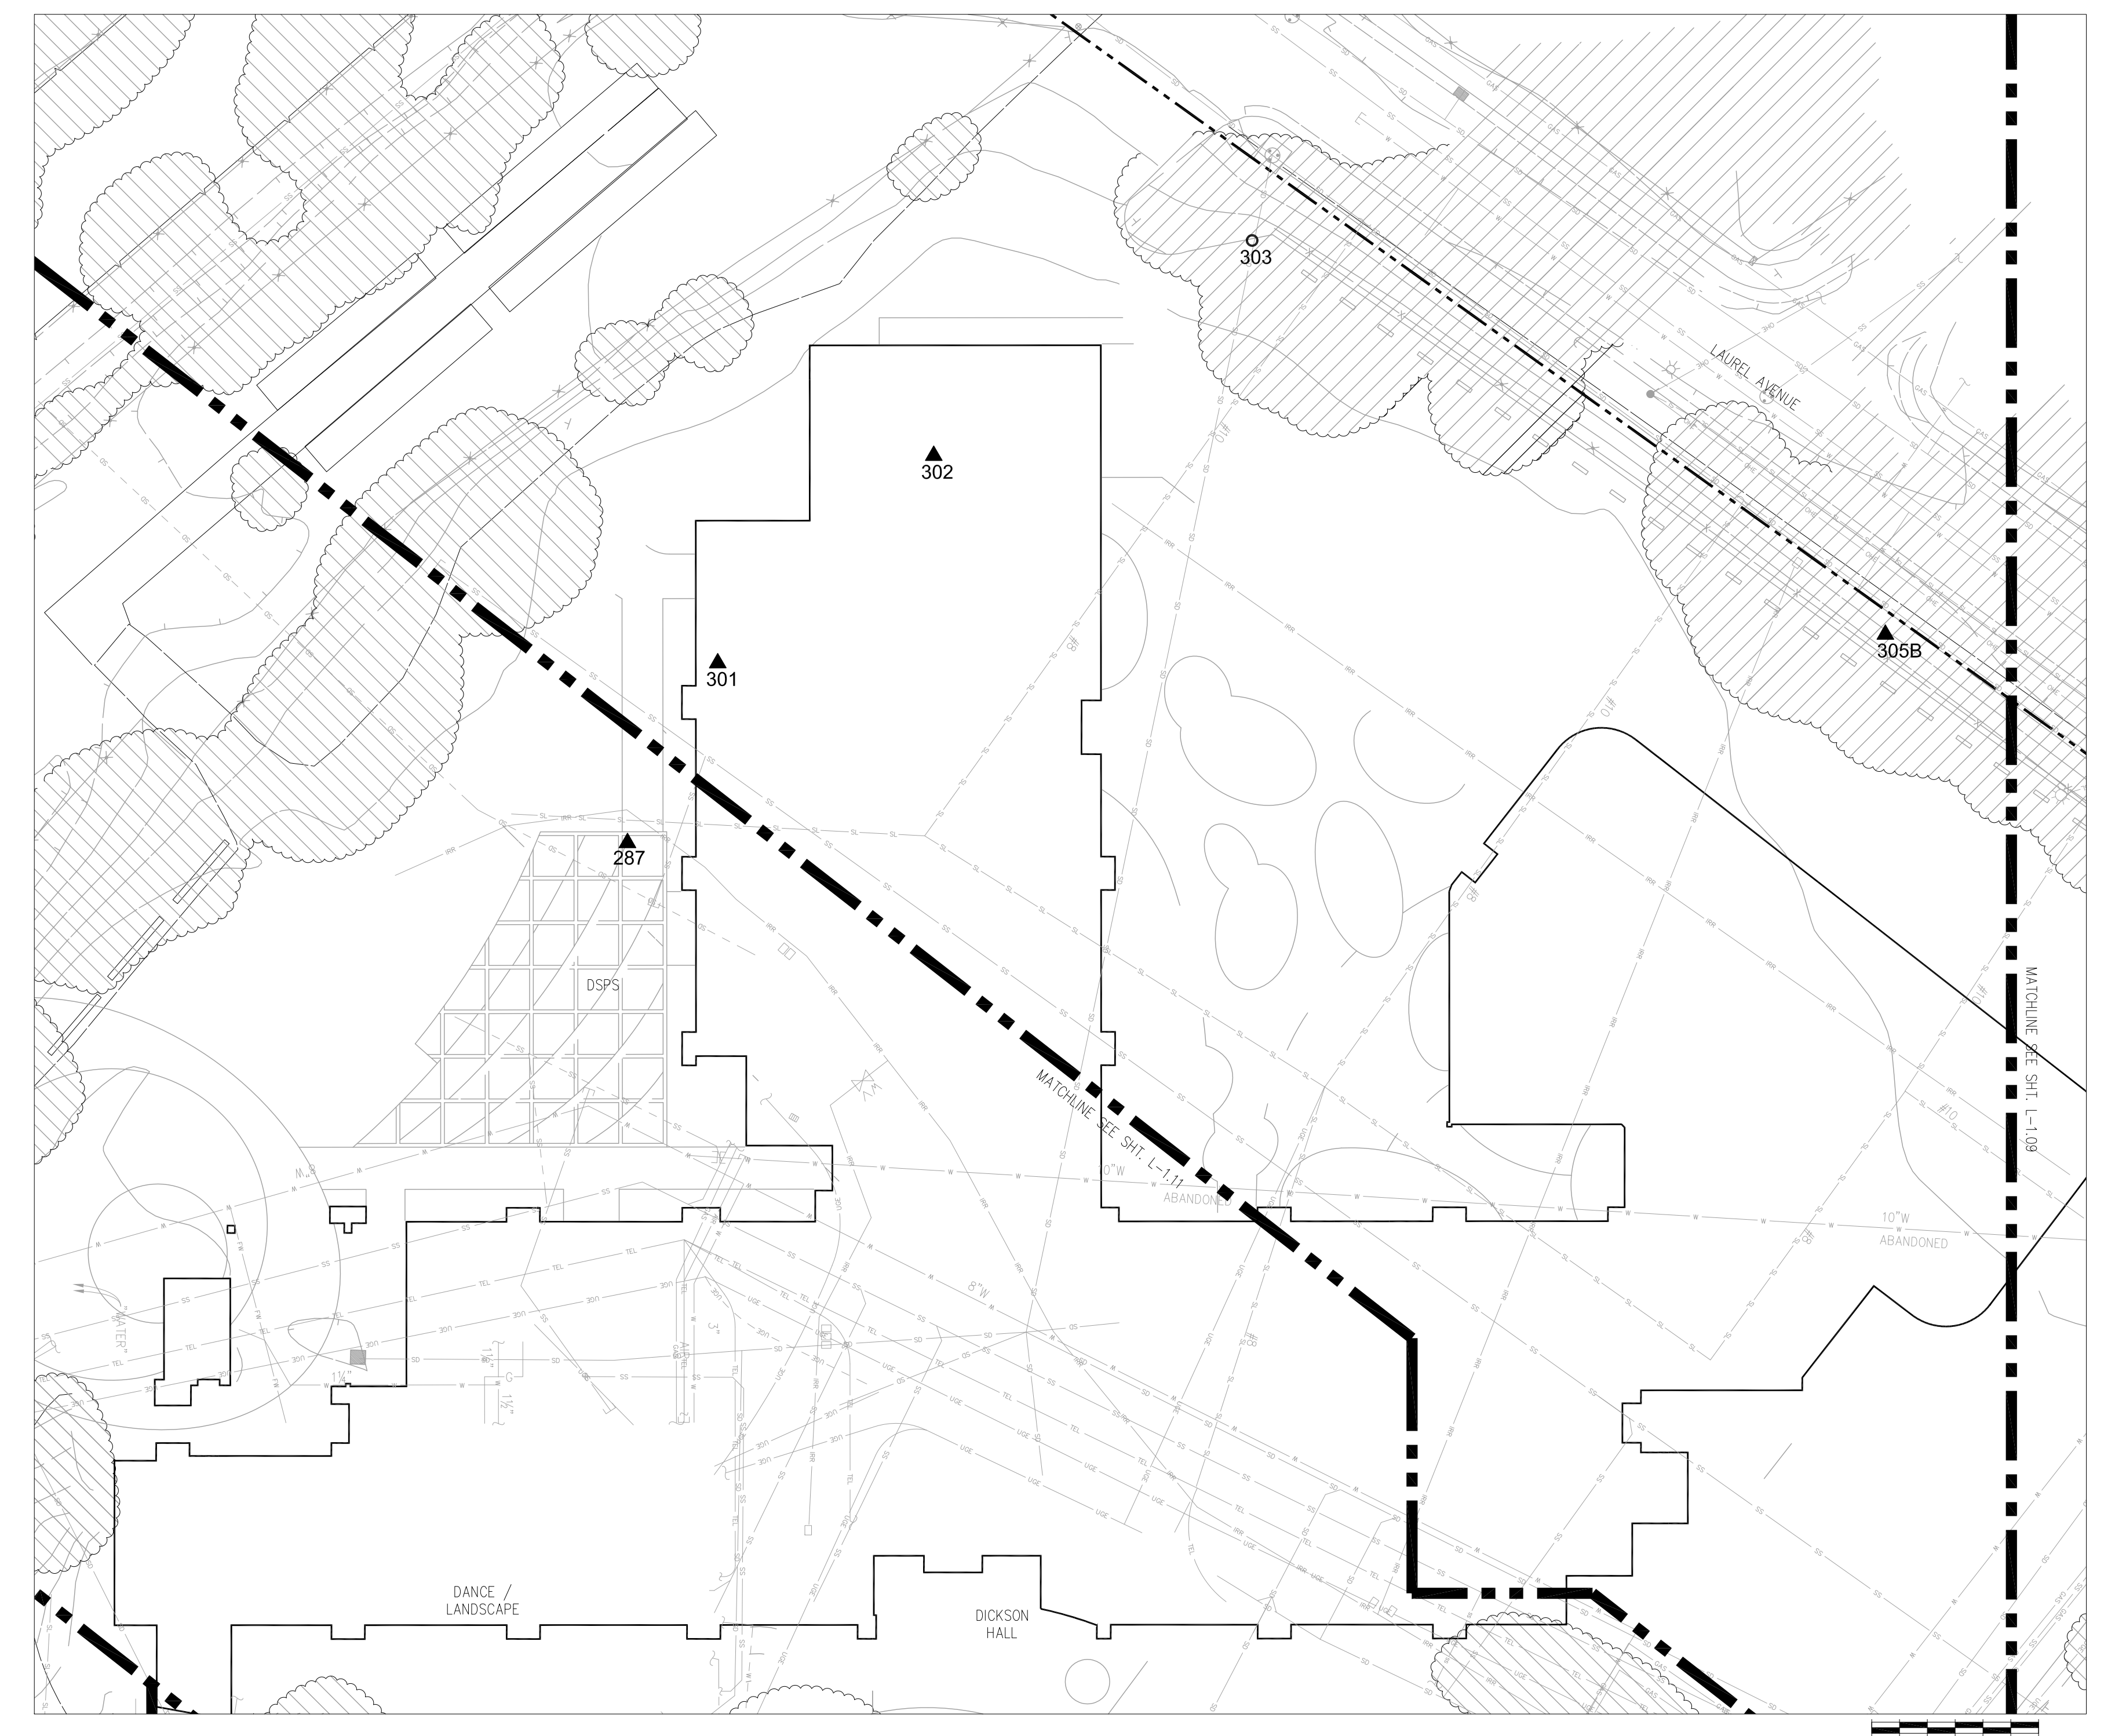
1 PARKING LOT #4/DICKSON HALL COMPLEX (TREES 301-305)
1" = 20', CONTOUR INTERVAL = 1'

Tree #	TREE ASSESSMENT								SCHEDULE OF WORK	
	Species (common)	Species (scientific)	Location	Size	Health	Structural Condition	Impacts to infrastructure	Conclusion	Recommendations	Priority
301	Coast Redwood	<i>Sequoia sempervirens</i>	Southeast corner of parking lot #3; near the DSPS building and across the road to the south	Two main stems; 36" and 18"	Fair to good	Fair; the tree has two stems. One stem is dominant the other is subordinate.	None	Small 6" sprout growing off southwest side of tree.	Prune sprouts at base. Prune branches and foliage up to 10' for visual clearance. Remove 6" sprout down to grade.	3
302	Evergreen Ash	<i>Frazinus uhdei</i>	At the south edge of the parking lot #3	18"	Fair	Fair	None		Crown cleaning to remove deadwood	4
303	Coast Live Oak	<i>Quercus agrifolia</i>	In the southwest corner planting island of parking area #3	Clump of two trees 12" and 32"	Fair; the larger tree has had a large branch removed to accommodate a new fence.	Fair	None		None	5

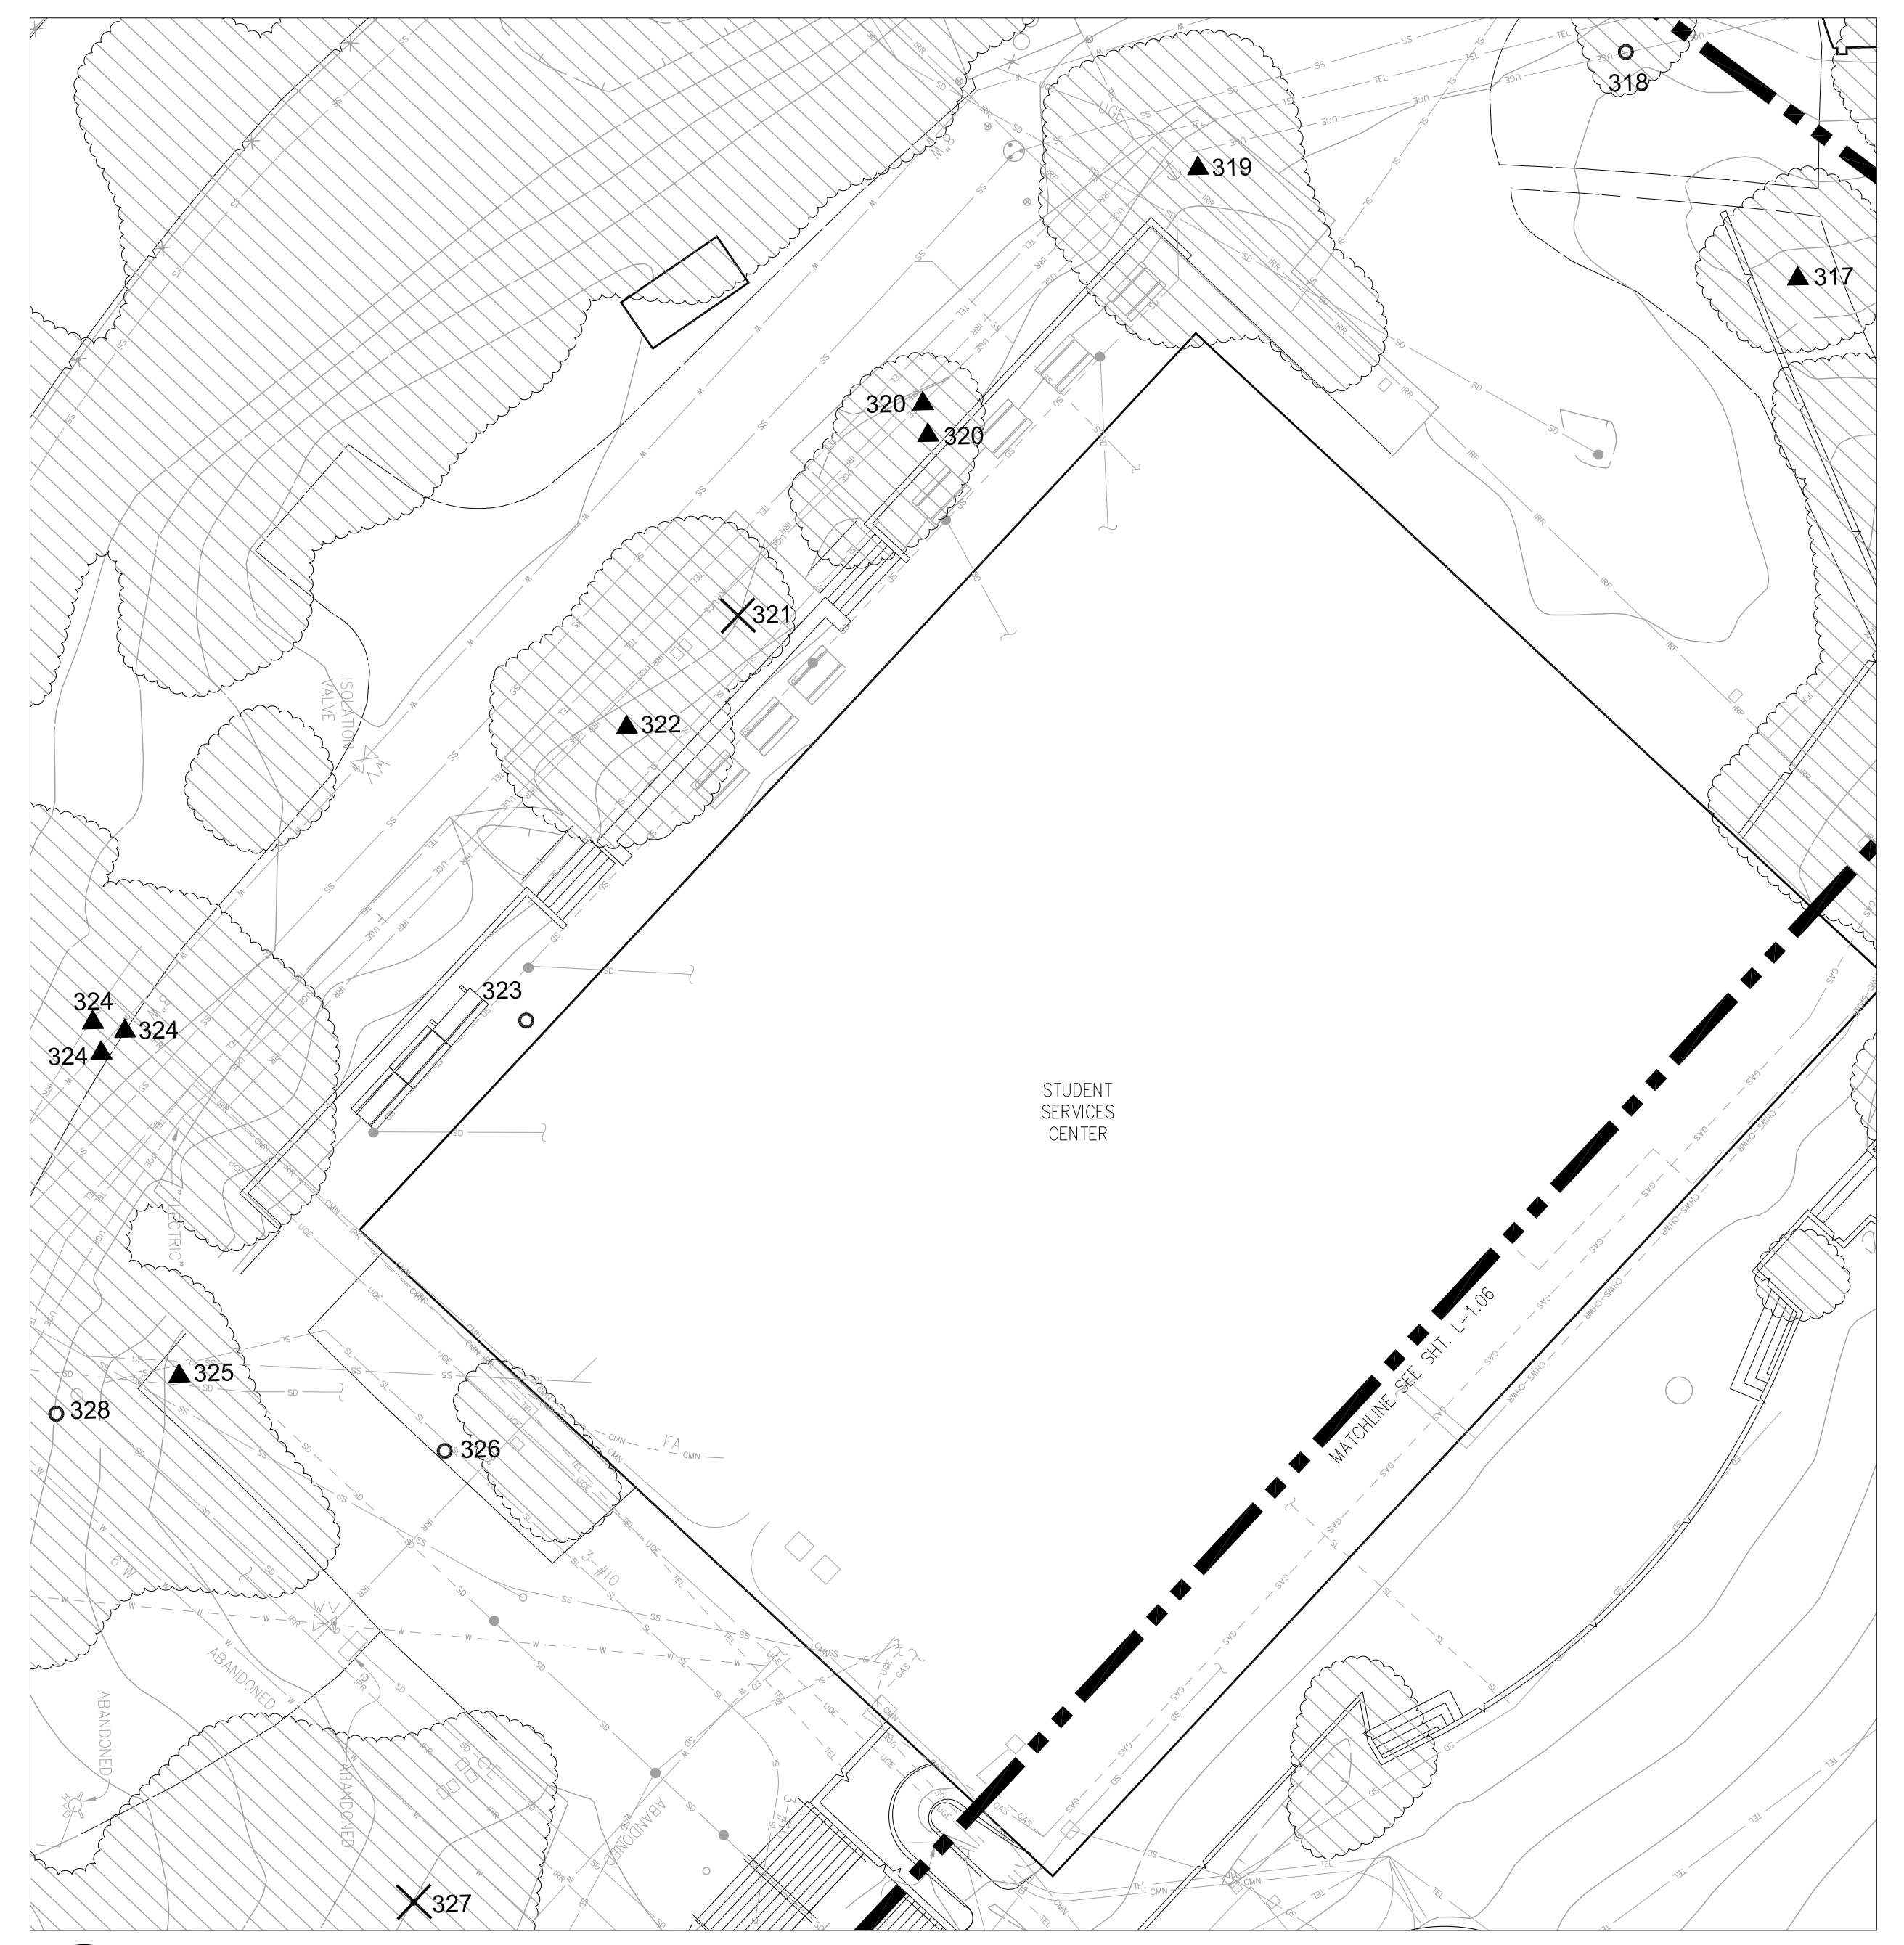
2 STUDENT SERVICES CENTER (TREES 317-328)
1" = 20', CONTOUR INTERVAL = 1'

TREE ASSESSMENT									SCHEDULE OF WORK	
Tree #	Species (common)	Species (scientific)	Location	Size	Health	Structural Condition	Impacts to Infrastructure	Conclusion	Recommendations	Priority
317	Coast Live Oak	<i>Quercus agrifolia</i>	Northwest corner of the Student Services Building; northwest corner of the parking area to the west of the Student Services Building; 1.5' from a large retaining wall at the northwest corner of the parking area	6"	Good; juvenile.	Fair	None		Prune to develop one central leader.	4
318	Valley Oak	<i>Quercus lobata</i>	On west side of the Student Services Building; west of the parking area	6"	Fair; growing in a confined area bordered by a retaining wall	Fair	None		None	5
319	Catalpa	<i>Catalpa speciosa</i>	Off of the southwest corner of the Student Services Building	24"	Fair; mature to over mature. Low vigor.	Fair	None	SW-reaching branch towards enclosed high voltage area has been damaged by vehicles and has large crack at attachment. Guy wire extends through canopy and is in direct contact with tree.	Remove deadwood over 2" in diameter. Remove SW extending branch approximately 8' in diameter which has cracks at base and evidence of vehicle damage.	2

320	Sweetshade	<i>Hymenosporum flavum</i>	Within 3' of a cement retaining wall; off of the south side of the Student Services Building; west of the west-most set of doors on the south side of the building	12"	Fair to poor; decay column from base of tree to first crotch. Decay in center most leader.	Poor to fair	None		The center most leader splits into three with decay in the middle stem.	3
321	Pin Oak	<i>Quercus palustris</i>	In center planting island off of the south side of the Student Services Building; east of the west-most stairway on the south side of the building	8"	Fair; basin planted	Poor; lateral branch taking over as leader.	None	Combination of basin planting and poor structure.	Remove and replace.	2
322	Coast Redwood	<i>Sequoia sempervirens</i>	In the center planting island just west of the east-most stairway on the south side of the building	36"	Good	Good	None		Prune sprouts at base. Prune branches and foliage up to 10' for visual clearance. Remove sprouts down to grade.	3

323	Sweetshade	<i>Hymenosporum flavum</i>	1.5' from the foundation of the Student Services Building; 7' from the east entrance on the south side of the building; west of the Emeritus College Office	12"	Good	Good	Growing one foot from foundation with no ill affects. Has been pruned away from building with good results.		None	5
324	Coast Redwood	<i>Sequoia sempervirens</i>	Off of the southeast corner of the Student Services Building; south of the cement retaining wall for the patio area; north of a black-top driveway on south side of the building	Four stems at 18" each	Good	Good to fair; many crossing branches.	None		Prune sprouts at base. Prune branches and foliage up to 10' for visual clearance. Remove all sprouts down to grade.	3
325	Corkscrew Willow	<i>Salix babylonica 'Crispa'</i>	Off of the southeast corner of the Student Services Building; on the east side of the stairway leading to the black-top drive	Multiple stems at 24" and 20"	Good to fair; mature.	Fair; Multi-stemmed but okay.		Lifting concrete creating trip hazard.	Augment the top of the concrete stairs to mitigate trip hazard.	2

326	Loquat	<i>Eriobotrya japonica</i>	South of the east entrance to the Student Services Building; under the eave of the building and is in conflict with the eave	Three stems at 10" each.	Fair; tree was topped to encourage growth away from building. Copious sprouts arising from topping cuts.	Fair. Strong lean away from building.	None		None	5
327	Siberian Elm	<i>Ulmus pumila</i>	In the lawn area between the (east) Student Services Building and (west) Learning Resource Center; north of the bridge to parking area 1 & 2	42"	Fair to poor; over mature. Tree has many old heading cuts with decay.	Poor to fair; decay present on limbs overhanging pathway.	None	There are many attachment points adjacent to decay.	Remove	1
328	Ash	<i>Fraxinus sp.</i>	In the south end of the grassy area between the Learning Resource Center and the Student Services Building	24"	Good	Good to fair		Surface roots visible in grass but no advanced decay present.	None	5
