COLLEGE OF MARIN

TREE HEALTH PROJECT

KENTFIELD CAMPUS

JULY 10, 2014

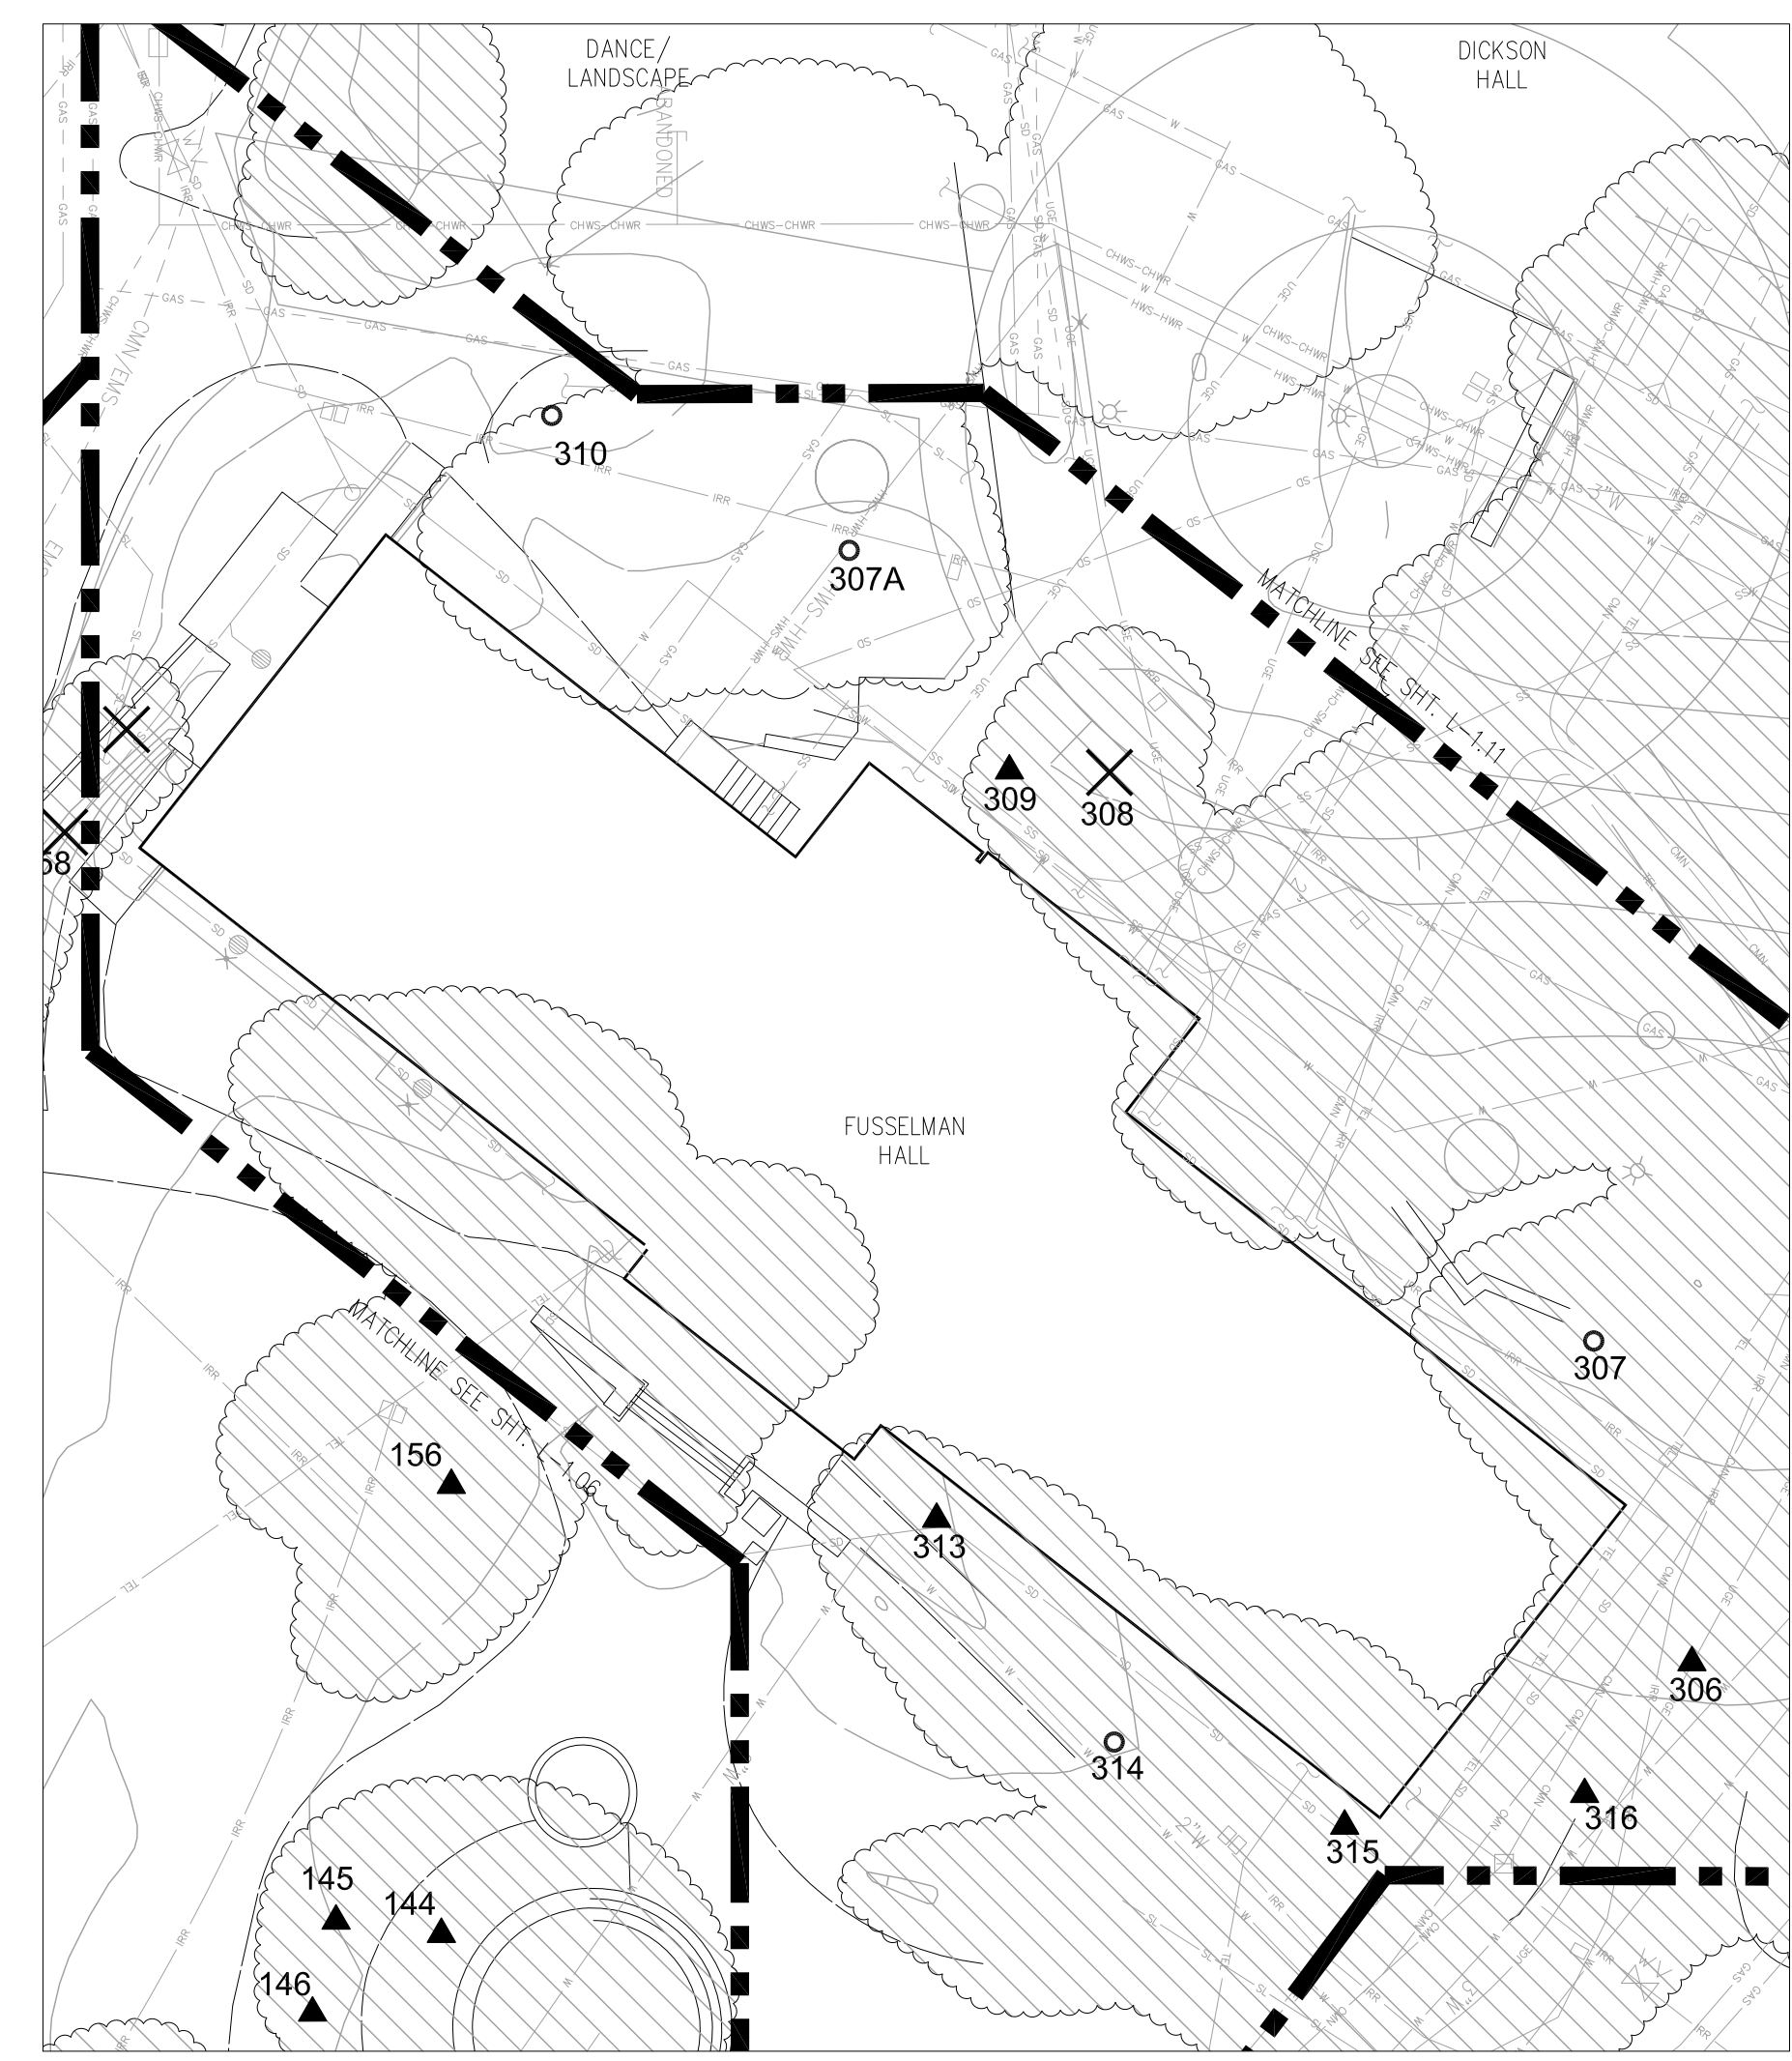
1 FUSSELMAN HALL (TREES 306-316)
1" = 20', CONTOUR INTERVAL = 1'

TREE ASSESSMENT									SCHEDULE OF WORK	
Tree #	Species (common)	Species (scientific)	Location	Size	Health	Structural Condition	Impacts to Infrastructure	Conclusion	Recommendations	Priority
306	Coast Redwood	<i>Sequoia sempervirens</i>	10' from the northwest corner of Fusselman Hall; southeast of the Redwood grove picnic area	24"	Fair	Fair; was topped in the past and has lost apical control.	Growing into building.		Prune off of building	3
307	Japanese Maple	<i>Acer palmatum</i>	Off of the northwest corner of a sitting area near the northwest corner of Fusselman Hall; 7' northwest of the privacy wood fence for the sitting area	Multi stem; 8 4" stems	Fair; tree is adjacent to newer construction. Has some cracking stems and old wounds.	Fair to good	None		None	5
308	Japanese Maple	<i>Acer palmatum</i>	west side of Fusselman Hall	Multi-stem	Very Poor; all stems show cracking bark and three stems are completely dead.	Poor	None		Remove	1

309	Little Leaf Linden	<i>Tilia Chordata</i>	30' east/southeast of circular landscaped area between Fusselman hall and new Science and Math Building	18"	Fair; mature. Decaying roots at base. Hollow sound when contacted with sounding hammer.	Fair to poor. Narrow angle branch attachment on long reaching limbs.	None	More thorough risk assessment needed.	Question contractors about possible root disturbance during construction. May need root crown excavation.	1
310	Japanese Maple	<i>Acer palmatum</i>	Near the southwest corner of Fusselman Hall; west side of the building	Dual stem; 4" each	Fair; canopy has been raised significantly and poorly pruned.	Fair	None		None	5
311	Coast Live Oak	<i>Quercus agrifolia</i>	Off of the southeast corner of Fusselman Hall; 2' south of a ramp entrance to the south side of the building	6"	Fair to good; growing close to building.	Fair	None		Prune to select one leader. Prune off building.	4

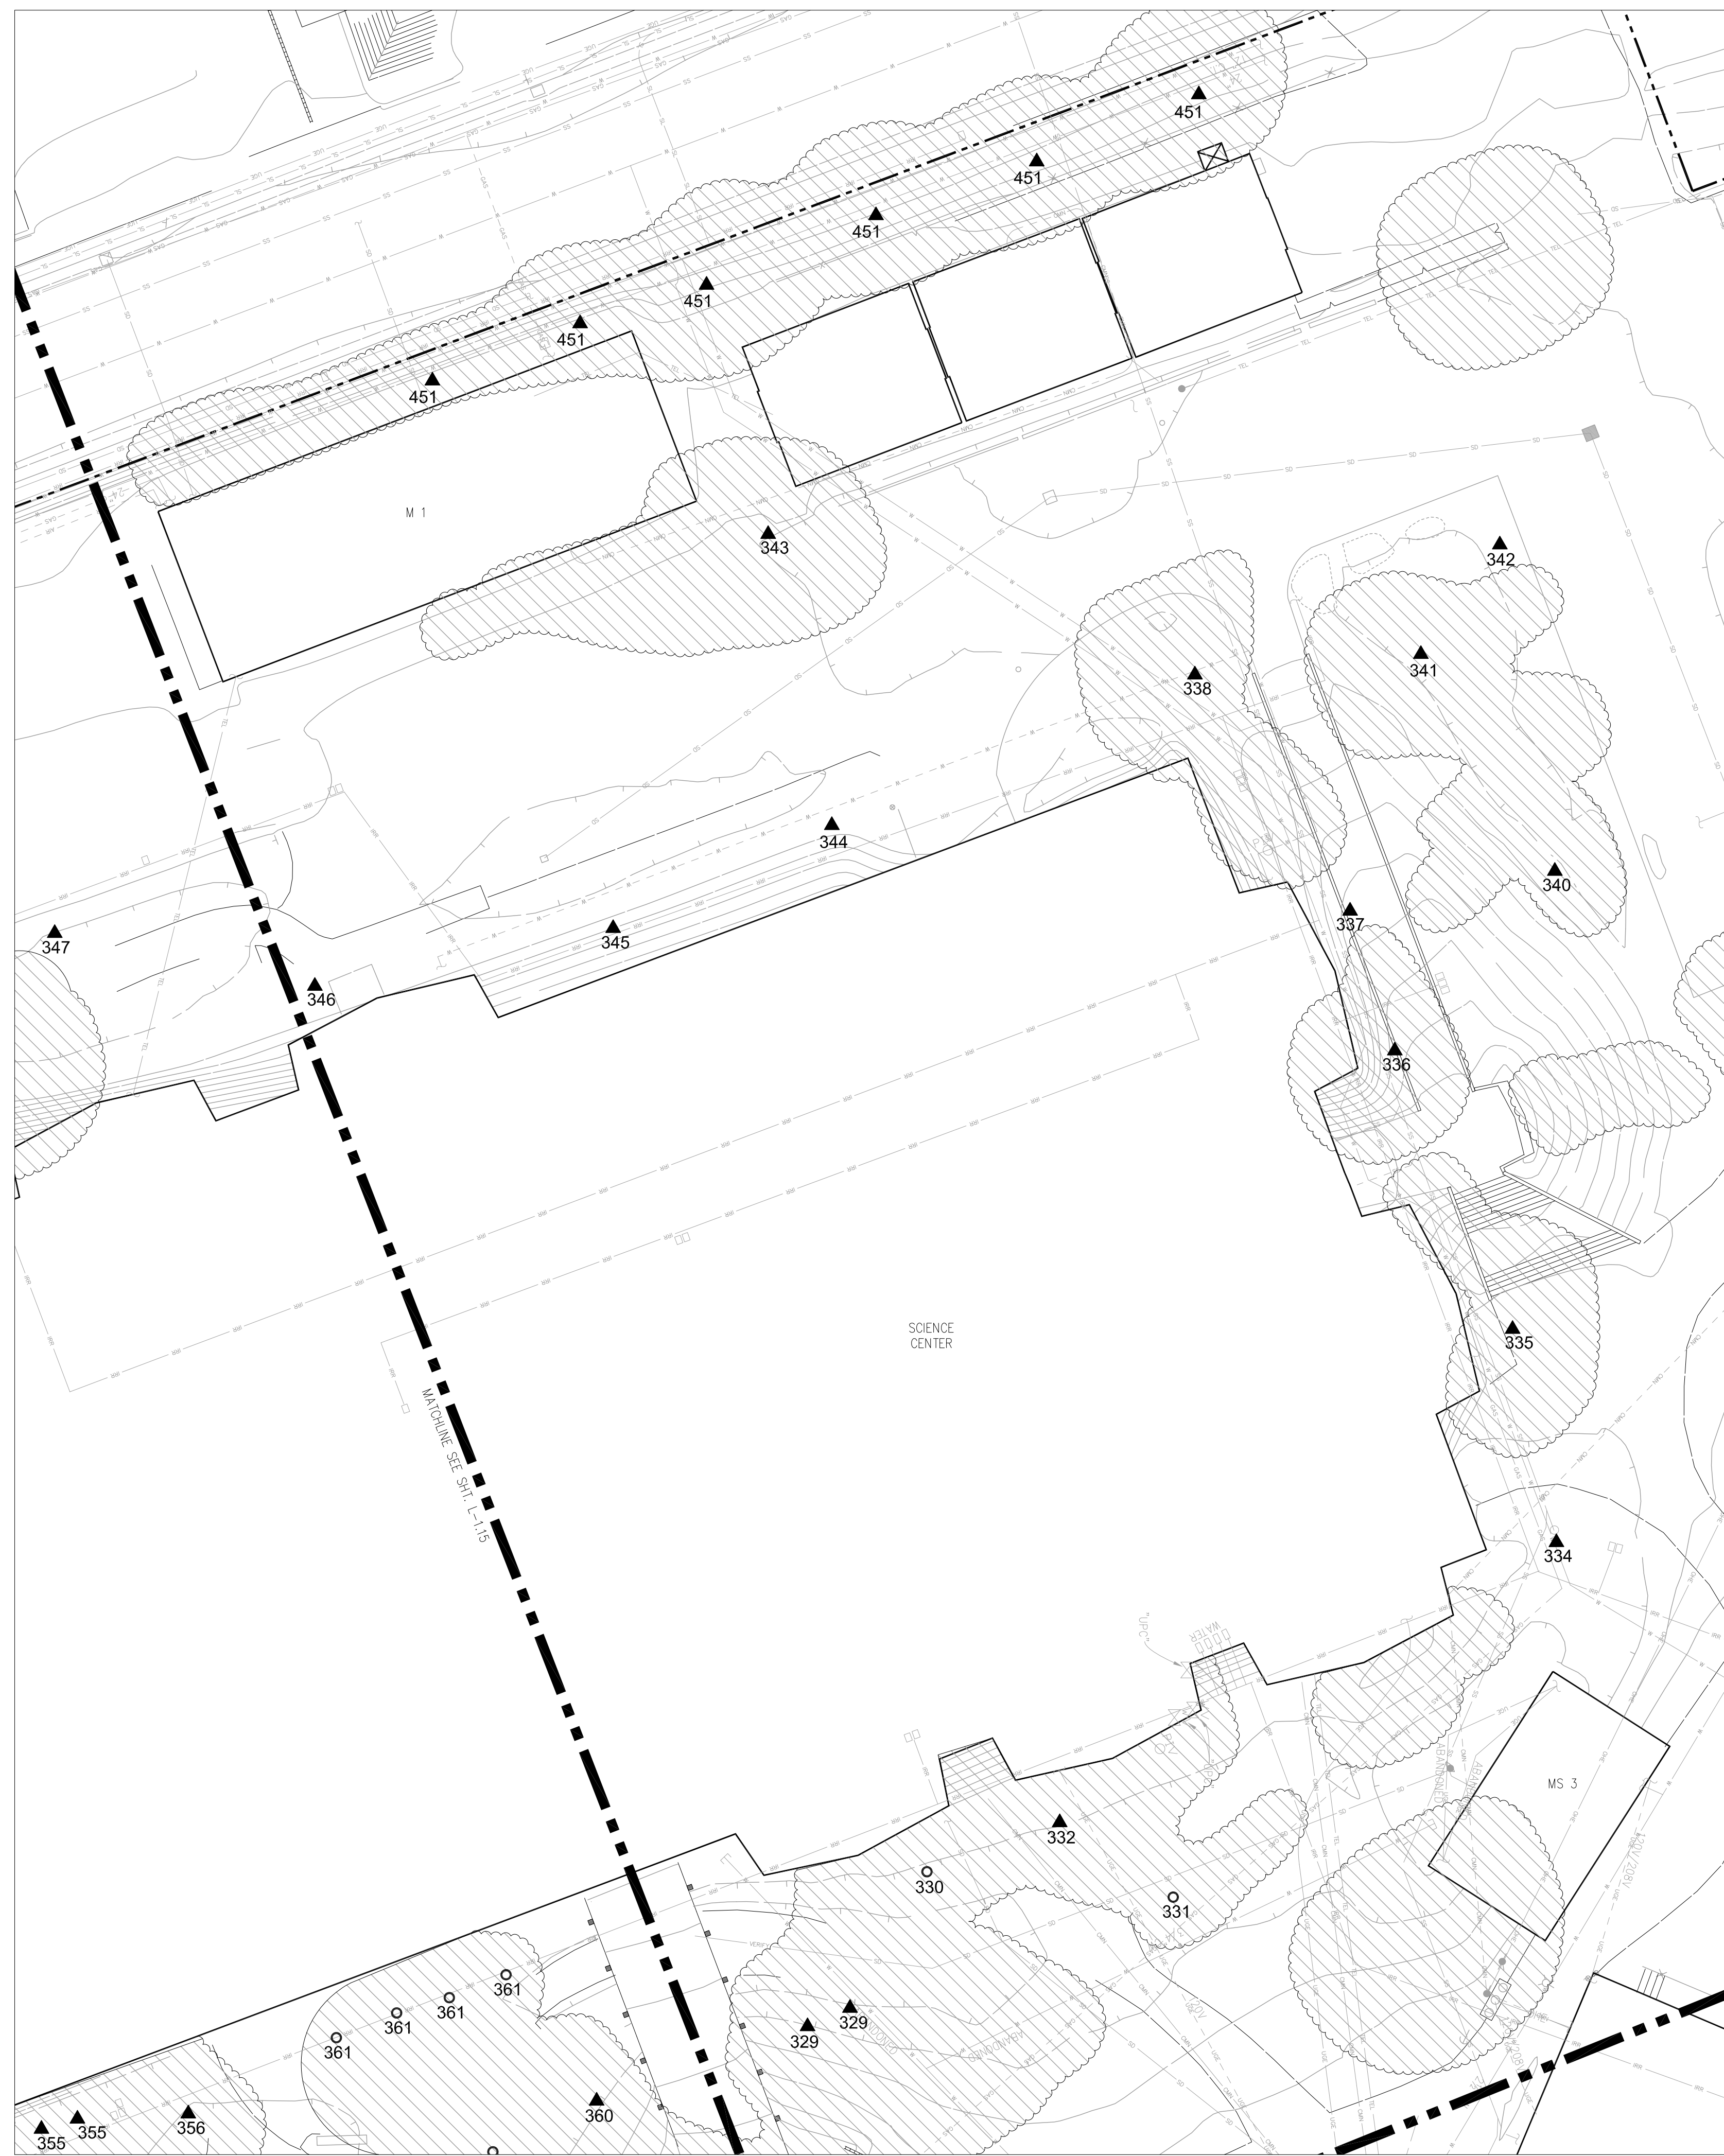
1 SCIENCE CENTER NORTH (TREES 329-346, 451)
 1" = 20', CONTOUR INTERVAL = 1'

TREE ASSESSMENT										SCHEDULE OF WORK	
Tree #	Species (common)	Species (scientific)	Location	Size	Health	Structural Condition	Impacts to infrastructure	Conclusion	Recommendations	Priority	
329	a Little-Leaf Linden	<i>Tilia cordata</i>	20 feet north of T-329	24"	Fair to good	Fair. Large co-dominant stem at 8'.	None	Large co-dominant stem not cause for concern.	Prune large water sprouts.	4	
329	Little-Leaf Linden	<i>Tilia cordata</i>	North side of the east entrance to the Science Building; up-slope (east) from a cement walkway leading to the entrance	20"	Fair to Good	Good	None		Prune branches to raise canopy to 8'. Remove lowest west extending branch. Clear vegetation around root crown by 2'	3	
330	Japanese Maple	<i>Acer palmatum</i>	On the east side of the Science Building; north of the main entrance	Group of 2; at 8' each	Good	Good. Old wounds with decay on main stems.	None		None	5	
331	Three Flowered Maple	<i>Acer triflorum</i>	10' east of the east side of the Science Building; north of a black-top pathway that leads to the parking garage under the building, on the north side of the main entrance	12"	Good	Good	None		None	5

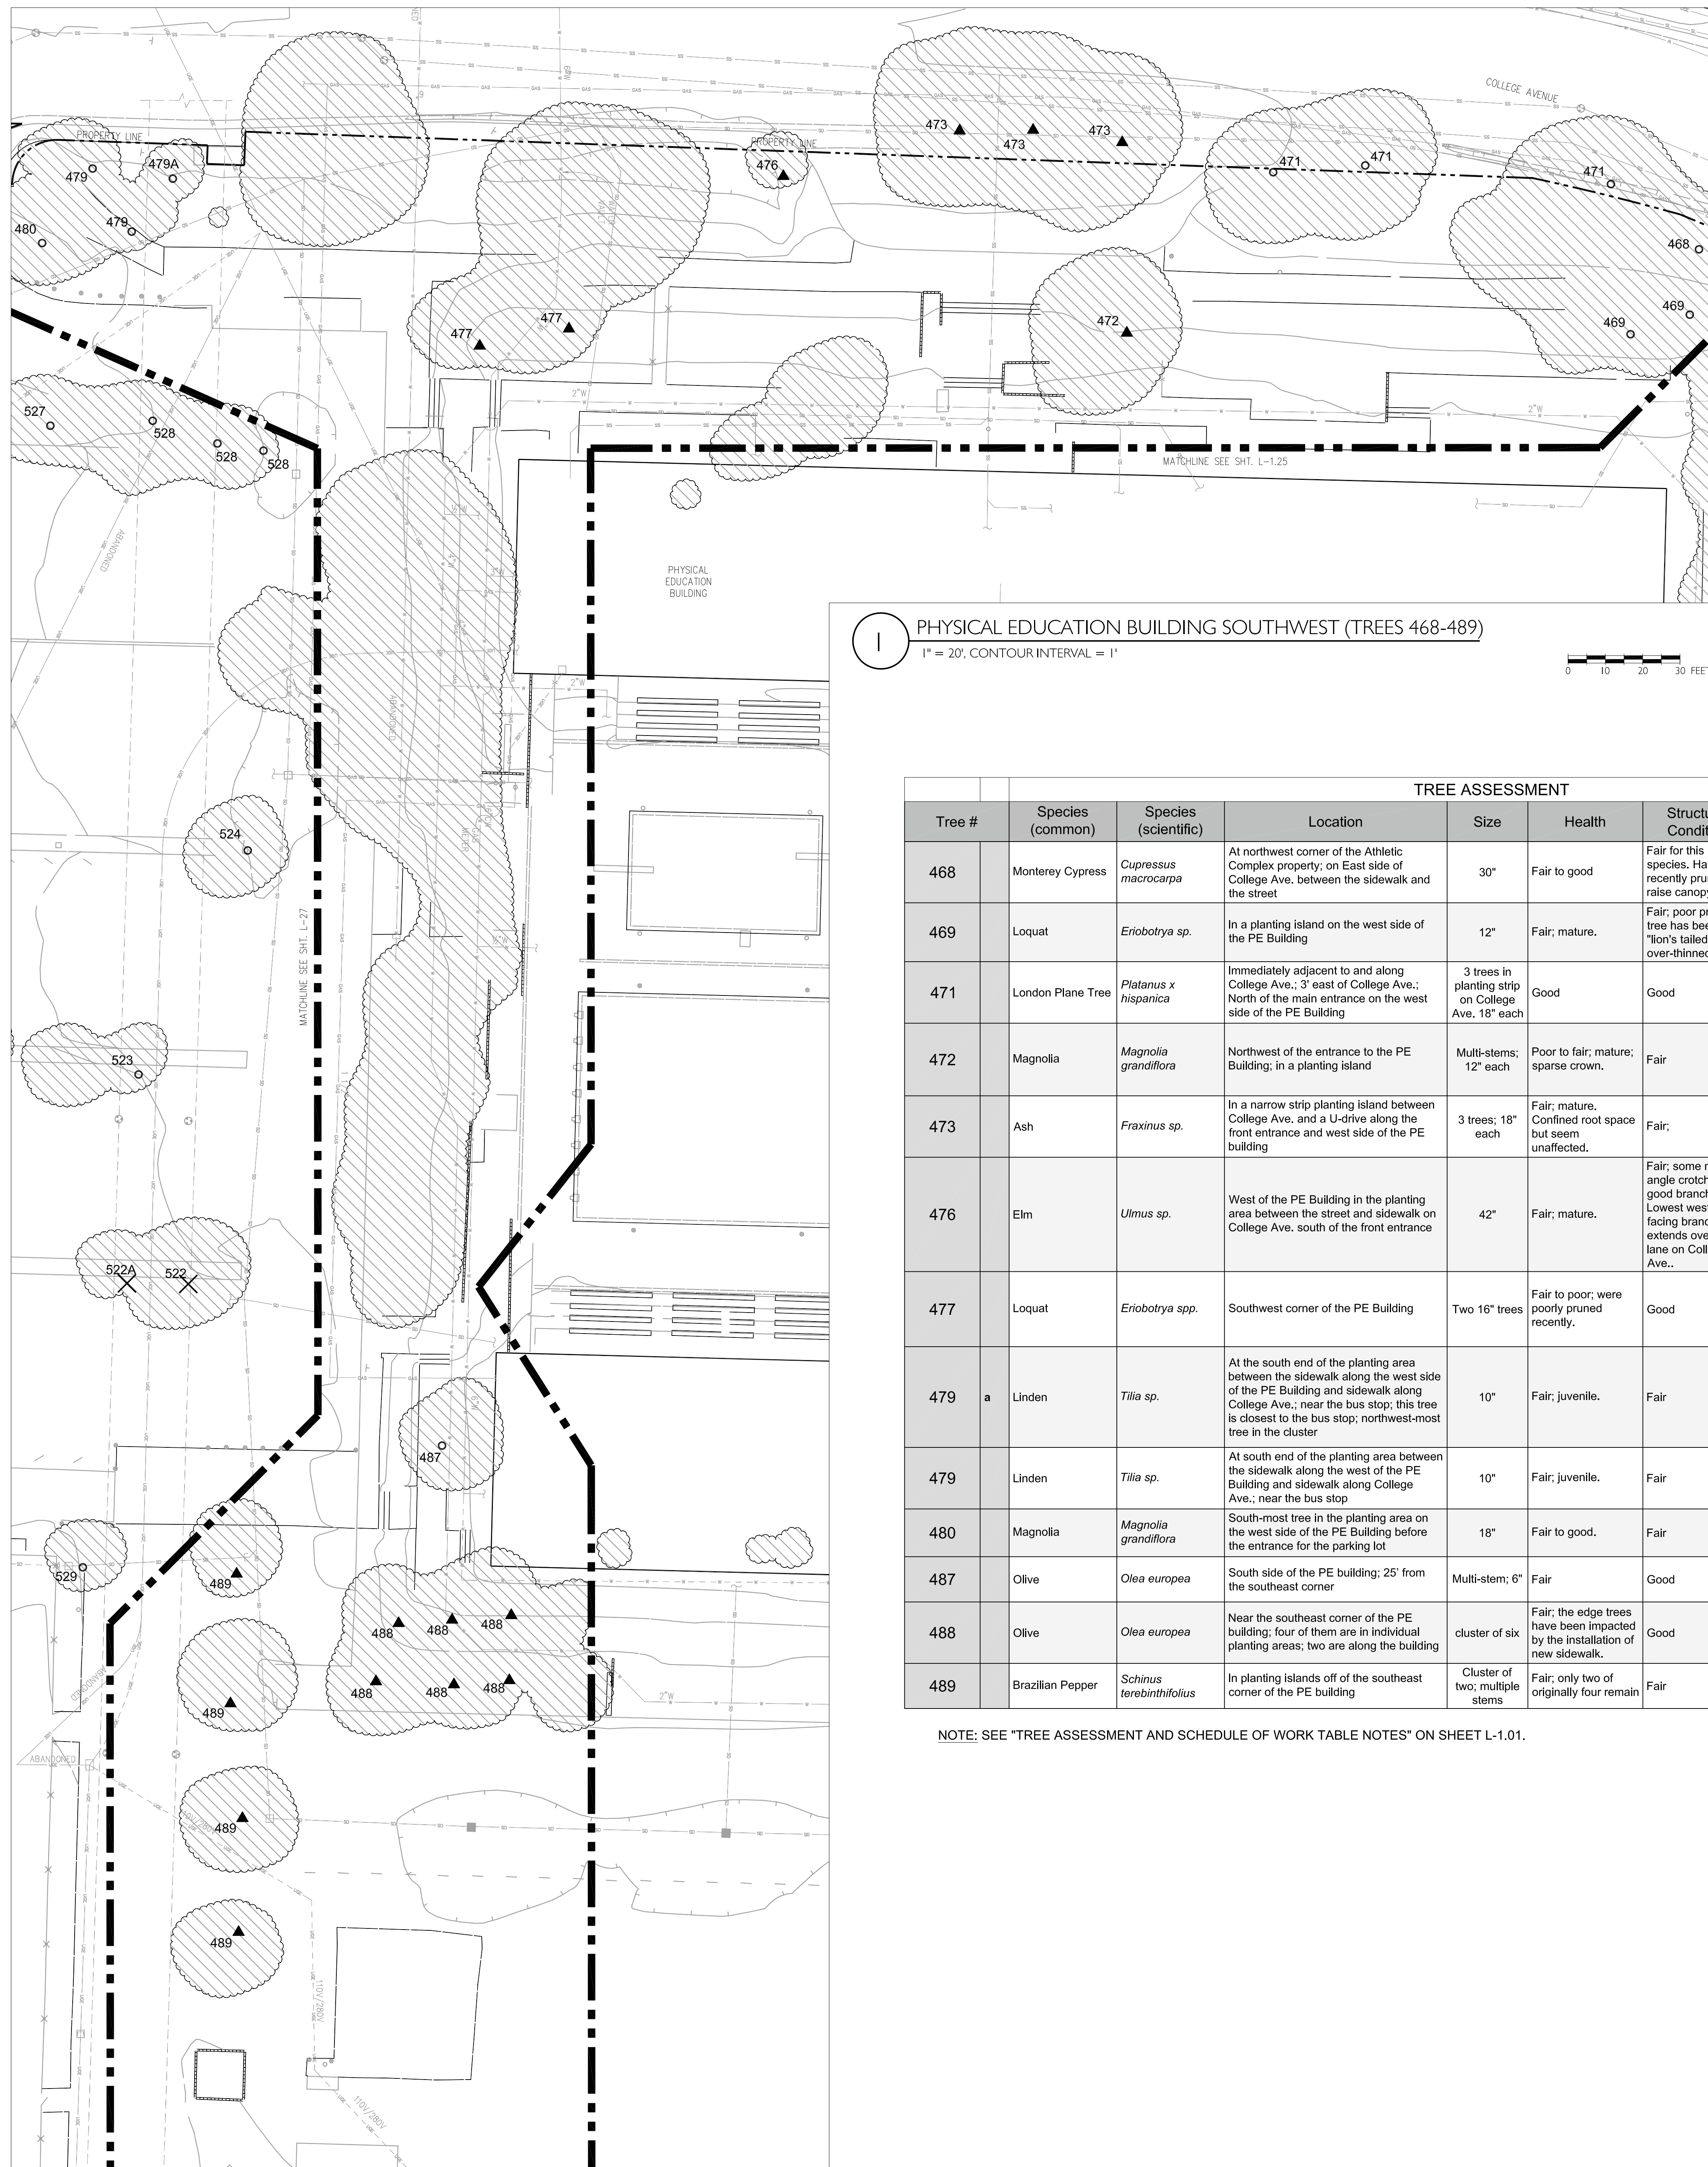
1 PHYSICAL EDUCATION BUILDING SOUTHWEST (TREES 468-489)
 1" = 20', CONTOUR INTERVAL = 1'

Tree #	Species (common)	Species (scientific)	Location	Size	Health	Structural Condition	Impacts to infrastructure	Conclusion	SCHEDULE OF WORK	
									Recommendations	Priority
468	Monterey Cypress	<i>Cupressus macrocarpa</i>	At northwest corner of the Athletic Complex property; on East side of College Ave., between the sidewalk and the street	30"	Fair to good	Fair for this species. Has been recently pruned to raise canopy.	None		None	5
469	Loquat	<i>Eriobotrya sp.</i>	In a planting island on the west side of the PE Building	12"	Fair; mature.	Fair; poor pruning; tree has been "lion's tailed" or over-thinned	None		None	5
471	London Plane Tree	<i>Platanus x hispanica</i>	Immediately adjacent to and along College Ave., 3' east of College Ave.; North of the main entrance on the west side of the PE Building	3 trees in planting strip on College Ave, 18" each	Good	Good	None		None	5
472	Magnolia	<i>Magnolia grandiflora</i>	Northwest of the entrance to the PE Building; in a planting island	Multi-stems; 12" each	Poor to fair; mature; sparse crown.	Fair	Conflicting with light next to bench.	Tree is stressed. It is possible that soil was compacted during construction.	Prune foliage off light. Fertilize. Apply mulch.	3

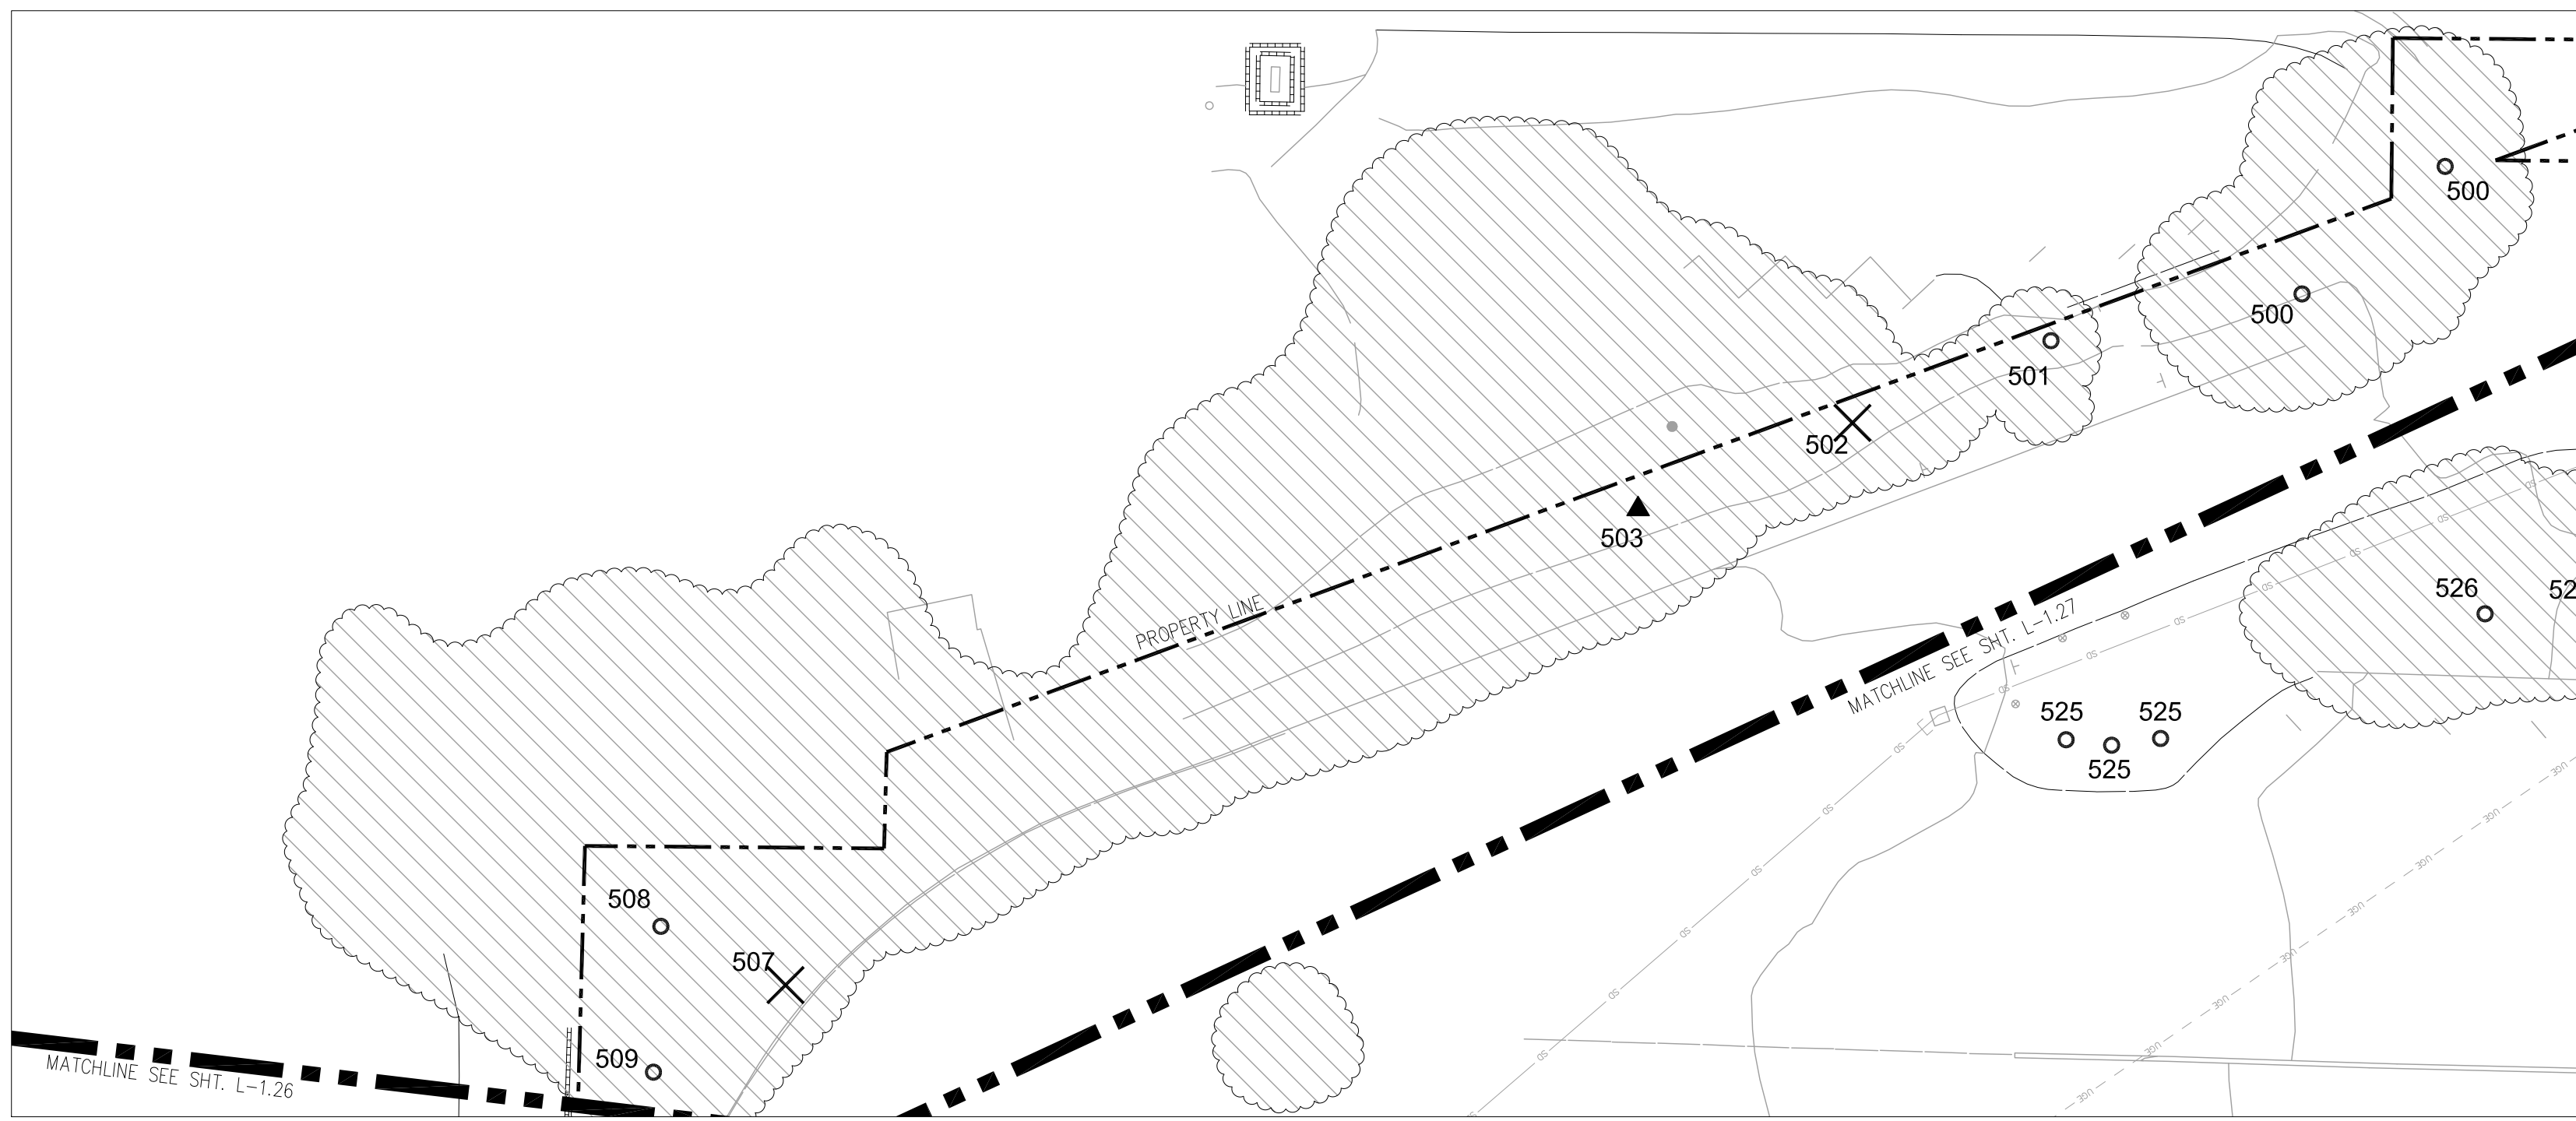
2 COLLEGE AVENUE (TREES 497-509)
1" = 20', CONTOUR INTERVAL = 1'

TREE ASSESSMENT									SCHEDULE OF WORK		
Tree #	Species (common)	Species (scientific)	Location	Size	Health	Structural Condition	Impacts to infrastructure	Conclusion	Recommendations	Priority	
497	Magnolia	<i>Magnolia veitchii</i>	15-20' south of T-494; inside the west patio area of the PE Building	12"	Trunk splits into two stems at 3". Tree is flowering nicely.	Good	None		None	5	
498	Magnolia	<i>Magnolia Grandiflora</i>	Within the east patio area inside the PE Building	24"	Fair, yellowing and slight die-back in crown.	Fair to good	None	May have been impacted by construction.	Clear ground cover around root crown	3	
499	Michelia	<i>Michelia doltsopa</i>	North end of the east patio area inside of the PE Building; 10 - 15' south of the junipers (T-492)	20" below split in to multiple stems	Fair to good	Good	None		None	5	
500	Allepo Pine	<i>Pinus halepensis</i>	South side of the driveway entrance into the parking lot for the PE Building; in a planting area that is covered with wood chips; immediately east of College Ave	Two trees; 24" each	Fair; tree 15' northwest of speed limit sign has co-dominant stems.	Tree closest to crosswalk has a corrected lean and copious cones.	Some lifting of pavement		None	5

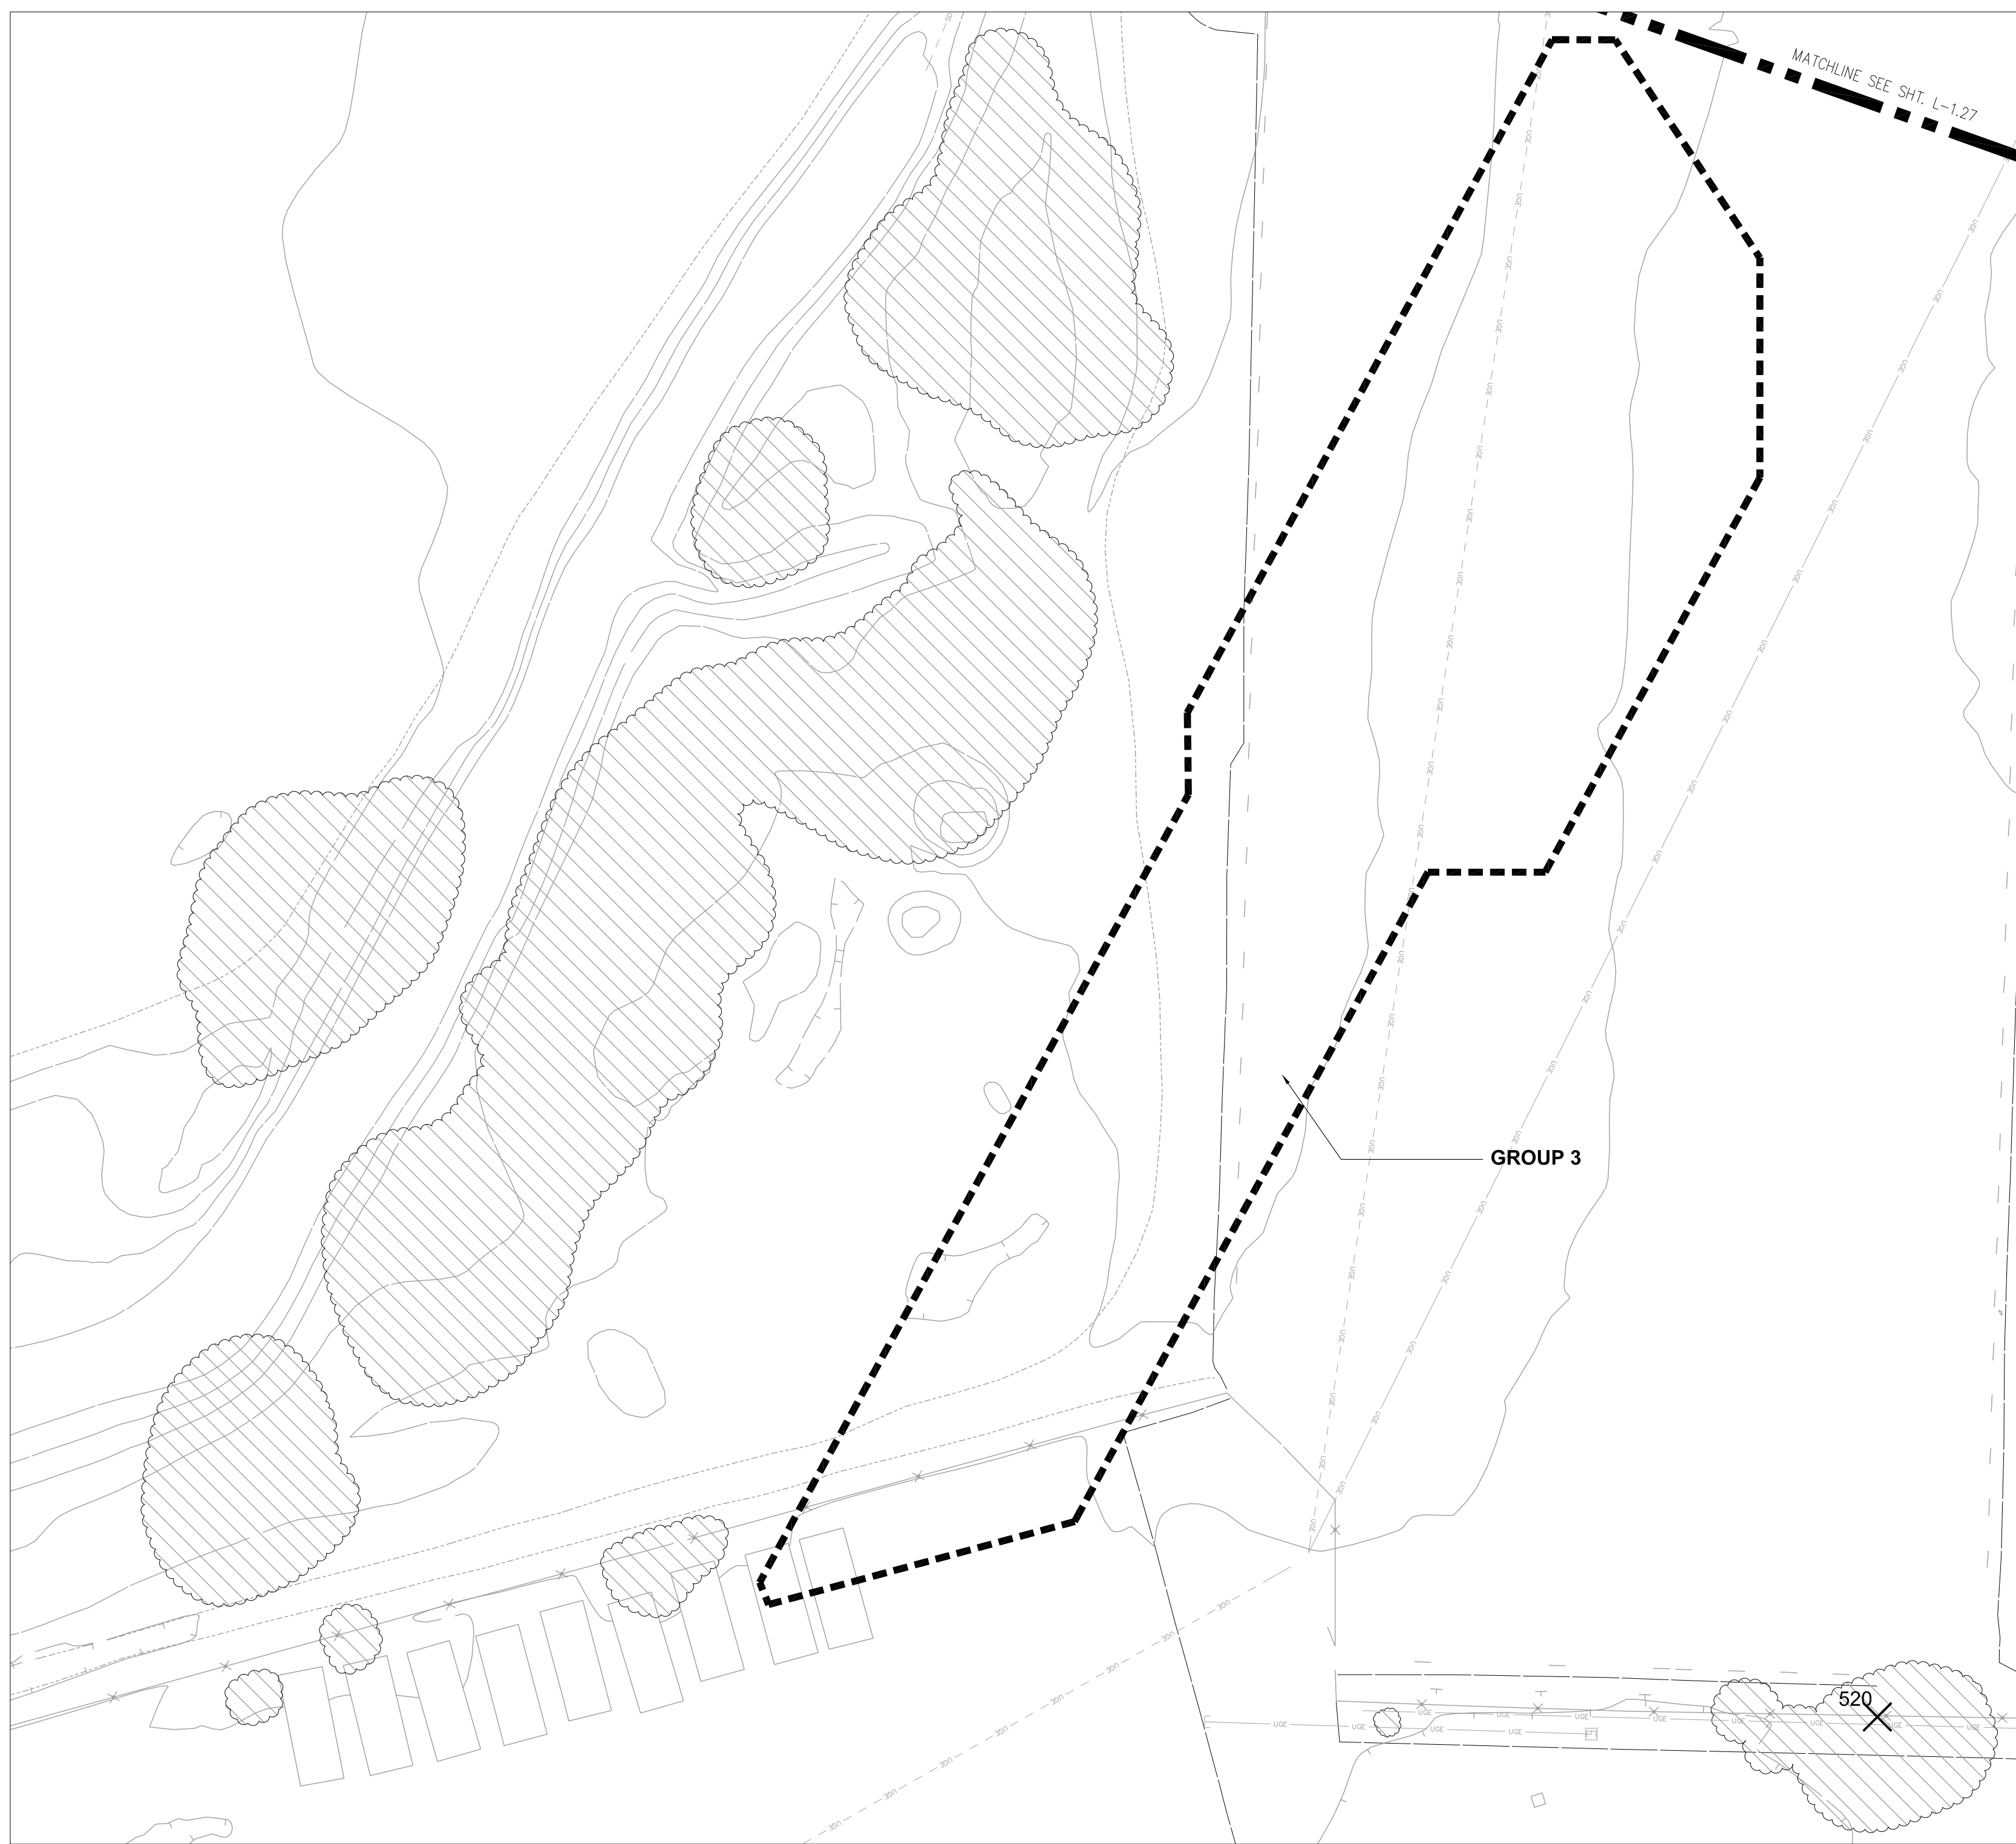
2 PARKING LOT # 11 (TREES 520)
1" = 20', CONTOUR INTERVAL = 1'

Tree #	Species (common)	Species (scientific)	Location	Size	Health	Structural Condition	Impacts to infrastructure	Conclusion	SCHEDULE OF WORK	
									Recommendations	Priority
520	Elm	<i>Ulmus sp.</i>	At east end of parking lot #11 and west of the track area; near the northeast corner of the parking lot	Dead					Remove	2
