COLLEGE OF MARIN

TREE HEALTH PROJECT

KENTFIELD CAMPUS

JULY 10, 2014

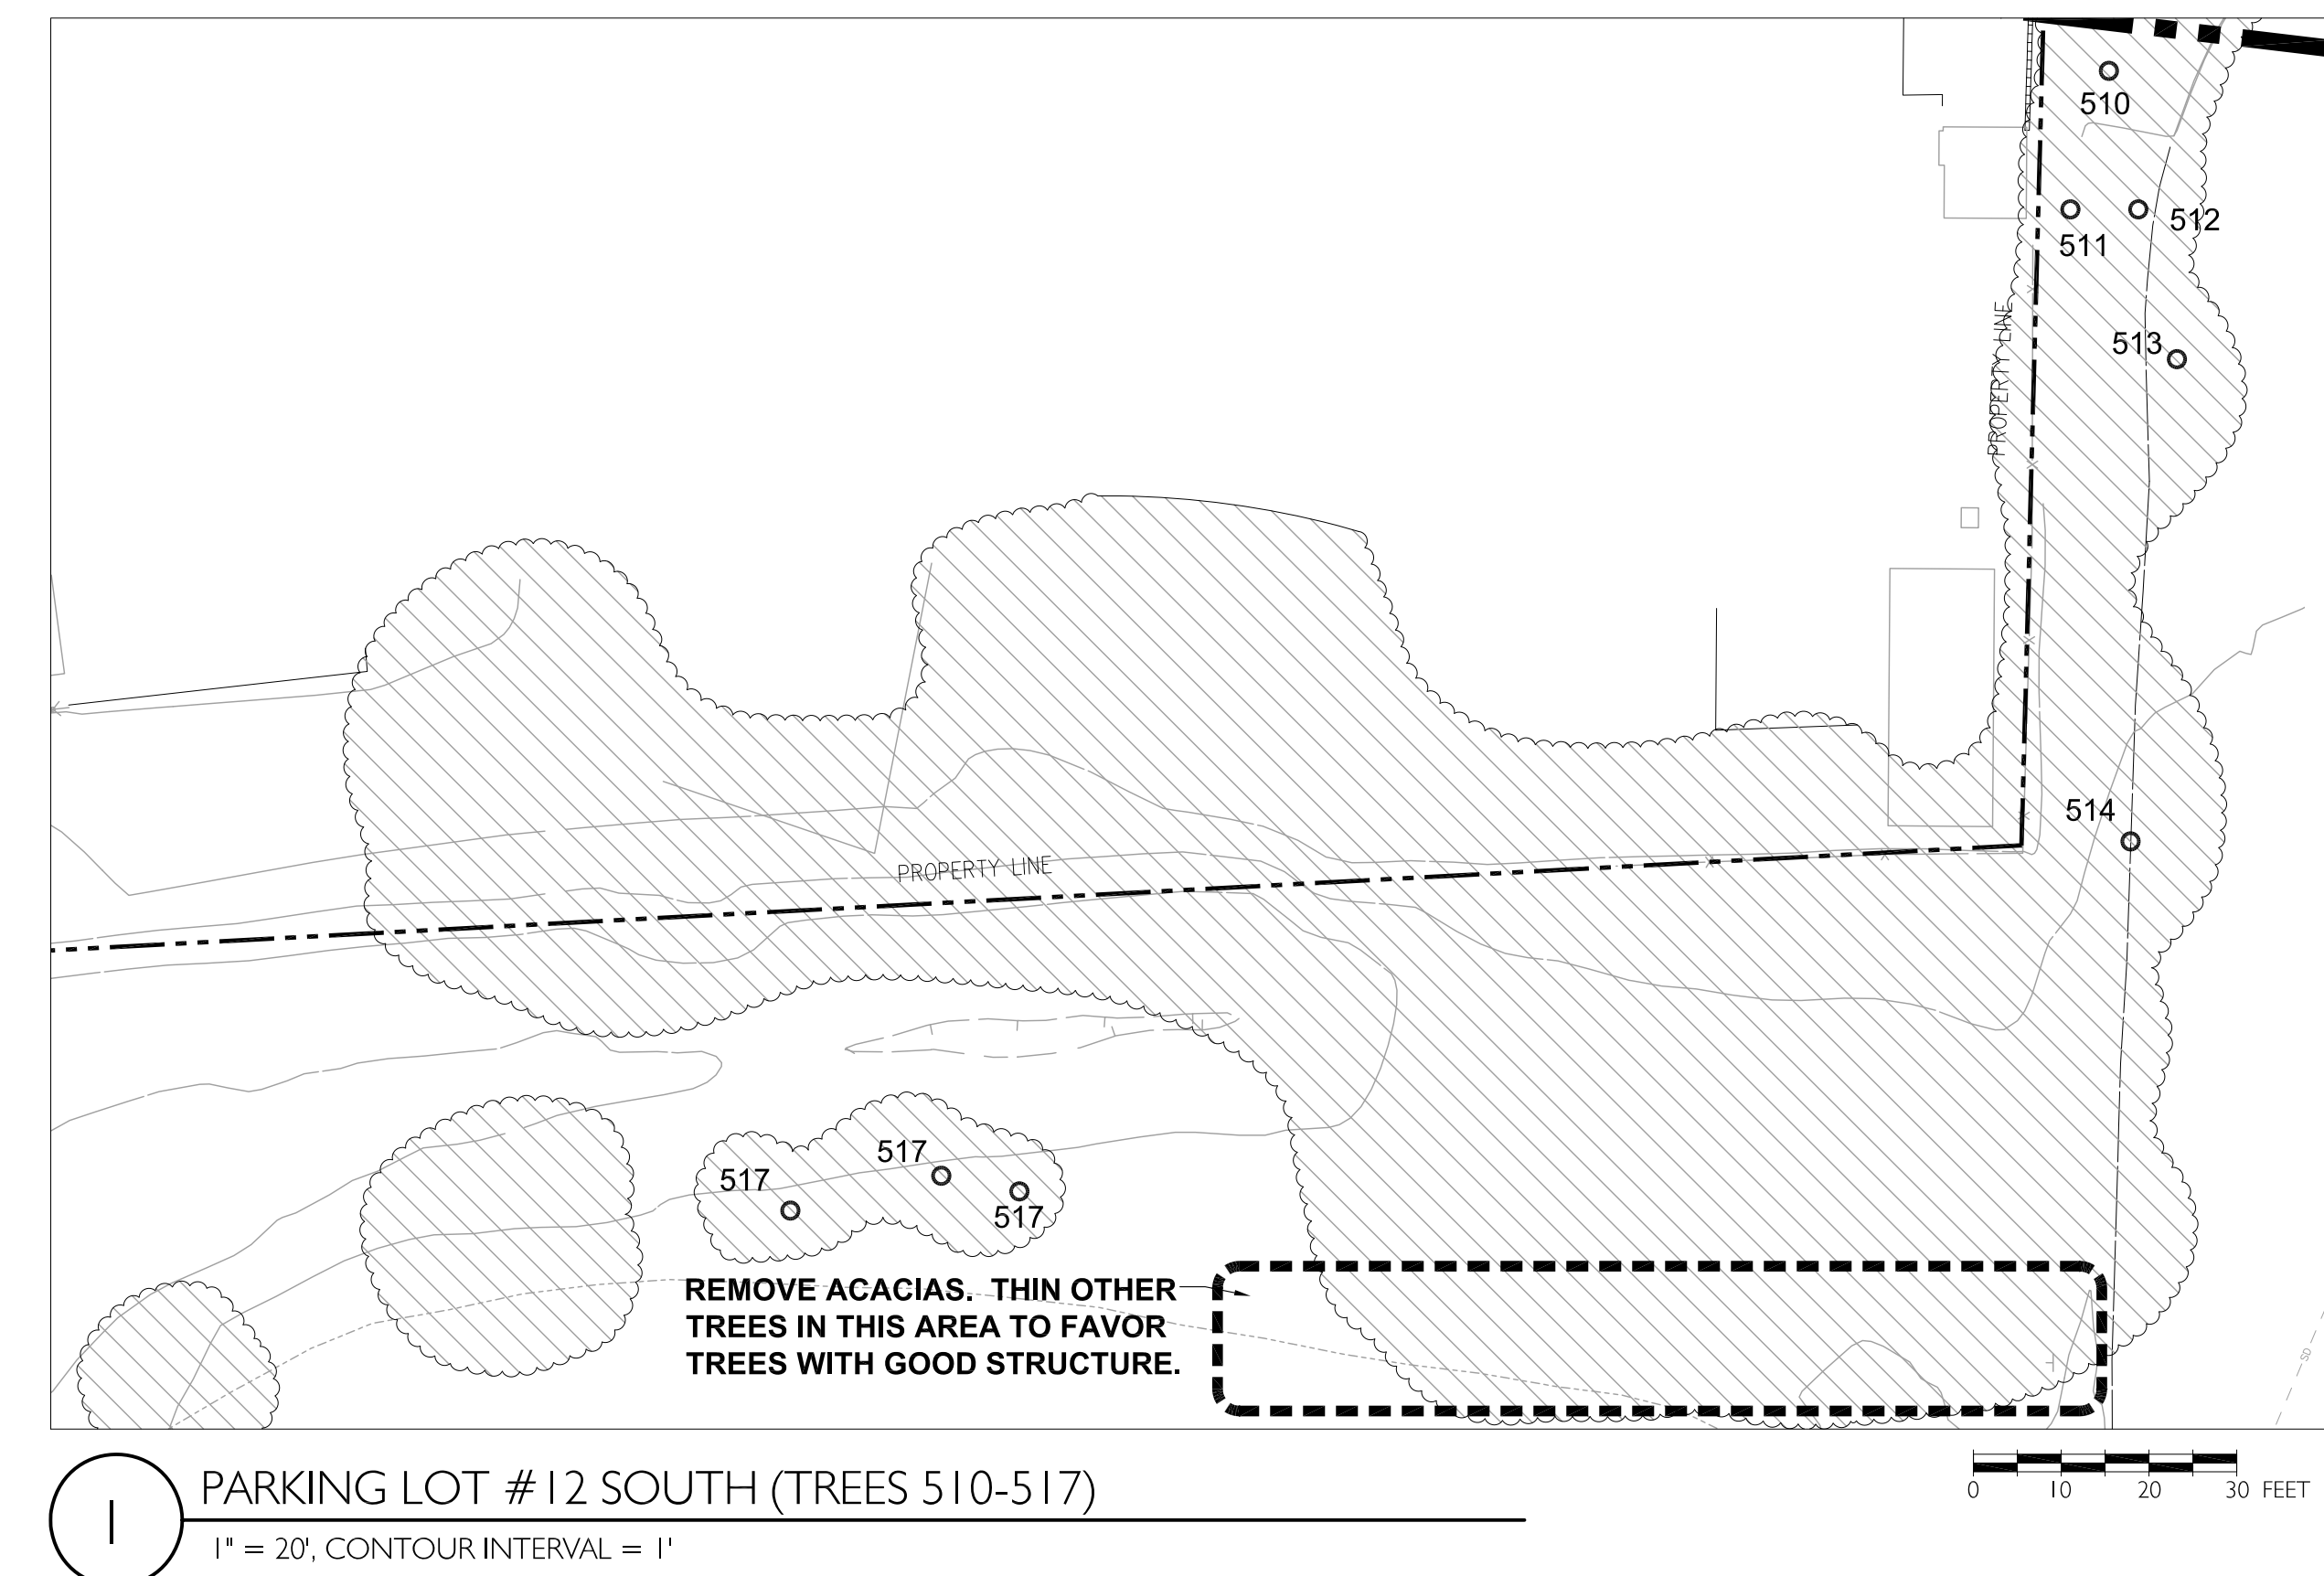
1 PARKING LOT # 12 SOUTH (TREES 510-517)
1" = 20', CONTOUR INTERVAL = 1'

Tree #	Species (common)	Species (scientific)	Location	Size	Health	Structural Condition	Impacts to infrastructure	Conclusion	SCHEDULE OF WORK	
									Recommendations	Priority
510	Elm	<i>Ulmus sp.</i>	South of T-508	6"	Good	Good	None		None	5
511	Elm	<i>Ulmus sp.</i>	East of a gravel pathway from the adjacent neighborhood into the PE Building parking lot	8"	Good	Good	None		None	5
512	Catalina Ironwood	<i>Lionothamnus floribundus exilifolius</i>	East of gravel path from the adjacent neighborhood into the PE Building parking lot	12"	Good	Good	None		None	5
513	Plum	<i>Prunus sp.</i>	East of T-511 and T-512	Multi-stem; 3"	Fair; mature.	Fair	None		None	5
514	Elm	<i>Ulmus sp.</i>	South of PE Parking area; east of T-513	12"	Good	Fair; some v-crotching	None		None	5
517	Coast Live Oak	<i>Quercus agrifolia</i>	South of T- 516; midway across the length of the parking lot on the west side	Cluster of three; 12", 8", 4"	Fair to good	Good	None		None	5

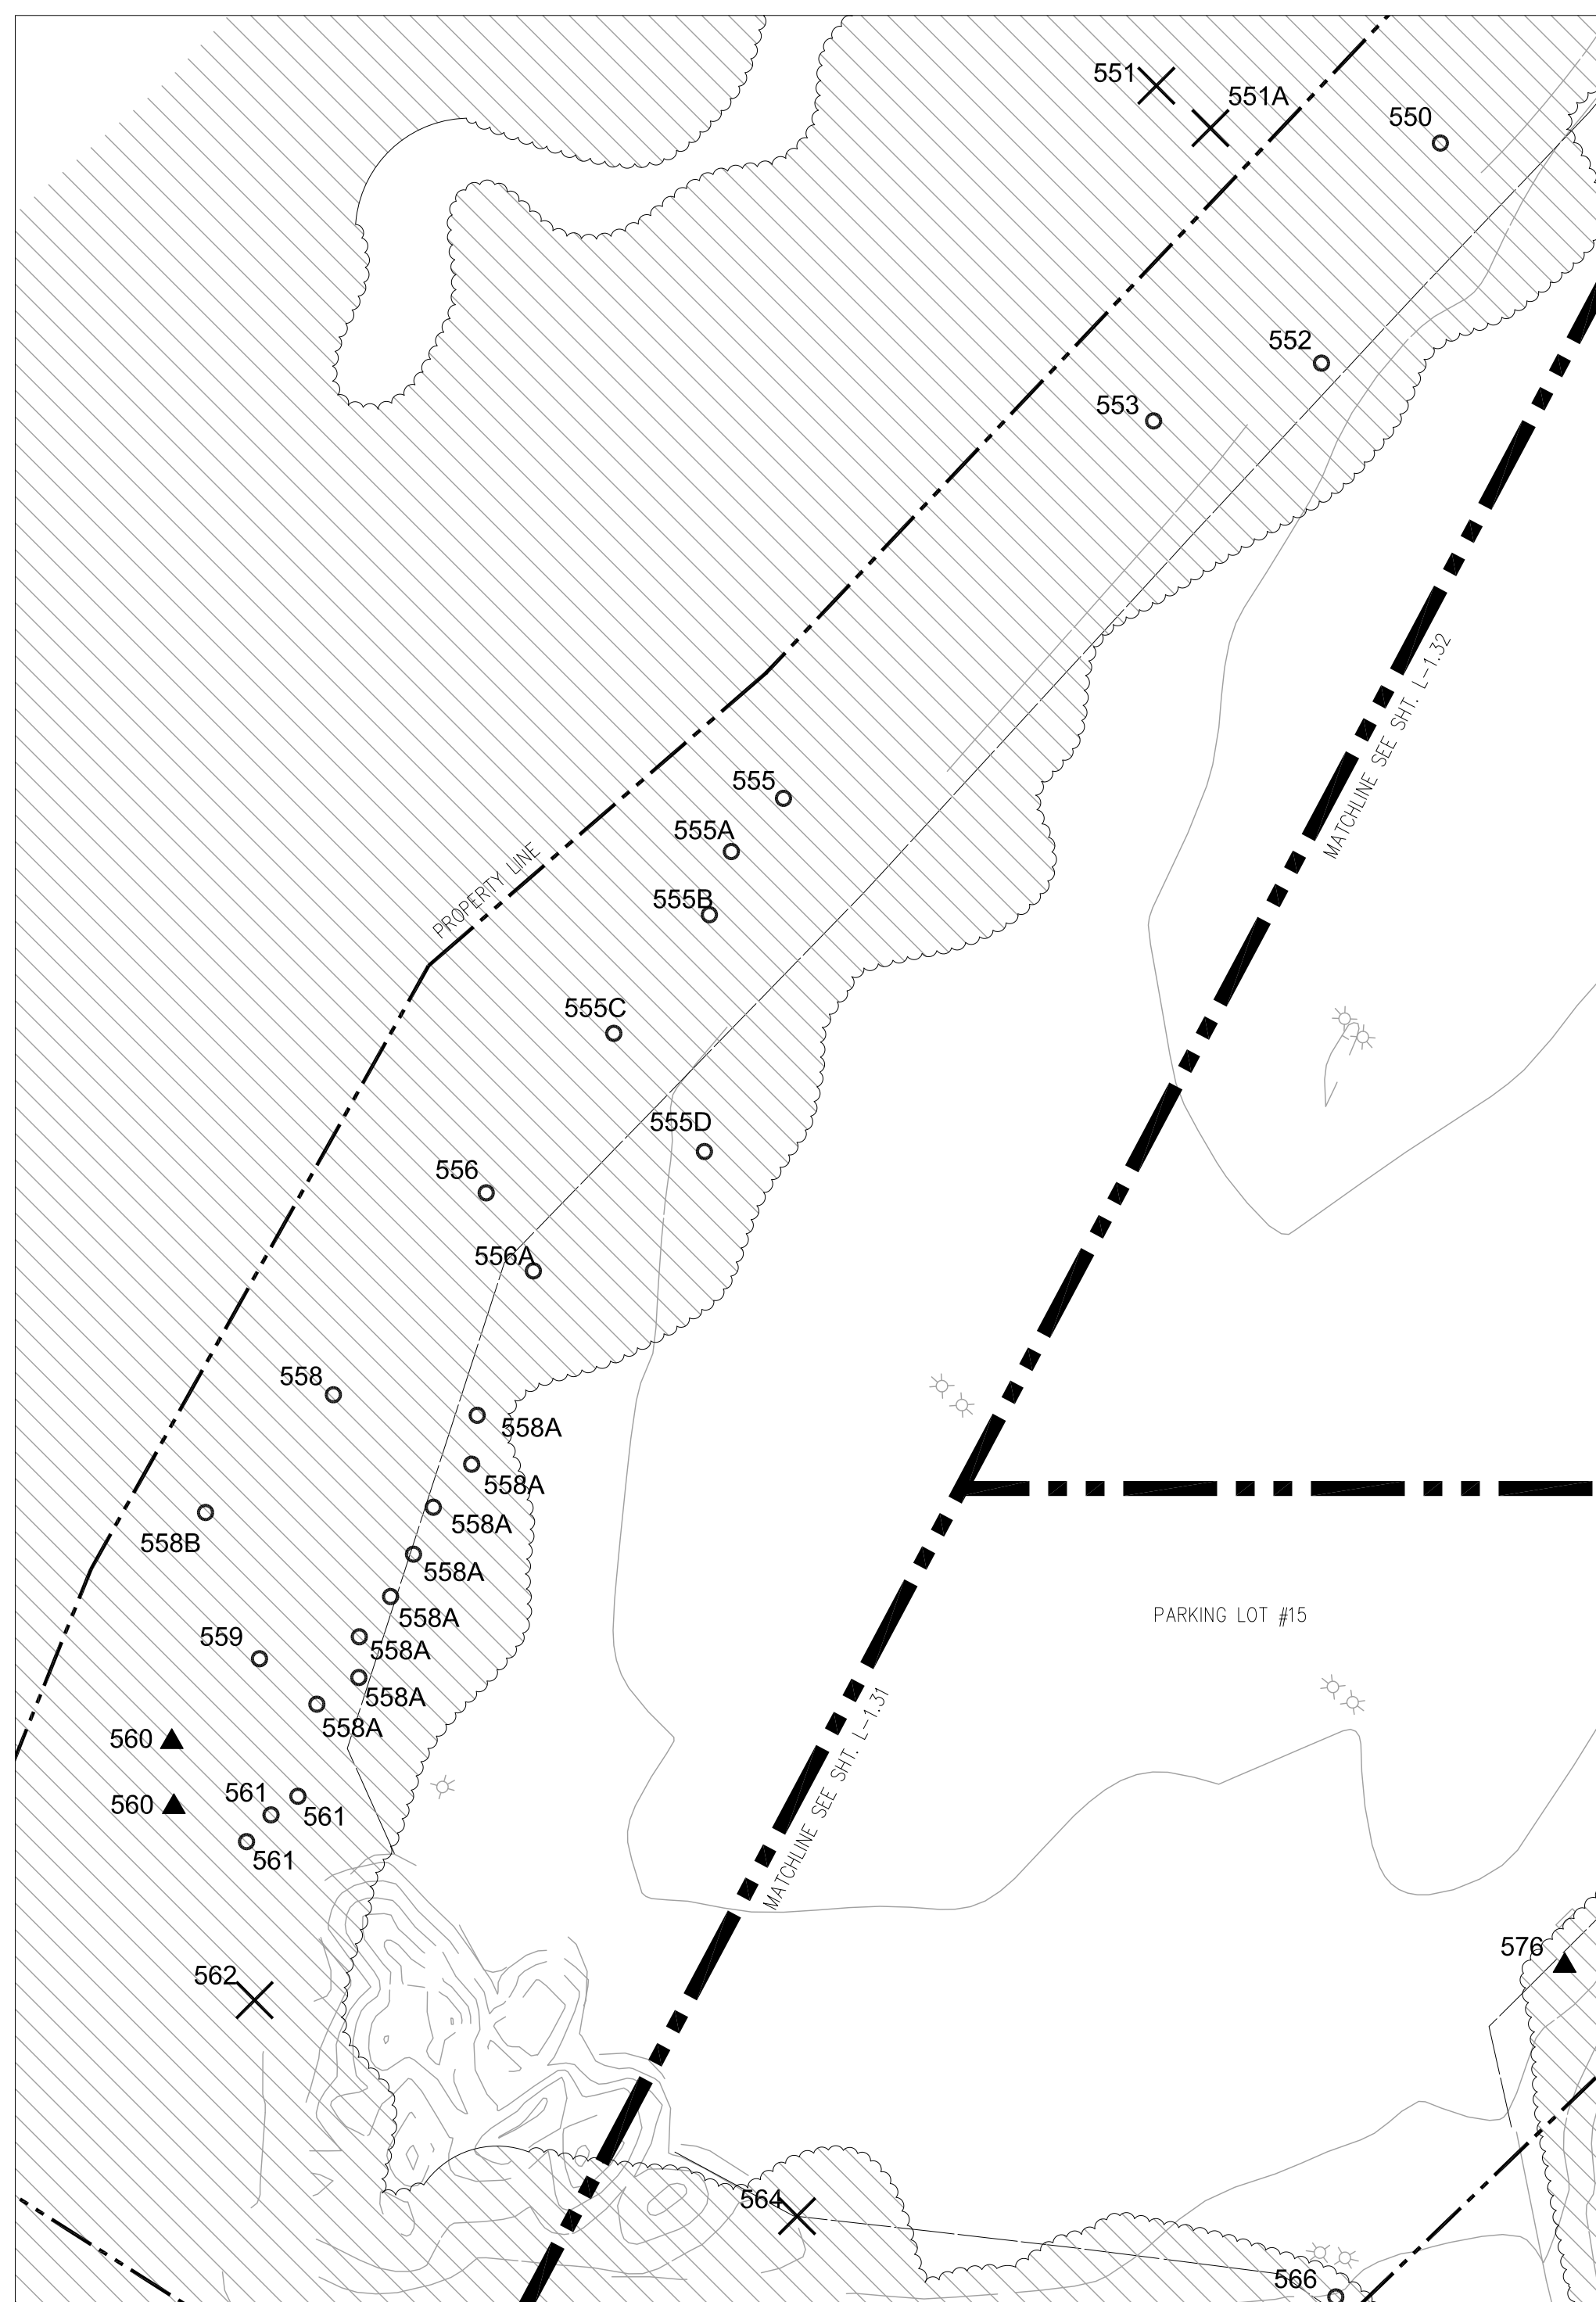
2 PARKING LOT # 15 SOUTH (TREES 550-563)
1" = 20', CONTOUR INTERVAL = 1'

TREE ASSESSMENT										SCHEDULE OF WORK	
Tree #	Species (common)	Species (scientific)	Location	Size	Health	Structural Condition	Impacts to infrastructure	Conclusion	Recommendations	Priority	
550	California Buckeye	<i>Aesculus californica</i>	Near the curve in the parking lot, on the south-southwest side of the parking area; approximately 15' up-slope from the asphalt	Multi-stem	Good; mature.	Fair	None		None	5	
552	California Buckeye	<i>Aesculus californica</i>	Approximately 10-15' southeast of T-550; up-slope and 20' from the parking lot	Good; mature. Pocket of decay at root crown.	Fair	None			None	5	
553	California Bay Laurel	<i>Umbellularia californica</i>	Approximately 10' south-southeast of T-552	12"	Fair; leaning towards parking lot.	Good	None		None	5	
555 a	California Bay Laurel	<i>Umbellularia californica</i>	Southeast of T-555	6"	Good	Good	None		None	5	
555 b	California Bay Laurel	<i>Umbellularia californica</i>	Southeast of T-555	6"	Good	Good	None		None	5

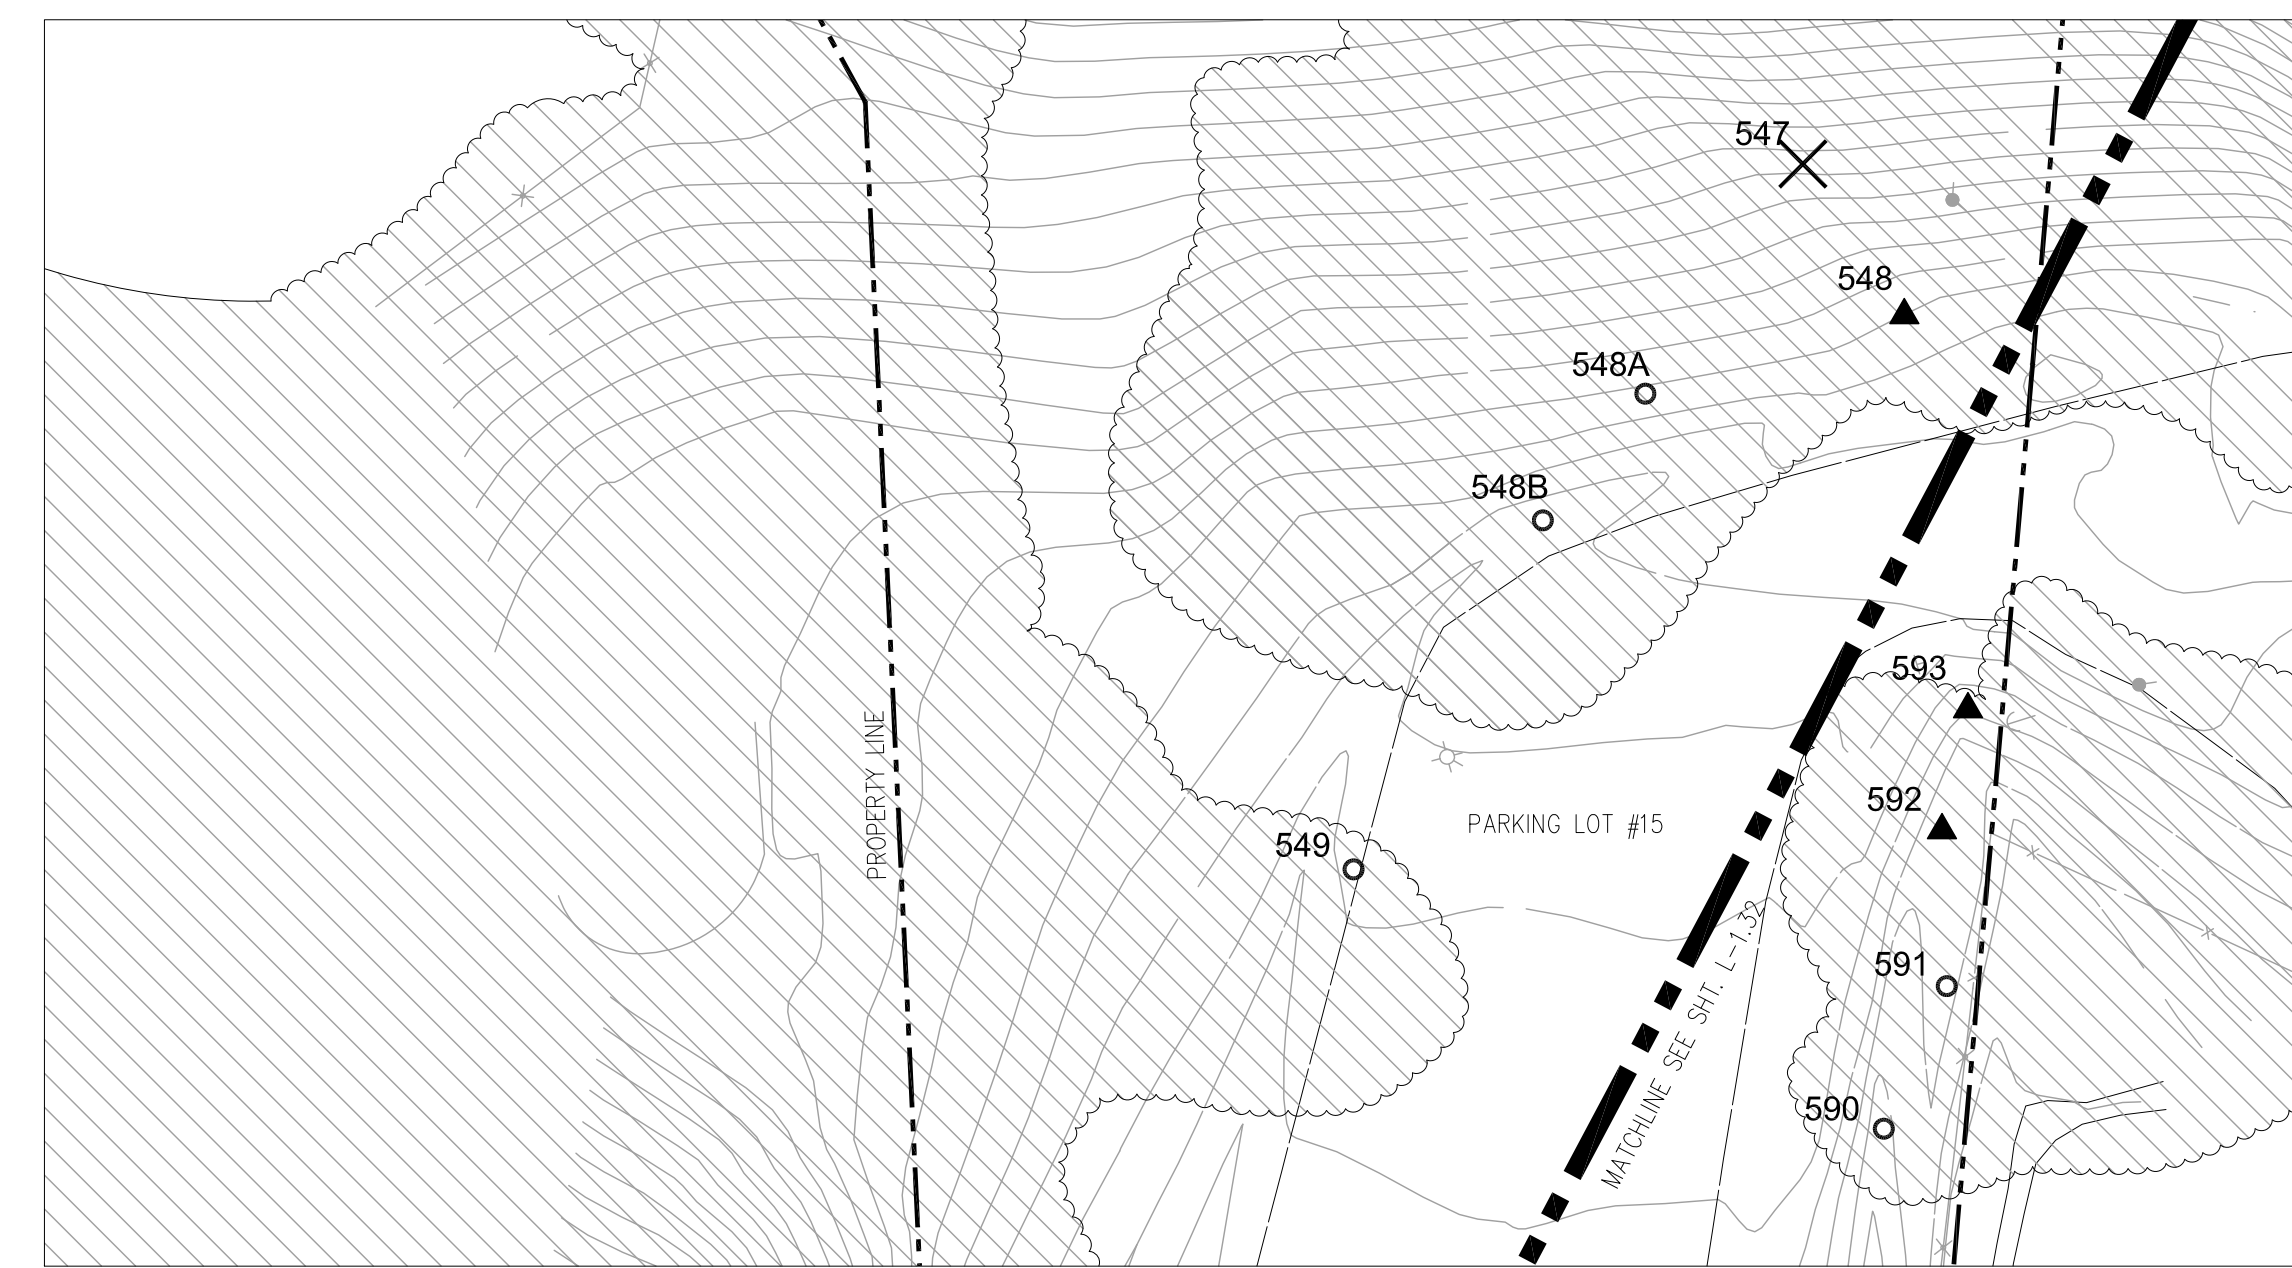
1 PARKING LOT # 15 WEST (TREES 547-549)
1" = 20', CONTOUR INTERVAL = 1'

TREE ASSESSMENT									SCHEDULE OF WORK	
Tree #	Species (common)	Species (scientific)	Location	Size	Health	Structural Condition	Impacts to infrastructure	Conclusion	Recommendations	Priority
547	Coast Live Oak	<i>Quercus agrifolia</i>	At the north end of Parking Lot #15; on the west side natural area; approximately 35' up-slope from the pavement	12"	Fair; significant rot at root crown. Leaning towards guy wires. Wounds from climbing spikes present on main stem from prior line clearance.	Poor	Potential impact to power pole if tree were to fail.		Remove.	2
548 a	Coast Live Oak	<i>Quercus agrifolia</i>	Approximately 15-20' south of T-547; up-slope from the asphalt parking area by approximately 18-20'	18"	Fair; small LCR. Leaning on adjacent valley oak.	Poor; lacking lateral branches.	None		None	5
548 a	California Bay	<i>Umbellularia californica</i>	Approximately 8-10' down-slope and east of T-547; a power pole is approximately 4' to the northwest of the tree base	6"	Good	Good	None		None	5

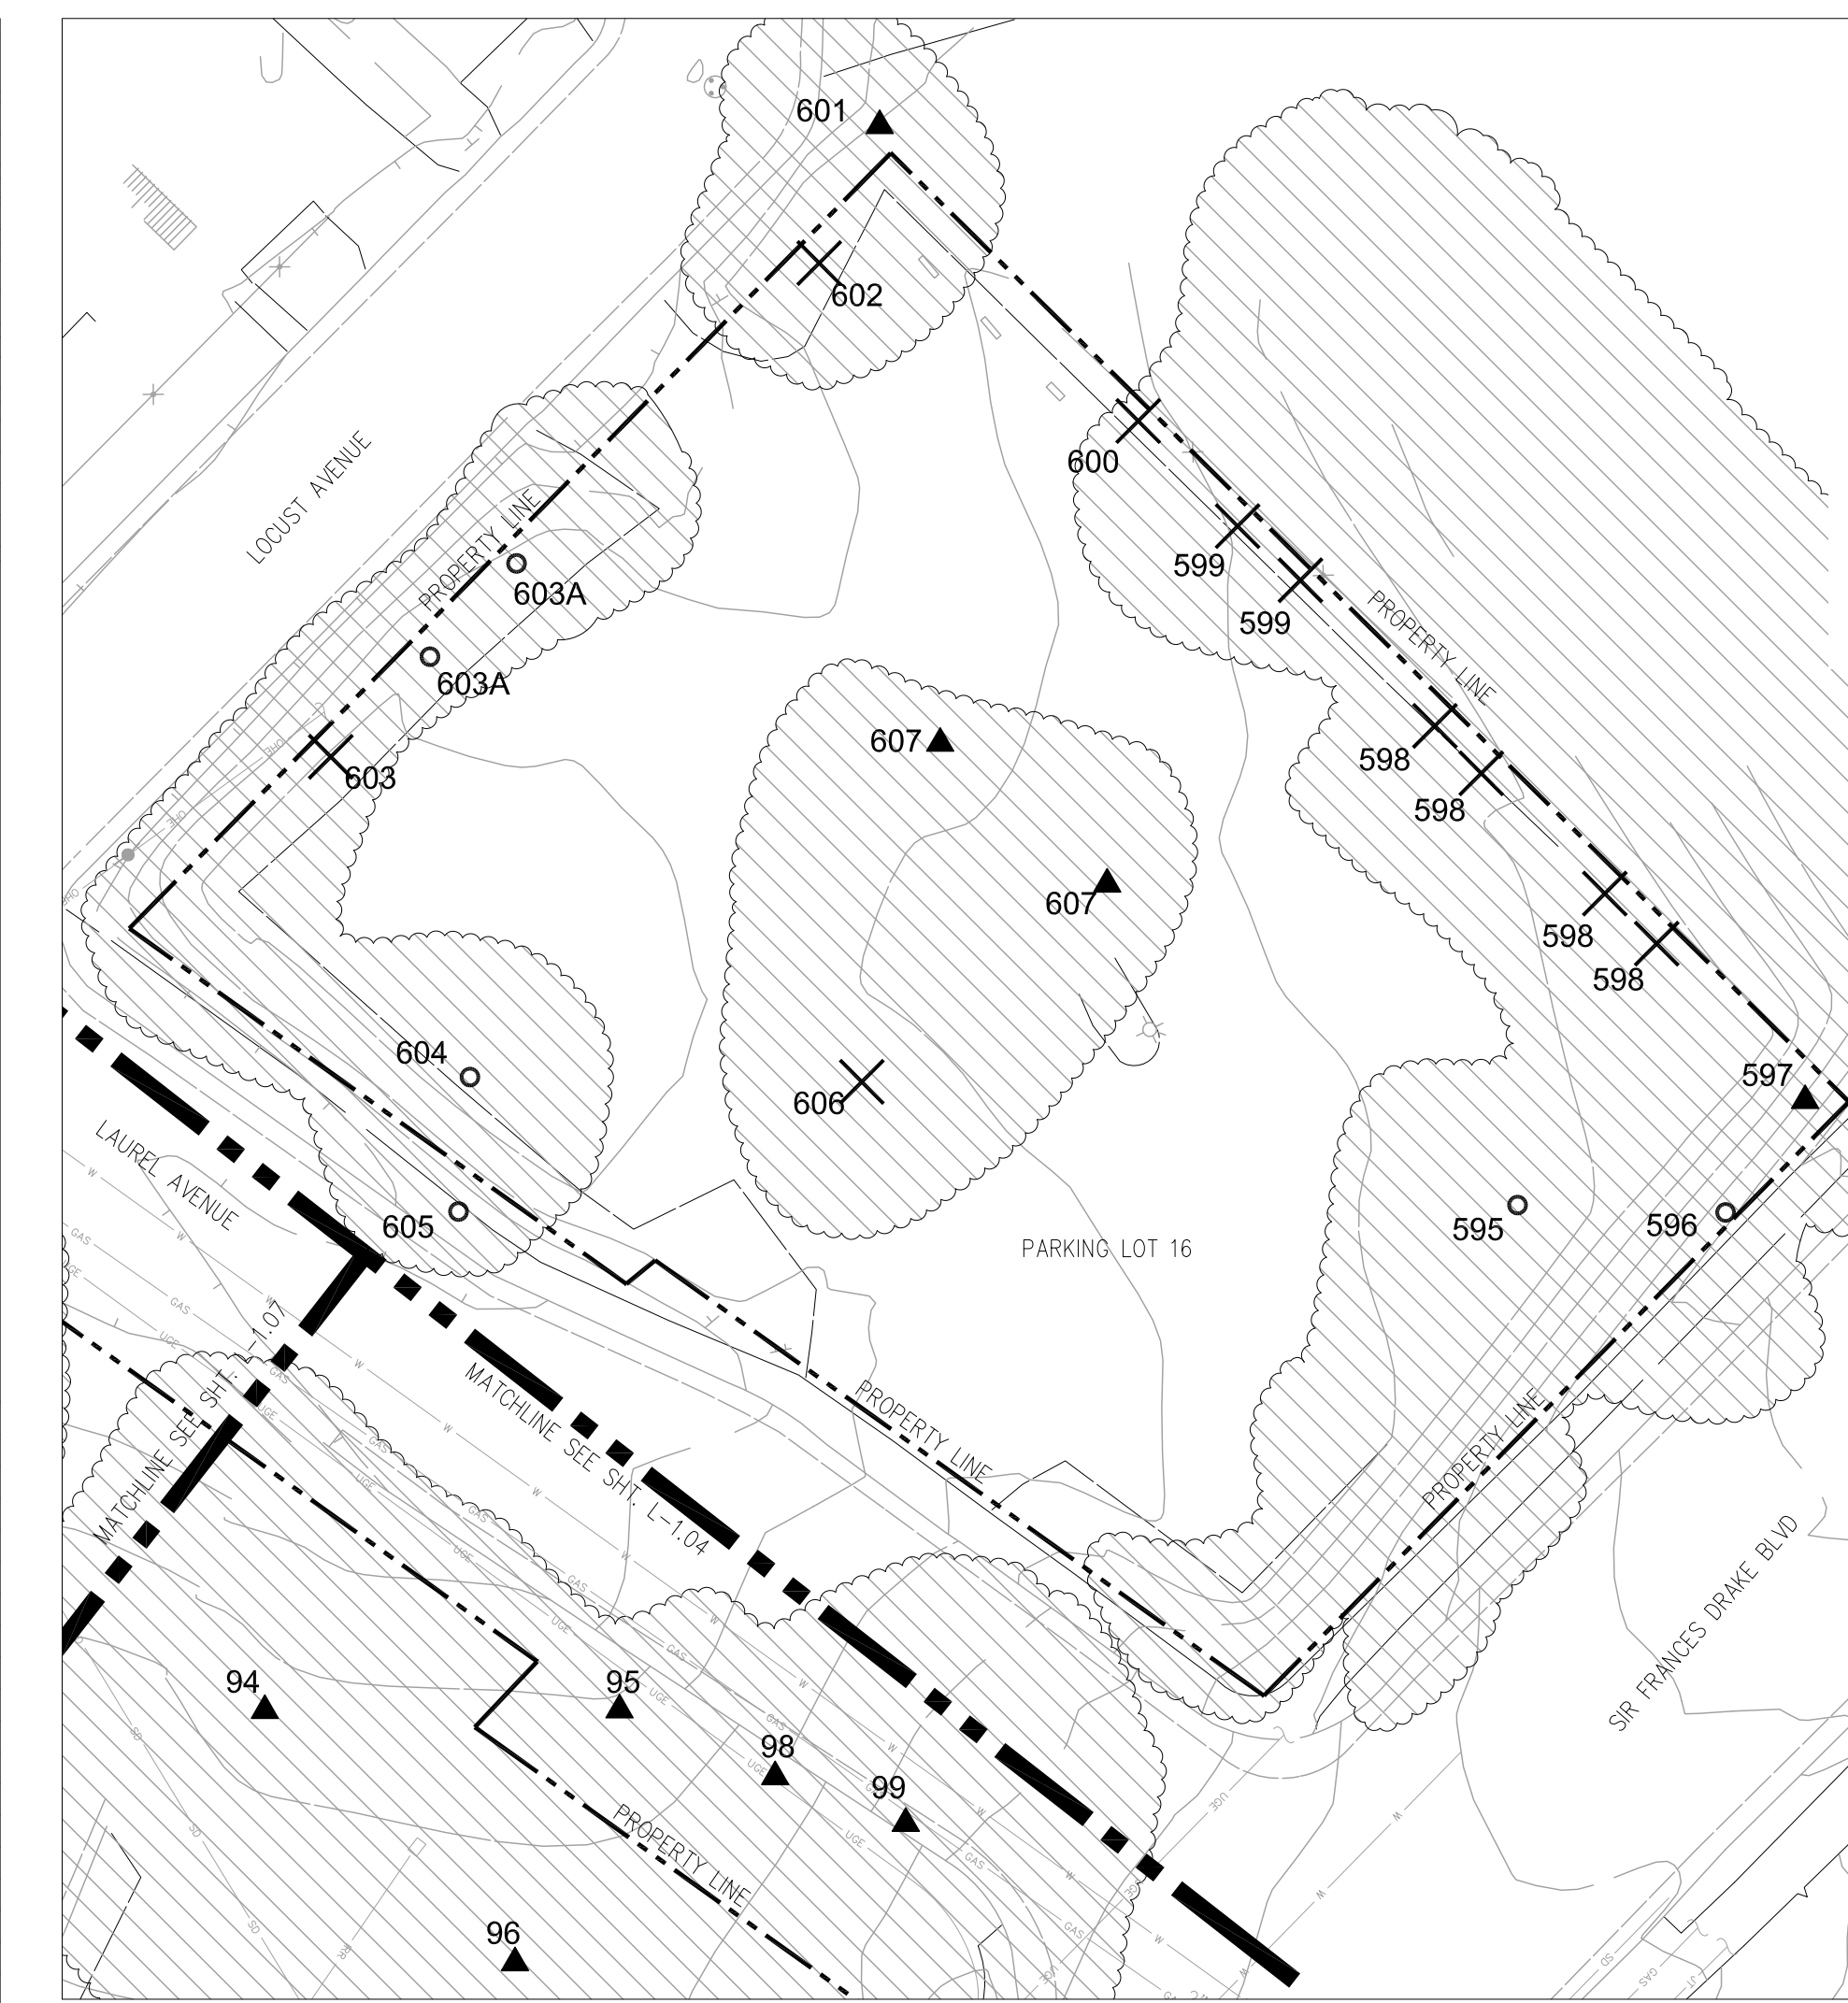
1 PARKING LOT #16 (TREES 595-607)
1" = 20', CONTOUR INTERVAL = 1'

TREE ASSESSMENT										SCHEDULE OF WORK	
Tree #	Species (common)	Species (scientific)	Location	Size	Health	Structural Condition	Impacts to Infrastructure	Conclusion	Recommendations	Priority	
595	Incense Cedar	<i>Calocedrus decurrens</i>	In a dirt planting area between two parking spaces near the northwest corner of Parking Lot #16	24"	Fair; sparse crown. Limited root zone.	Good	None		None	5	
596	Coast Live Oak	<i>Quercus agrifolia</i>	Northwest of T-595; approximately 3.5-4' down-slope from the sidewalk along Sir Francis Drake Blvd	18"	Good	Good	None		None		
597	Incense Cedar	<i>Calocedrus decurrens</i>	20' Northwest of T-596 directly adjacent to SFD	24"	Good; mature.	Fair to good; corrected south-southeast lean.	Located 1' from electrical boxes but no apparent damage.	Black acacia sprouts growing at base.	Remove all black acacia sprouts.	1	
598	Blackwood Acacia	<i>Acacia melanoxylon</i>	Along the west side of Parking Lot #16; there are four trees between the asphalt and the wood fence that separates the college and a private property	cluster of four trees	Fair; seems that tree was removed and has sprouted back.	Fair	None	Sprout growth is encroaching adjacent parking space.	Remove and stump grnd.	1
