Kentfield Learning Resource Center/ Student Center Programming

COLLEGE OF
MARIN

October 26, 2018

FACILITY CONDITION ASSESSMENT

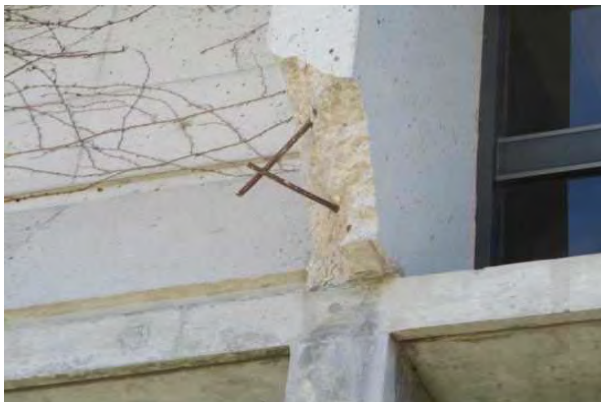
#11:

- Part of an exterior concrete fin has fallen off, exposing the fin's rebar. Repair of the damaged fin is recommended. In addition, a close inspection of the remaining fins to forestall any future damage of this nature is recommended.
- Ongoing periodic maintenance, including patching repairs, graffiti removal, and recaulking, is highly recommended. Future lifecycle replacements of the components listed above will be required.

EXTERIOR WALL, BROKEN CONCRETE FIN

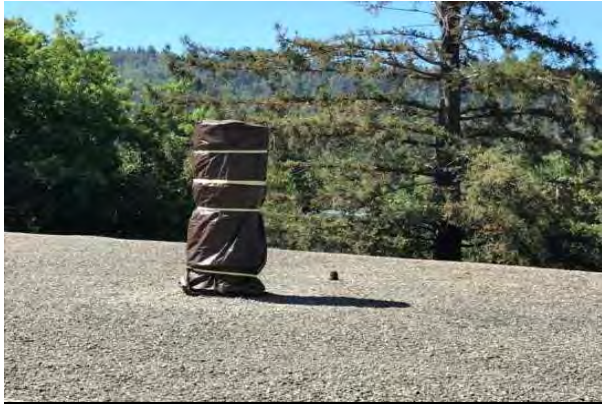
#13:	LEAKING CHIMNEY
------	-----------------

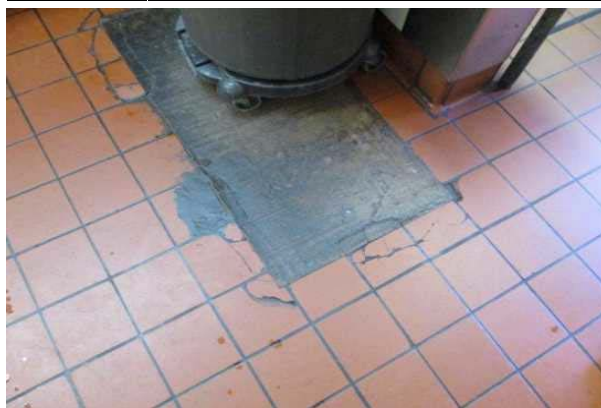
#18:	KITCHEN QUARRY TILE, CRACKED AND BROKEN
------	---
