COLLEGE OF MARIN

TREE HEALTH PROJECT

KENTFIELD CAMPUS

JULY 10, 2014

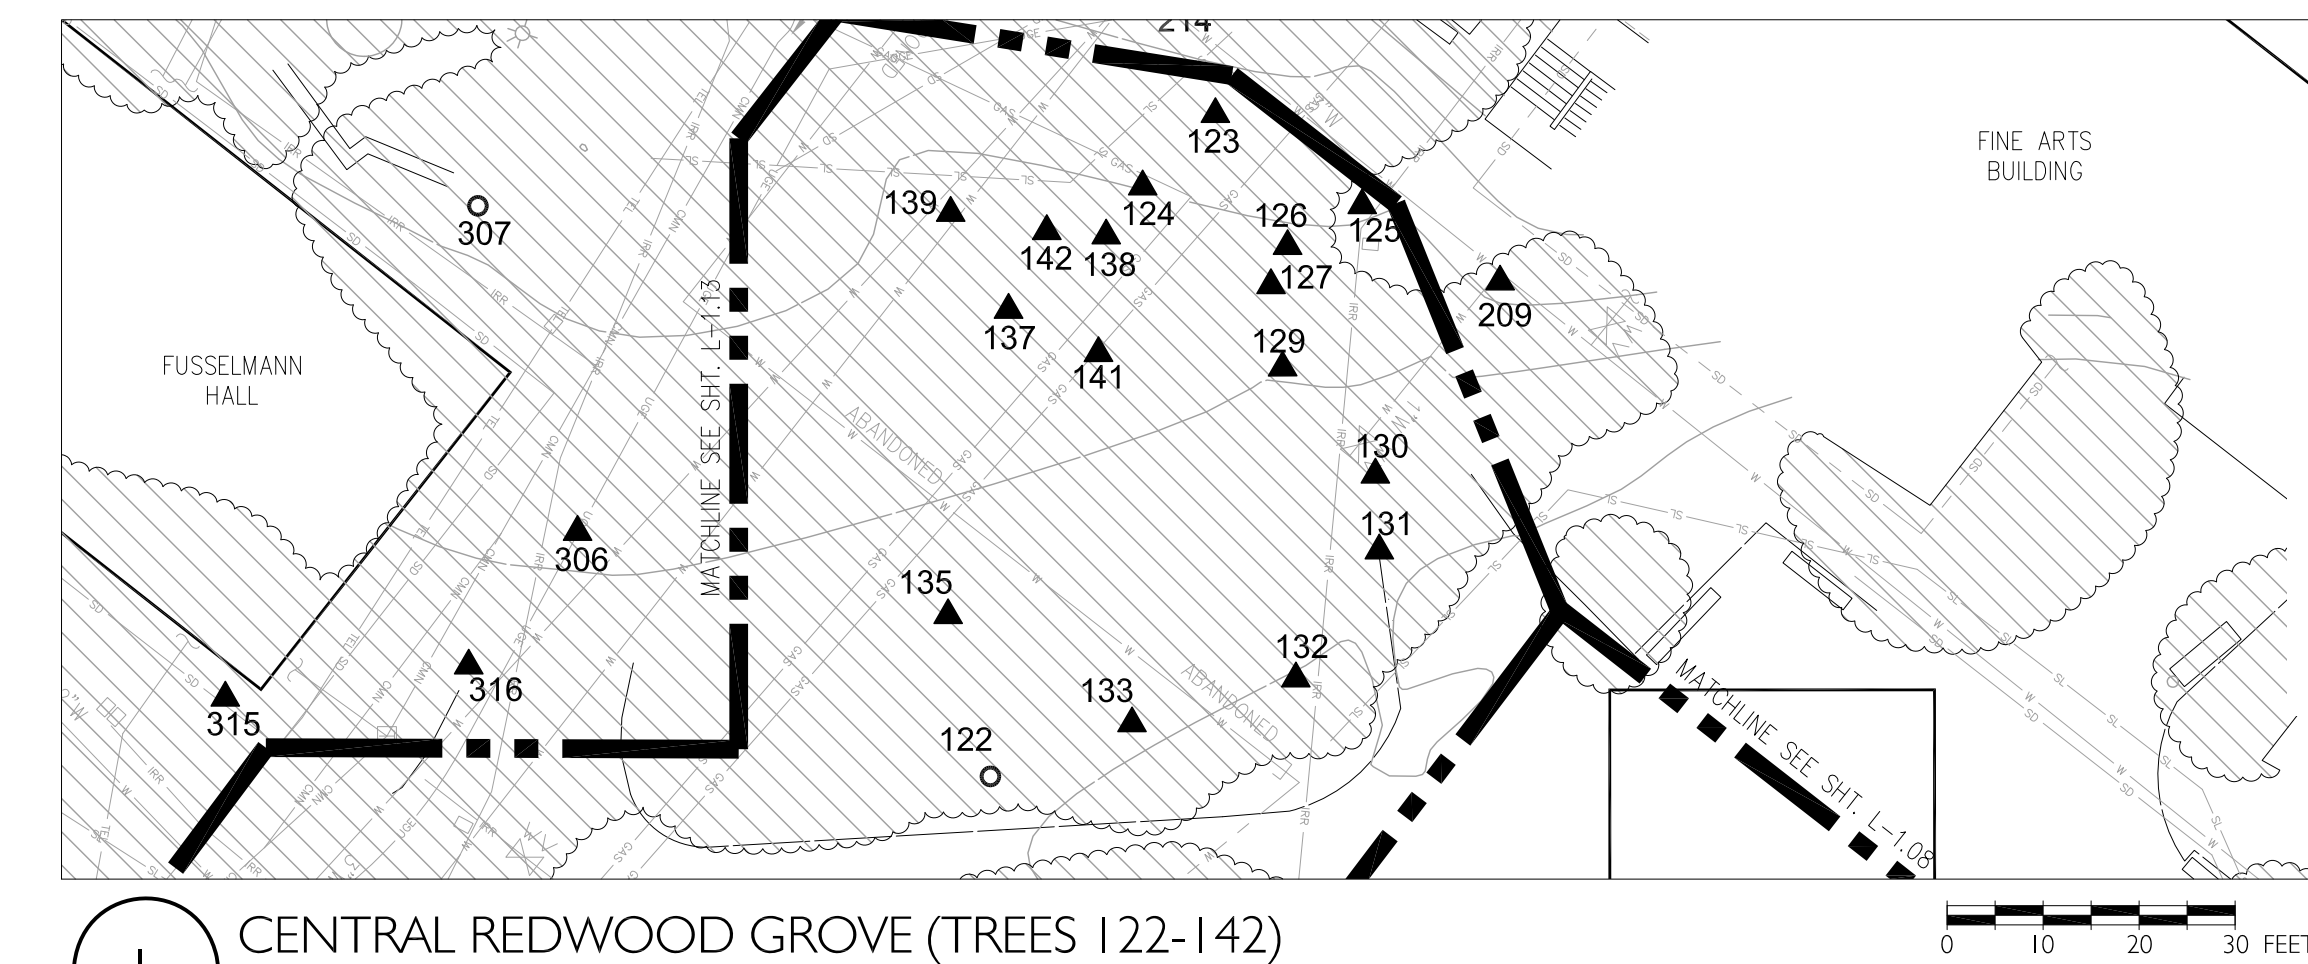
1 CENTRAL REDWOOD GROVE (TREES 122-142)

126	Coast Redwood	<i>Sequoia sempervirens</i>	Immediately adjacent to concrete bench; 4' east of T-125 and approximately 4.5' northwest of T-127	60"	Good	Good	None/insignificant.		Prune sprouts at base. Prune branches and foliage up to 10' for visual clearance.	3
127	Coast Redwood	<i>Sequoia sempervirens</i>	At northeast corner of this grouping; approximately 4' T-129 and about 5' from T-126	72"	Good	3 stems, 2 broken.	None/insignificant.		Prune sprouts at base. Prune branches and foliage up to 10' for visual clearance.	3
129	Coast Redwood	<i>Sequoia sempervirens</i>	Approximately 3' from T-130; in the center of this Redwood grove	36"	Good	Good	None/insignificant.		Prune sprouts at base. Prune branches and foliage up to 10' for visual clearance.	3
130	Coast Redwood	<i>Sequoia sempervirens</i>	On the east side of the grove between T-131 and T-127	18"	Good	Broken top and suppressed.	None/insignificant.		Prune sprouts at base. Prune branches and foliage up to 10' for visual clearance.	3

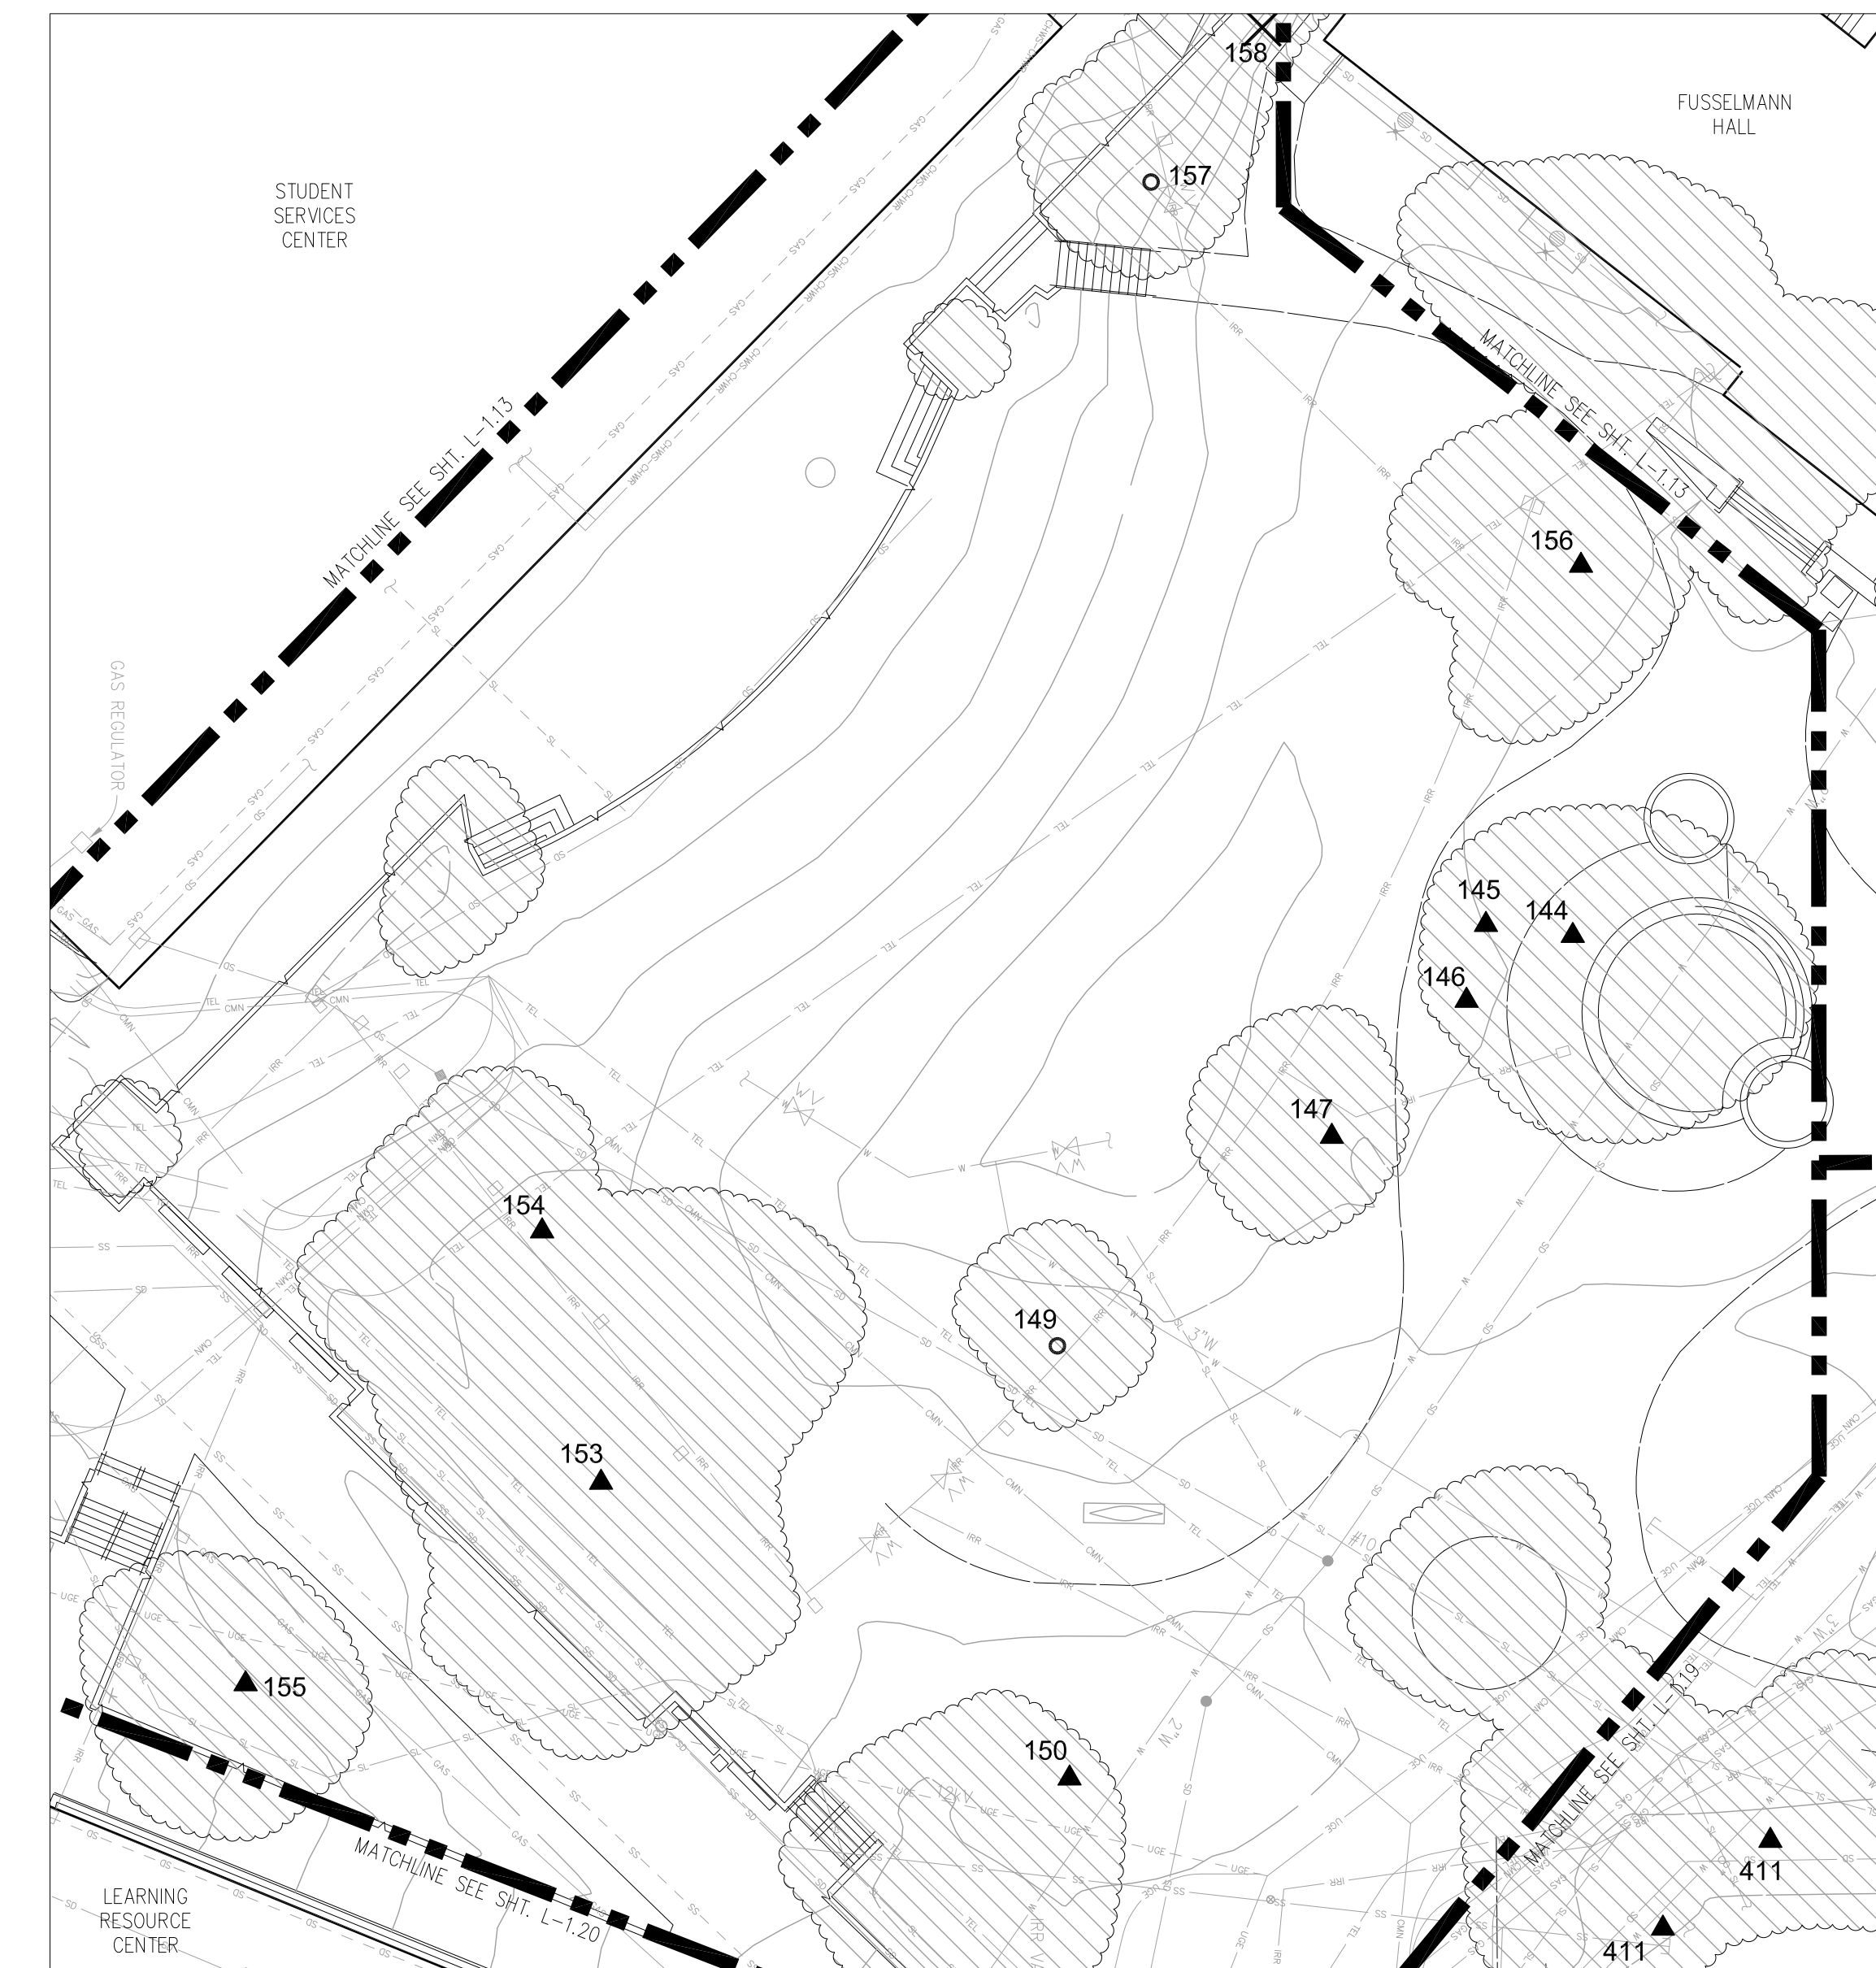
2 CENTRAL QUAD SOUTH (TREES 144-158)

153	Big Leaf Maple	<i>Acer macrophyllum</i>	In a large planting island east of the retaining wall near the Student Resource Center	44"	Fair; epiphytes present in main crotch at 7' suggesting possible decay. Old cabling system present. Cables display slacking. One cable is attached in to a dead stub.			Large dead limb extending east north east.	Crown cleaning. Cabling system needs maintenance. Additional risk assessment.	1
154	Akebono Cherry	<i>Prunus x yedoensis 'Akebono'</i>	In planting bed near stair and retaining wall east of the Student Resource Center	18"	Fair to poor. Mature tree in decline. Sun scald present.	Poor to fair	None		Trim back long extending limb.	4
155	Camphor	<i>Cinnamomum camphora</i>	North of the Learning Resource Center along the sidewalk	20"	Fair. Girdling roots present.	Fair	None		Crown cleaning.	4
156	European Horsechestnut	<i>Aesculus hippocastanum</i>	East of a large stump in front of Fusselman Hall	16"	Fair to good	Fair	New construction present within 5' of root crown. Roots have been disturbed to install new bench footings. Concrete has been poured within root zone.	Tree should be monitored during and after construction.	Monitor for signs of decline and schedule health assessment if symptoms are present.	2

157	Swamp Cypress		Off of the southeast corner of Fusselman Hall and the northwest corner of the Student Services Building	12"	Fair	Good	None		None	5
158	Dawn Redwood	<i>Metasequoia glyptostroboides</i>	Near the southeast corner of Fusselman Hall	14"	Poor health due to confined root zone and high albedo area.	Fair. Two competing leaders.	None	Longevity of this tree is in doubt due to its placement and high albedo.	Remove	1

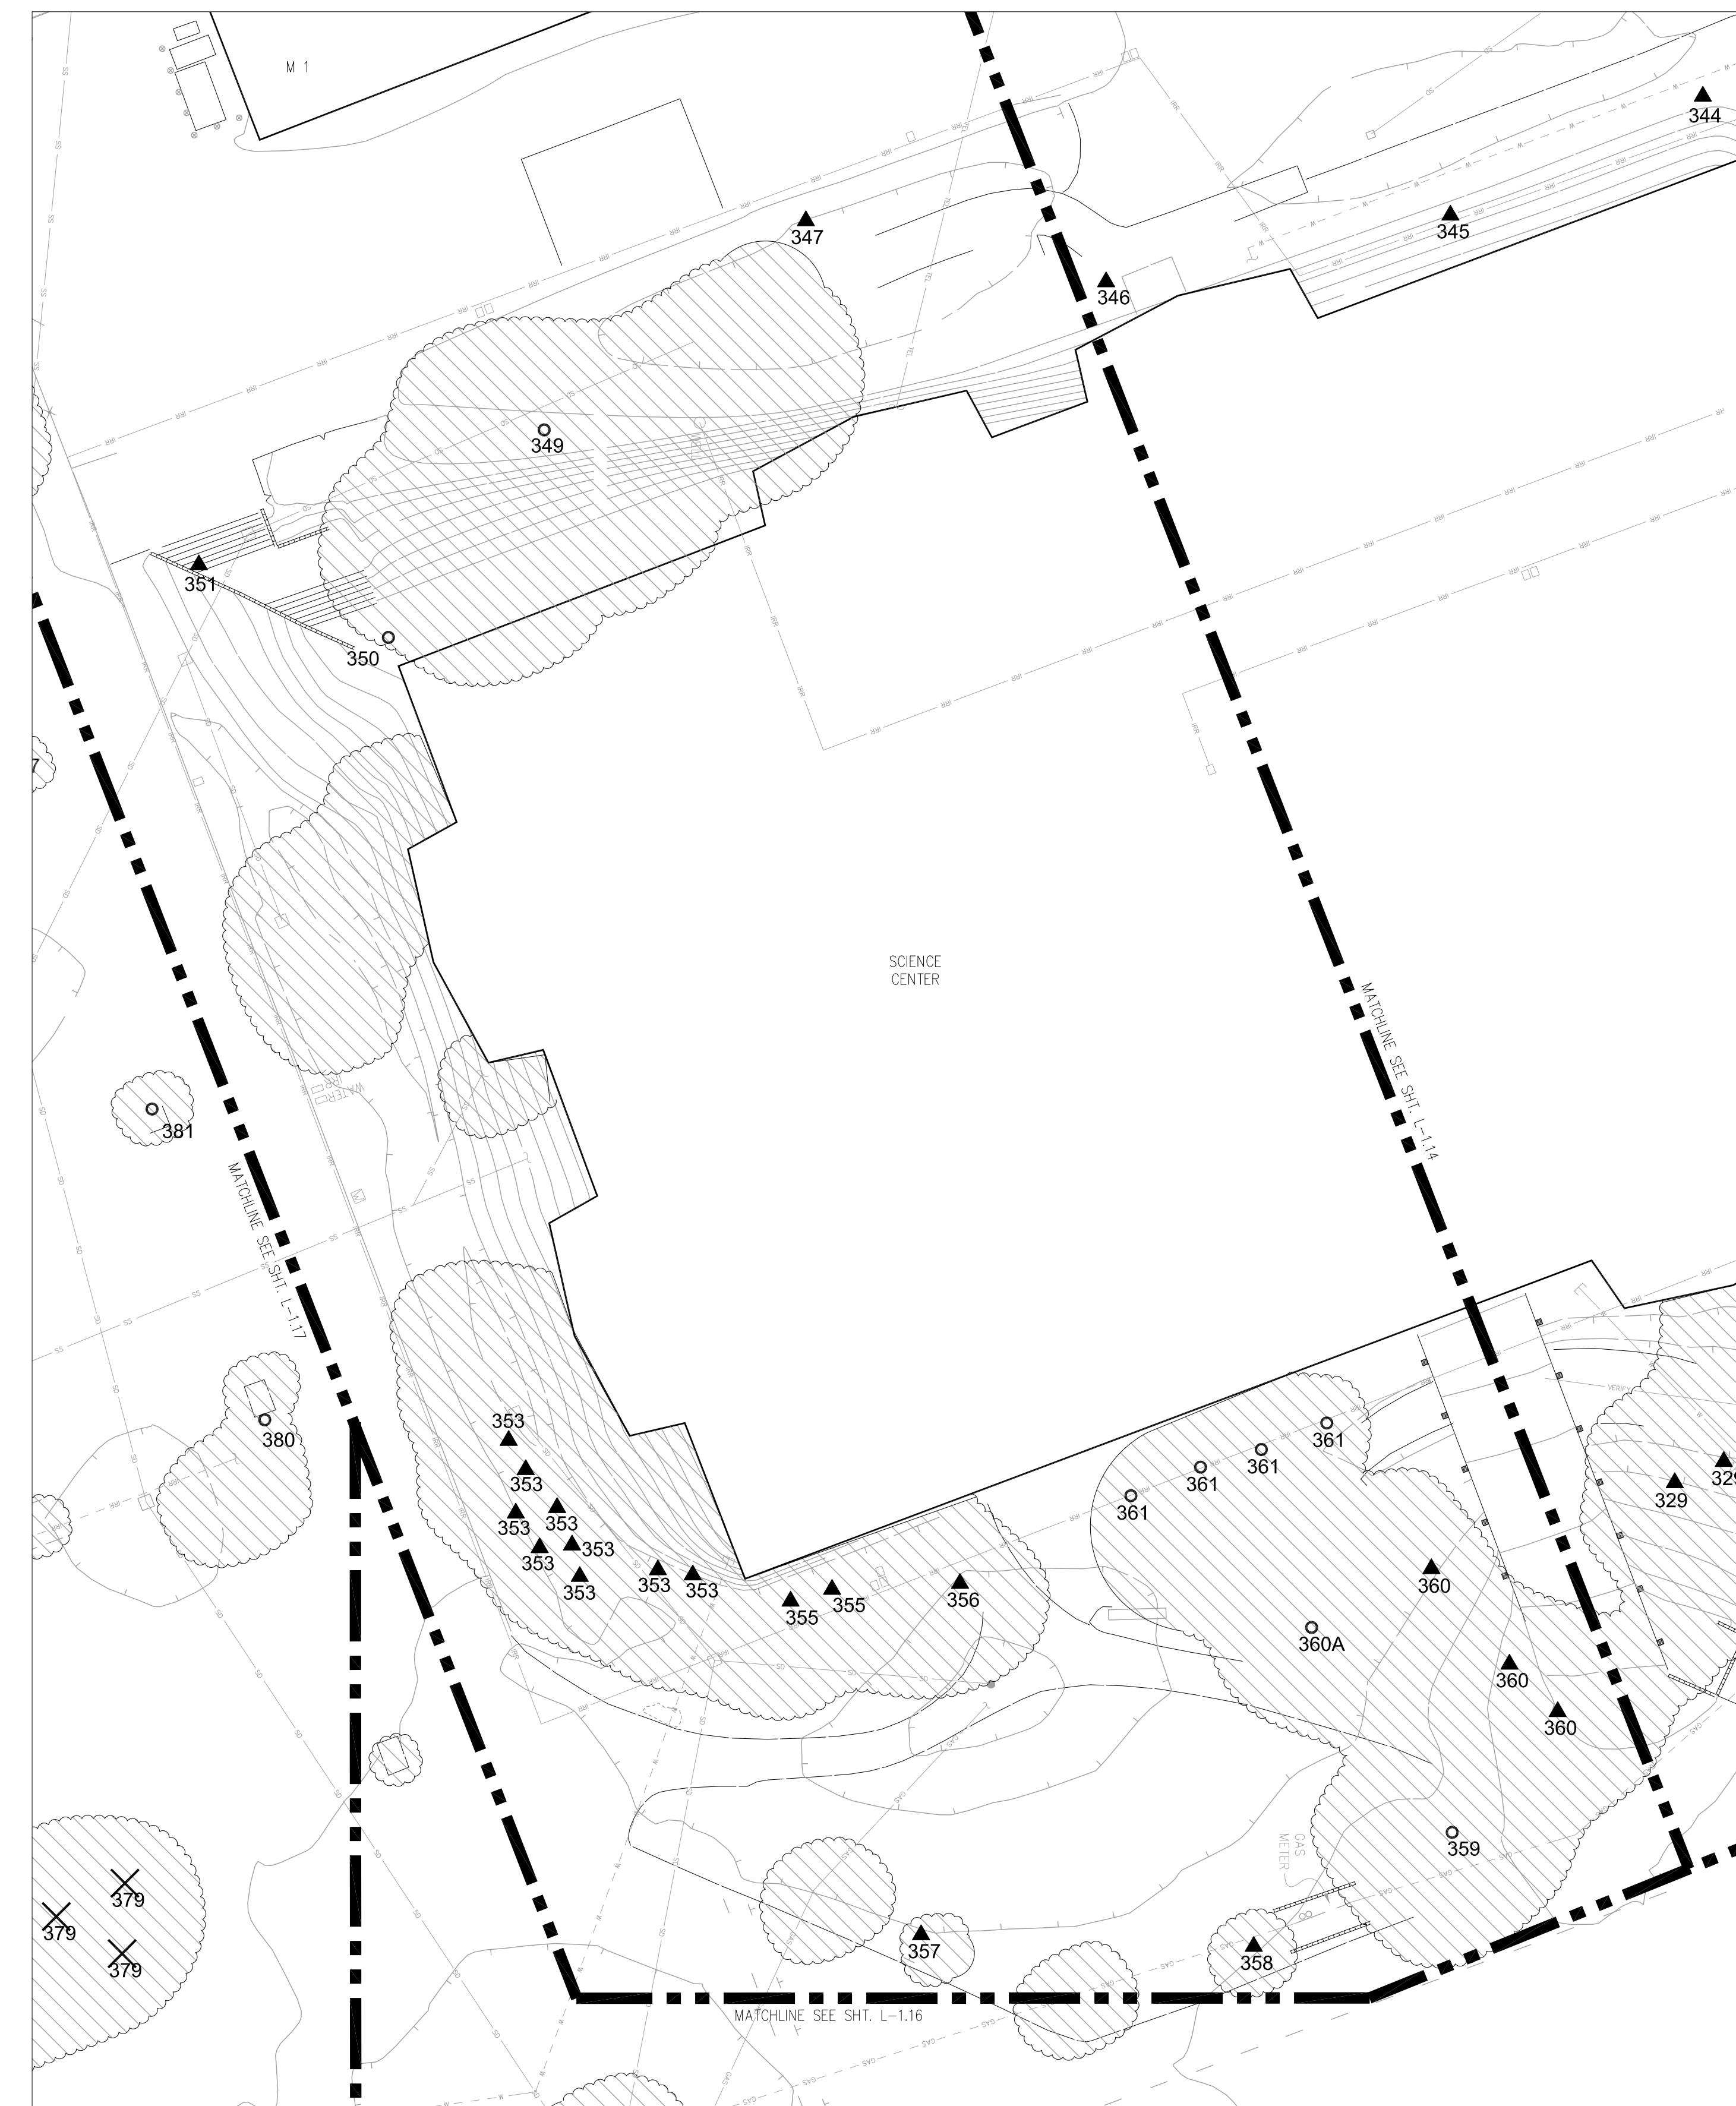
I SCIENCE CENTER SOUTH (TREES 347-361)
1" = 20', CONTOUR INTERVAL = 1'

360	a Catalpa	<i>catalpa sp.</i>	Located on east side of building on south side of main entrance	8"	Good	Good	None		None	
360	Little-Leaf Linden	<i>Tilia cordata</i>	South of the main east entrance to the Science Center	18"	Good	Good	None	Multiple dead limbs suspended in canopy	Remove hanging dead branches and deadwood	2
361	Japanese Maple	<i>Acer palmatum</i>	On the east side of the building and south of the main entrance; within 15' from the foundation to the building	Cluster of four	Good	Good	None		None	5

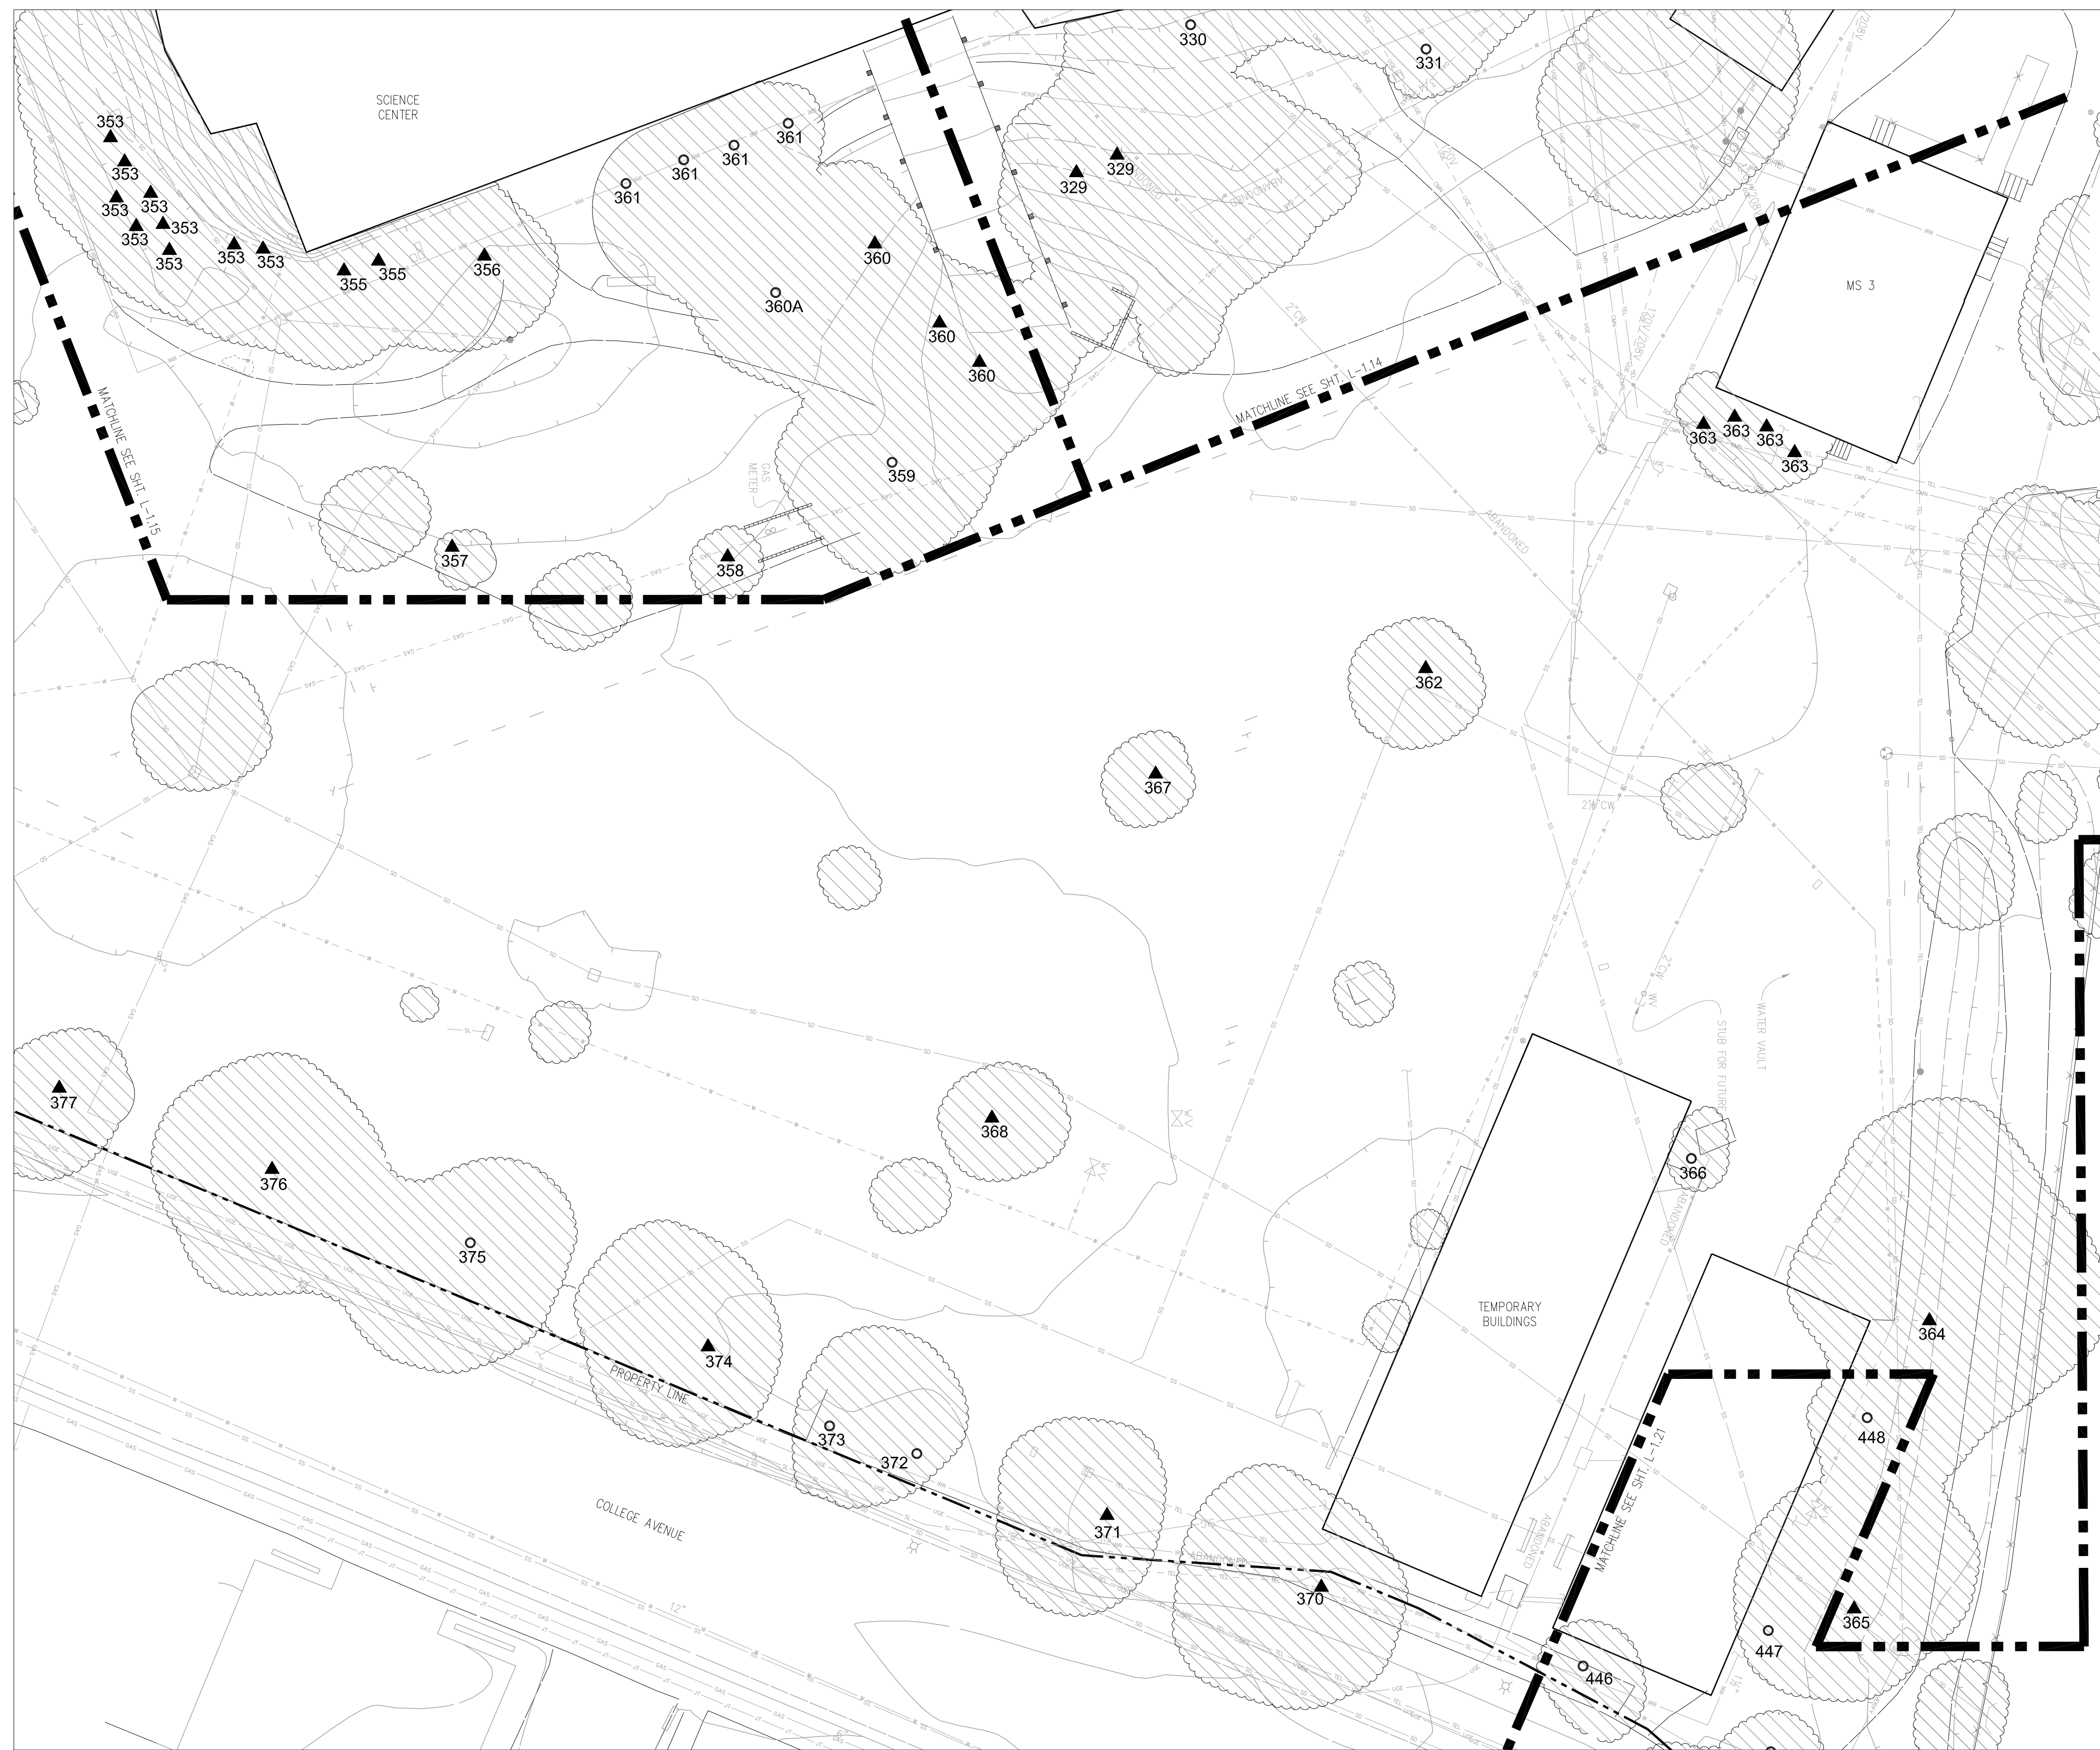
1 PARKING LOT #6 (TREES 362-377)
1" = 20', CONTOUR INTERVAL = 1'

375	Flowering Ash	<i>Fraxinus ornus</i>	Along College Ave, proceeding south from T-374; south of the second entrance to parking lot #1 and 2	24"	Good	Fair	None		None	5
376	Flowering Ash	<i>Fraxinus ornus</i>	Along College Ave, proceeding south from T-375	24"	Fair	Fair	None		None	5
376	Flowering Ash	<i>Fraxinus ornus</i>	Along College Ave, proceeding south from T-375	6"	Good	Fair	None	Appears to be replacement tree	Prune for structure. Develop one central leader. It is important to develop strong structure when the tree is young, especially because it is a street tree.	1
377	Flowering Ash	<i>Fraxinus ornus</i>	Along College Ave, proceeding south from T-376; south-most Ash in this row of trees along College Ave.	30"	Fair to good	Fair	Slight pavement lifting from roots	Trunk is growing into metal brace at base of tree. Much deadwood in canopy overhanging parking lot.	Remove deadwood. Remove metal structure at base of tree to allow for wound closure.	2

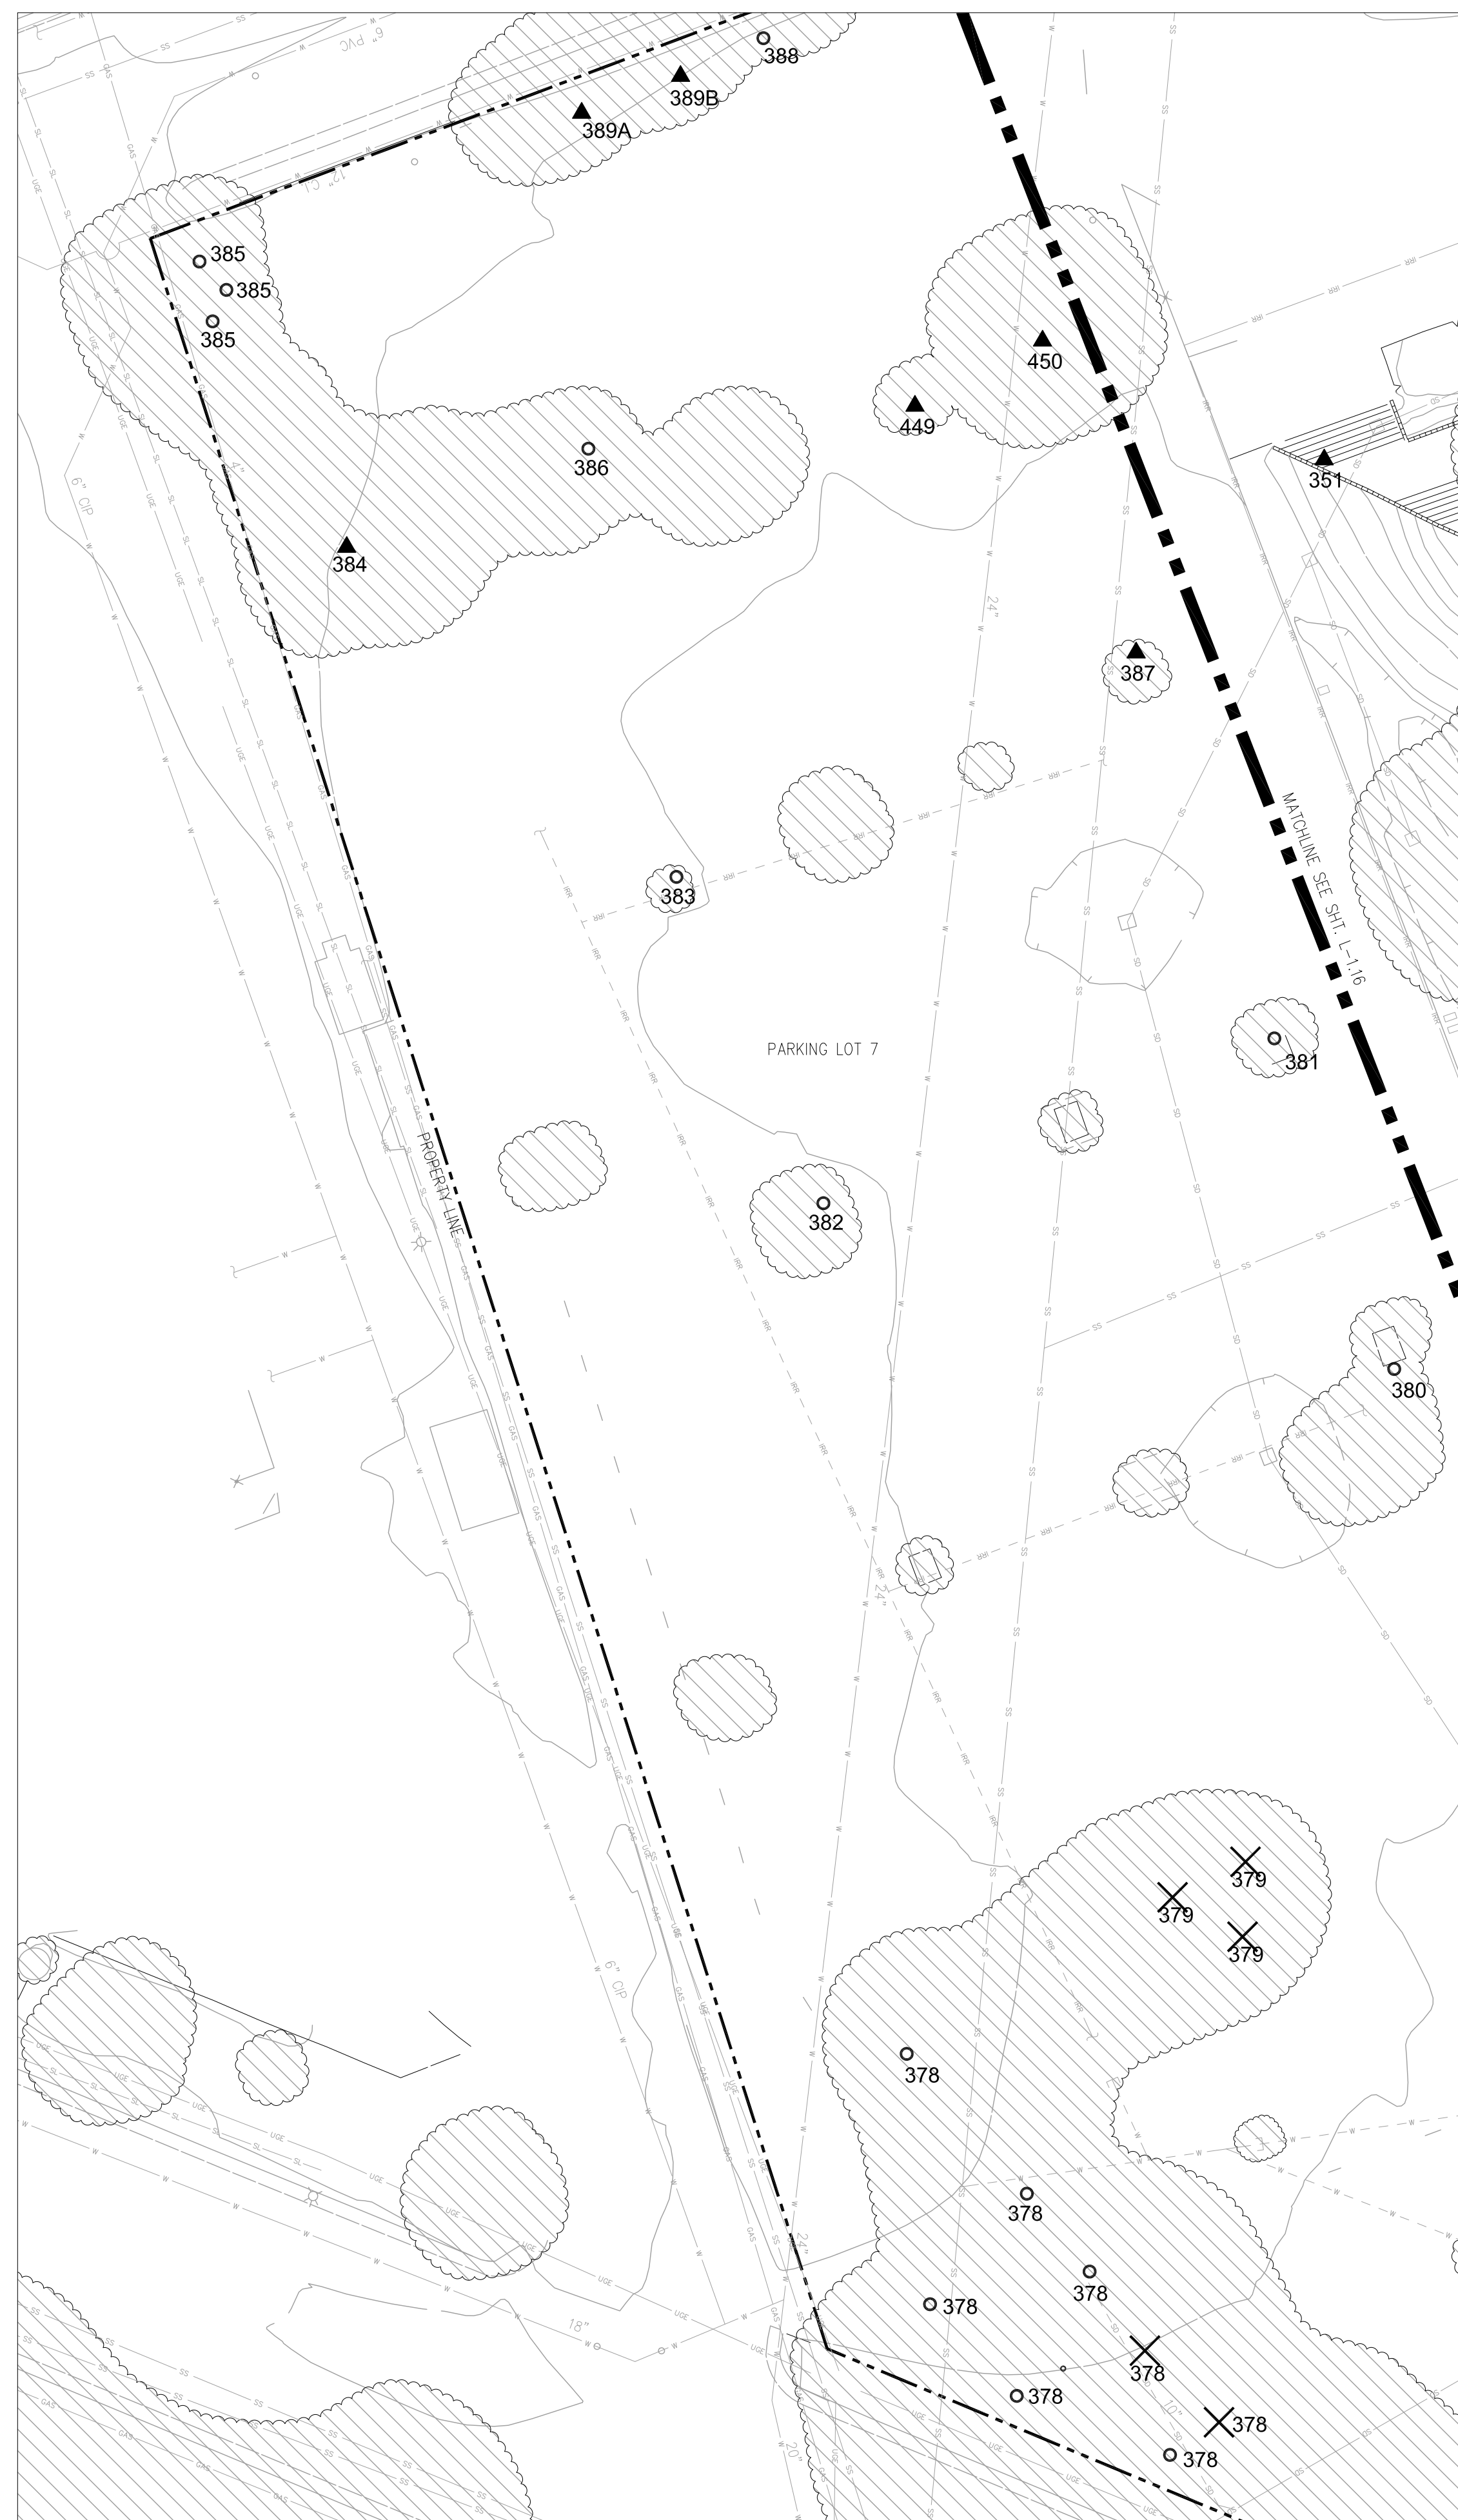
3 PARKING LOT #7 (TREES 378-392, 449-450)
1" = 20', CONTOUR INTERVAL = 1'

449	Incense Cedar	<i>Calocedrus decurrens</i>	In the receiving area ("do not enter" area) off of the west side of the science building. The tree is adjacent to the fence that runs between this area and the sidewalk along the west side of the science building	12"	Fair; root system surrounded by pavement. Crown is competing with adjacent ash tree.	Good	None	Vine is growing throughout canopy.	Remove vine from canopy.	3
450	Ash	<i>Fraxinus sp.</i>	To the west of T-449	20"	Fair; Past branch failure evident. Northwest facing leader with included bark at attachment.	Poor fair	None	Risk of failure could be mitigated with 15% crown reduction and deadwood removal.		2

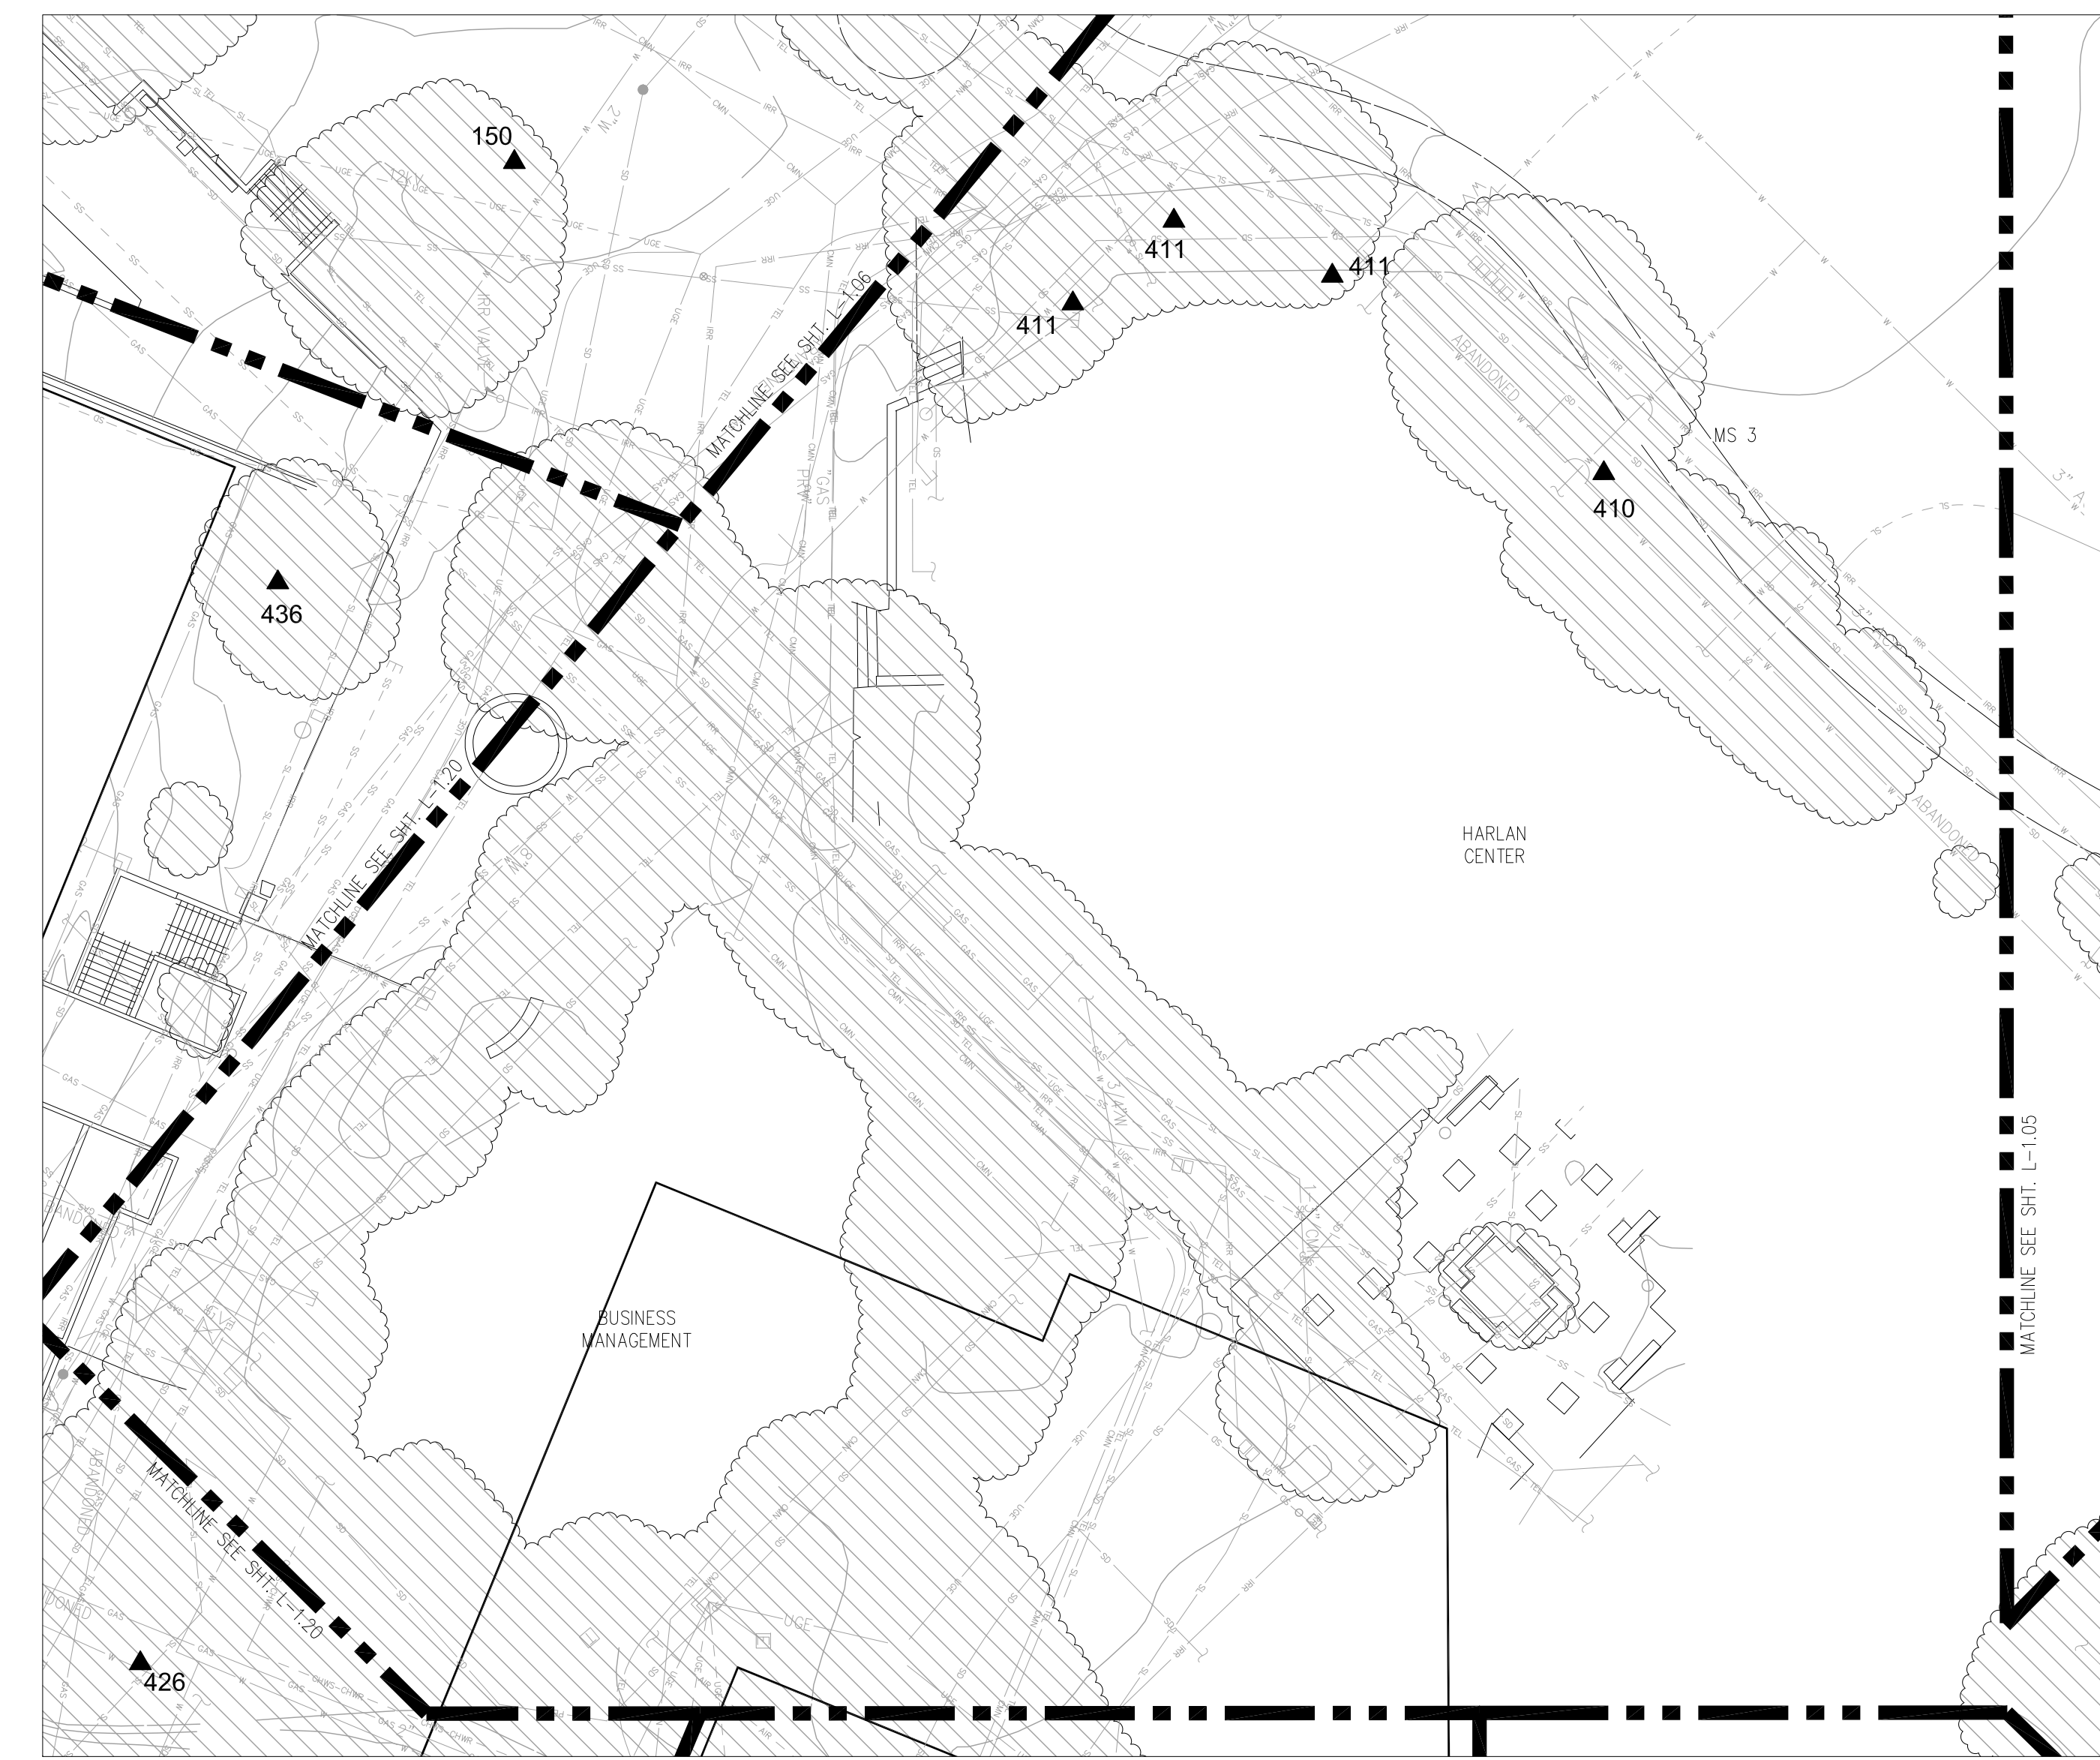
1 HARLAN CENTER / BUSINESS MANAGEMENT (TREES 410-411)
1" = 20', CONTOUR INTERVAL = 1'

TREE ASSESSMENT									SCHEDULE OF WORK	
Tree #	Species (common)	Species (scientific)	Location	Size	Health	Structural Condition	Impacts to infrastructure	Conclusion	Recommendations	Priority
410	Coast Redwood	<i>Sequoia sempervirens</i>	On west side of the Harlan Center; both trees are within 12" of the foundation	Cluster of two at 24" each	Good; development on both sides of this tree.	Good	None		Monitor post construction for stress.	2
411	Japanese Maple	<i>Acer palmatum</i>	At the southwest corner of the Harlan Center	Cluster of two mature, multi stem	Fair; mature, root zones affected by removal of path. No apparent adverse affects.	Good	None		Monitor post construction for stress.	3
