COLLEGE OF MARIN

TREE HEALTH PROJECT

KENTFIELD CAMPUS

JULY 10, 2014

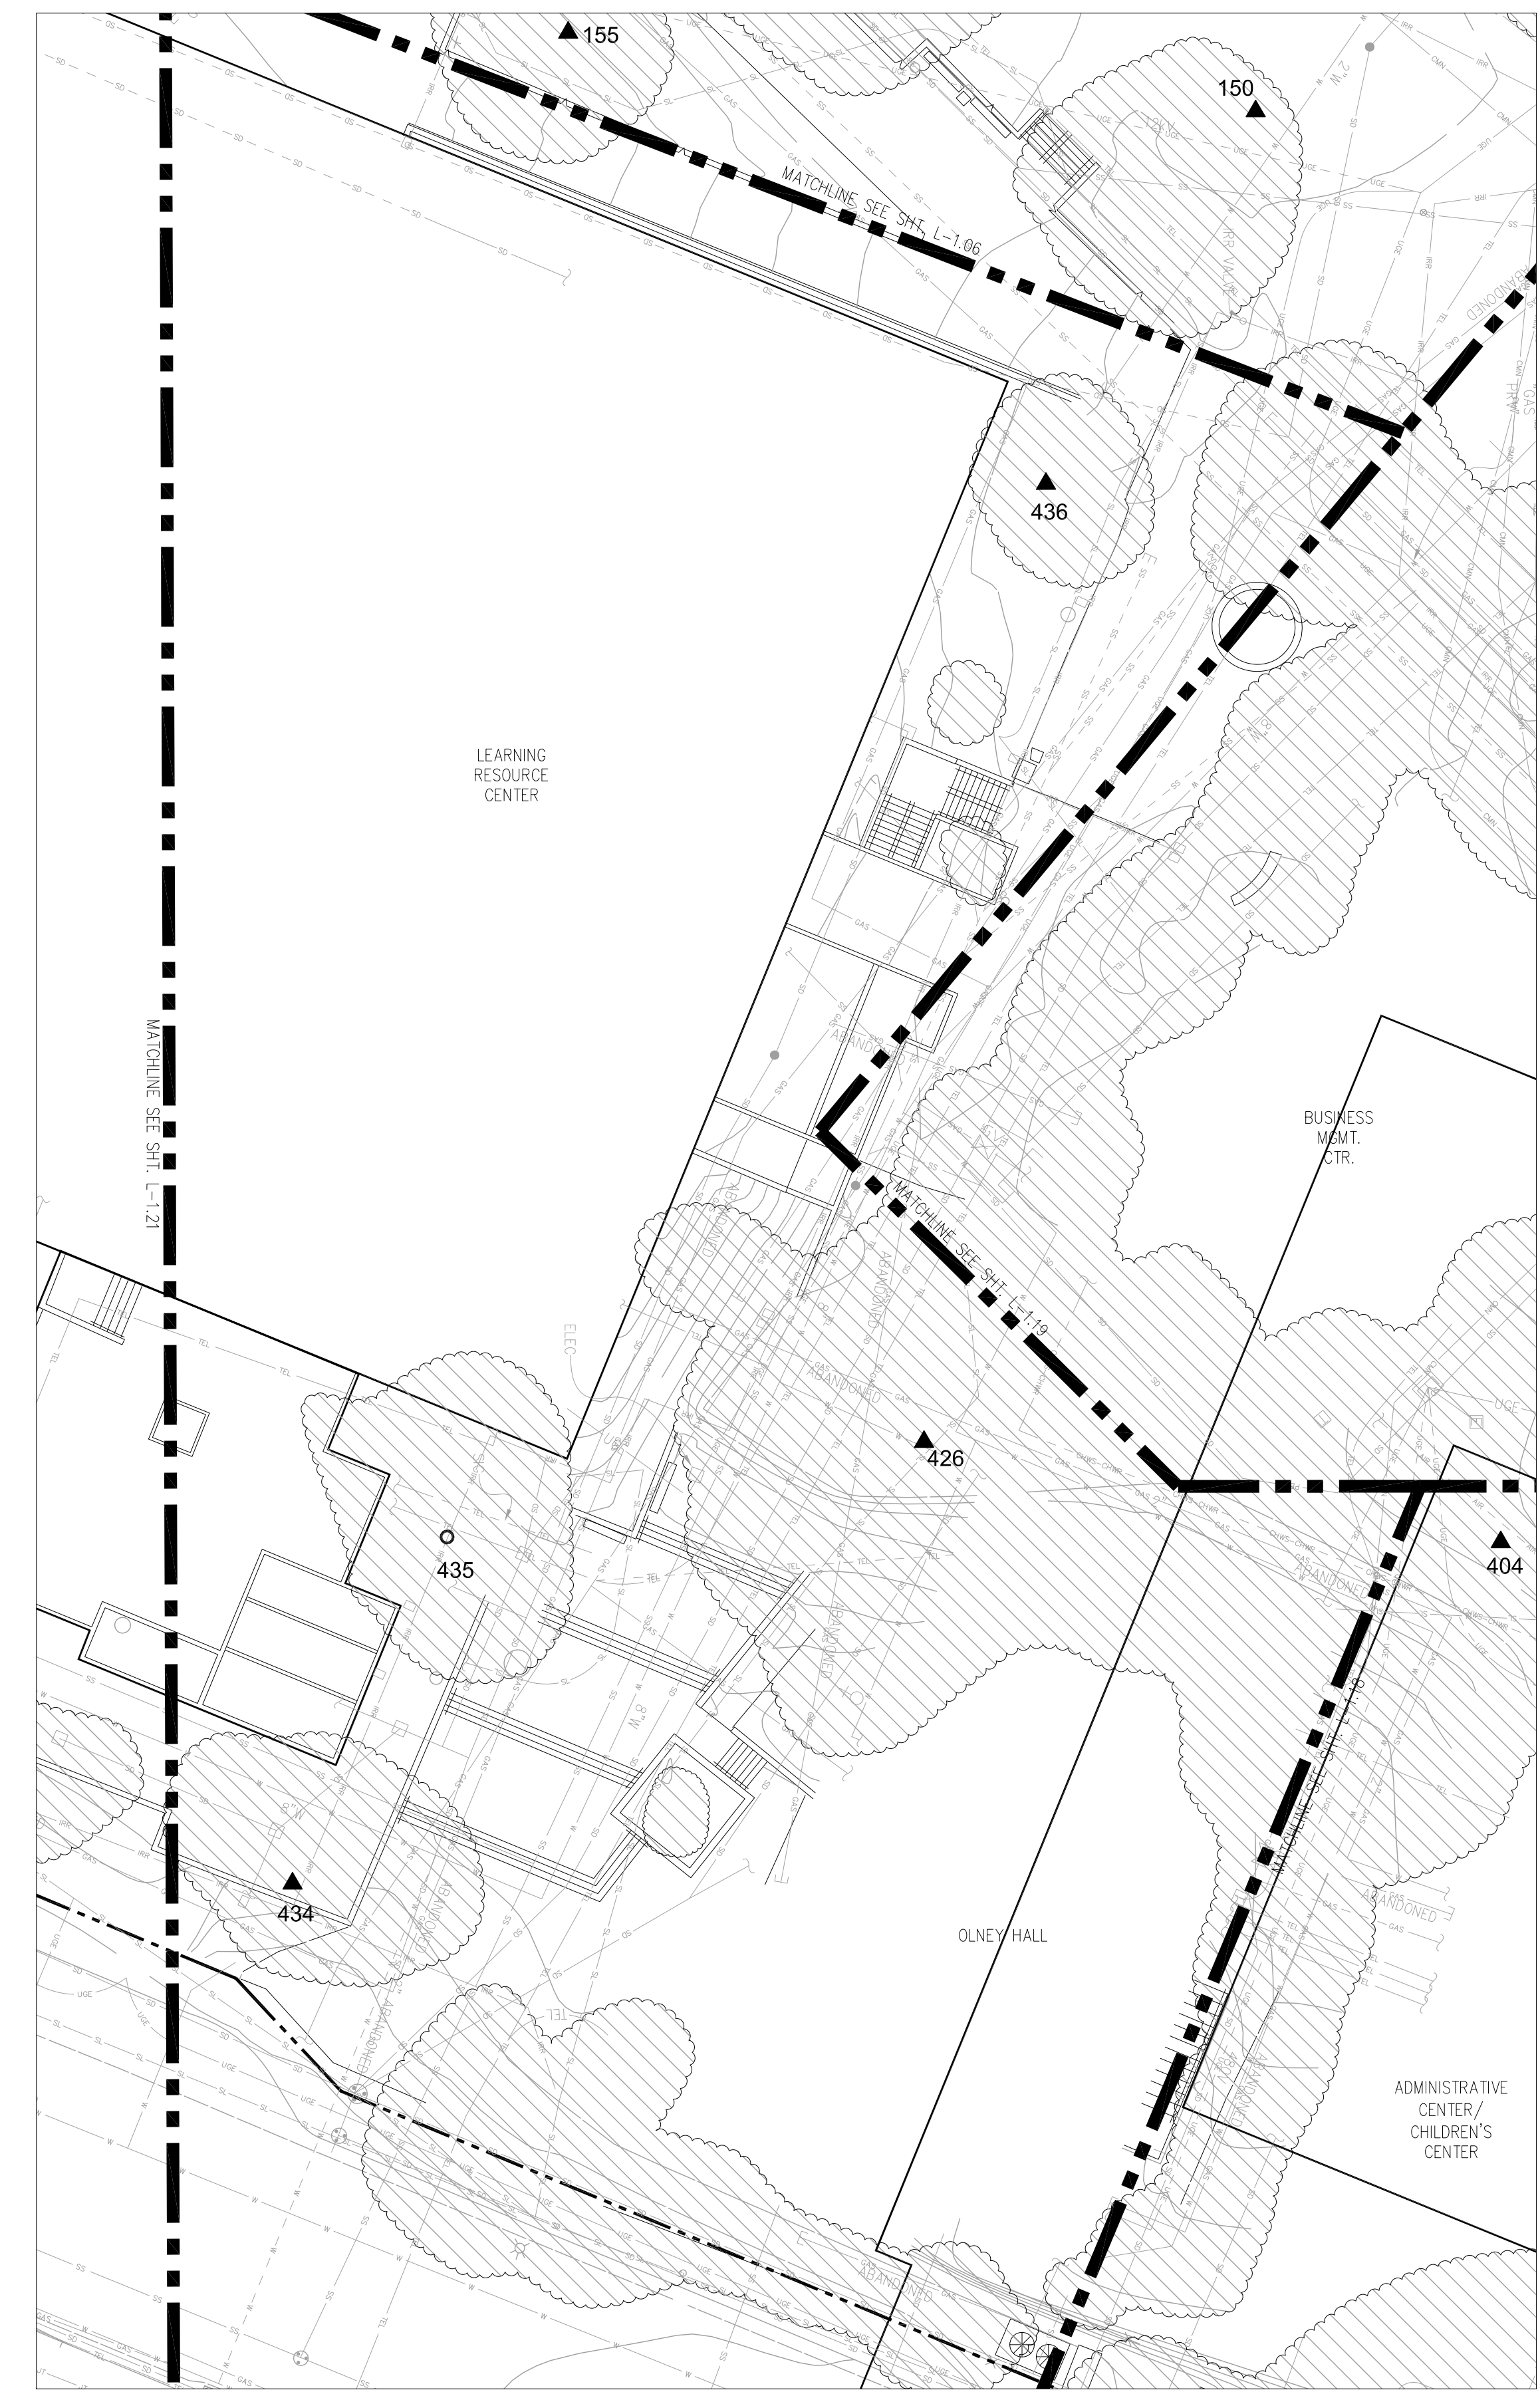
1 LEARNING RESOURCE CENTER / OLNEY HALL (TREES 426-436)
1" = 20', CONTOUR INTERVAL = 1'

436	Mayten	<i>Maytenus boaria</i>	On the northwest corner of the Learning Resource Center	18"	Fair; decay column on main stem.	Fair	None		Raise canopy to provide sidewalk clearance.	3

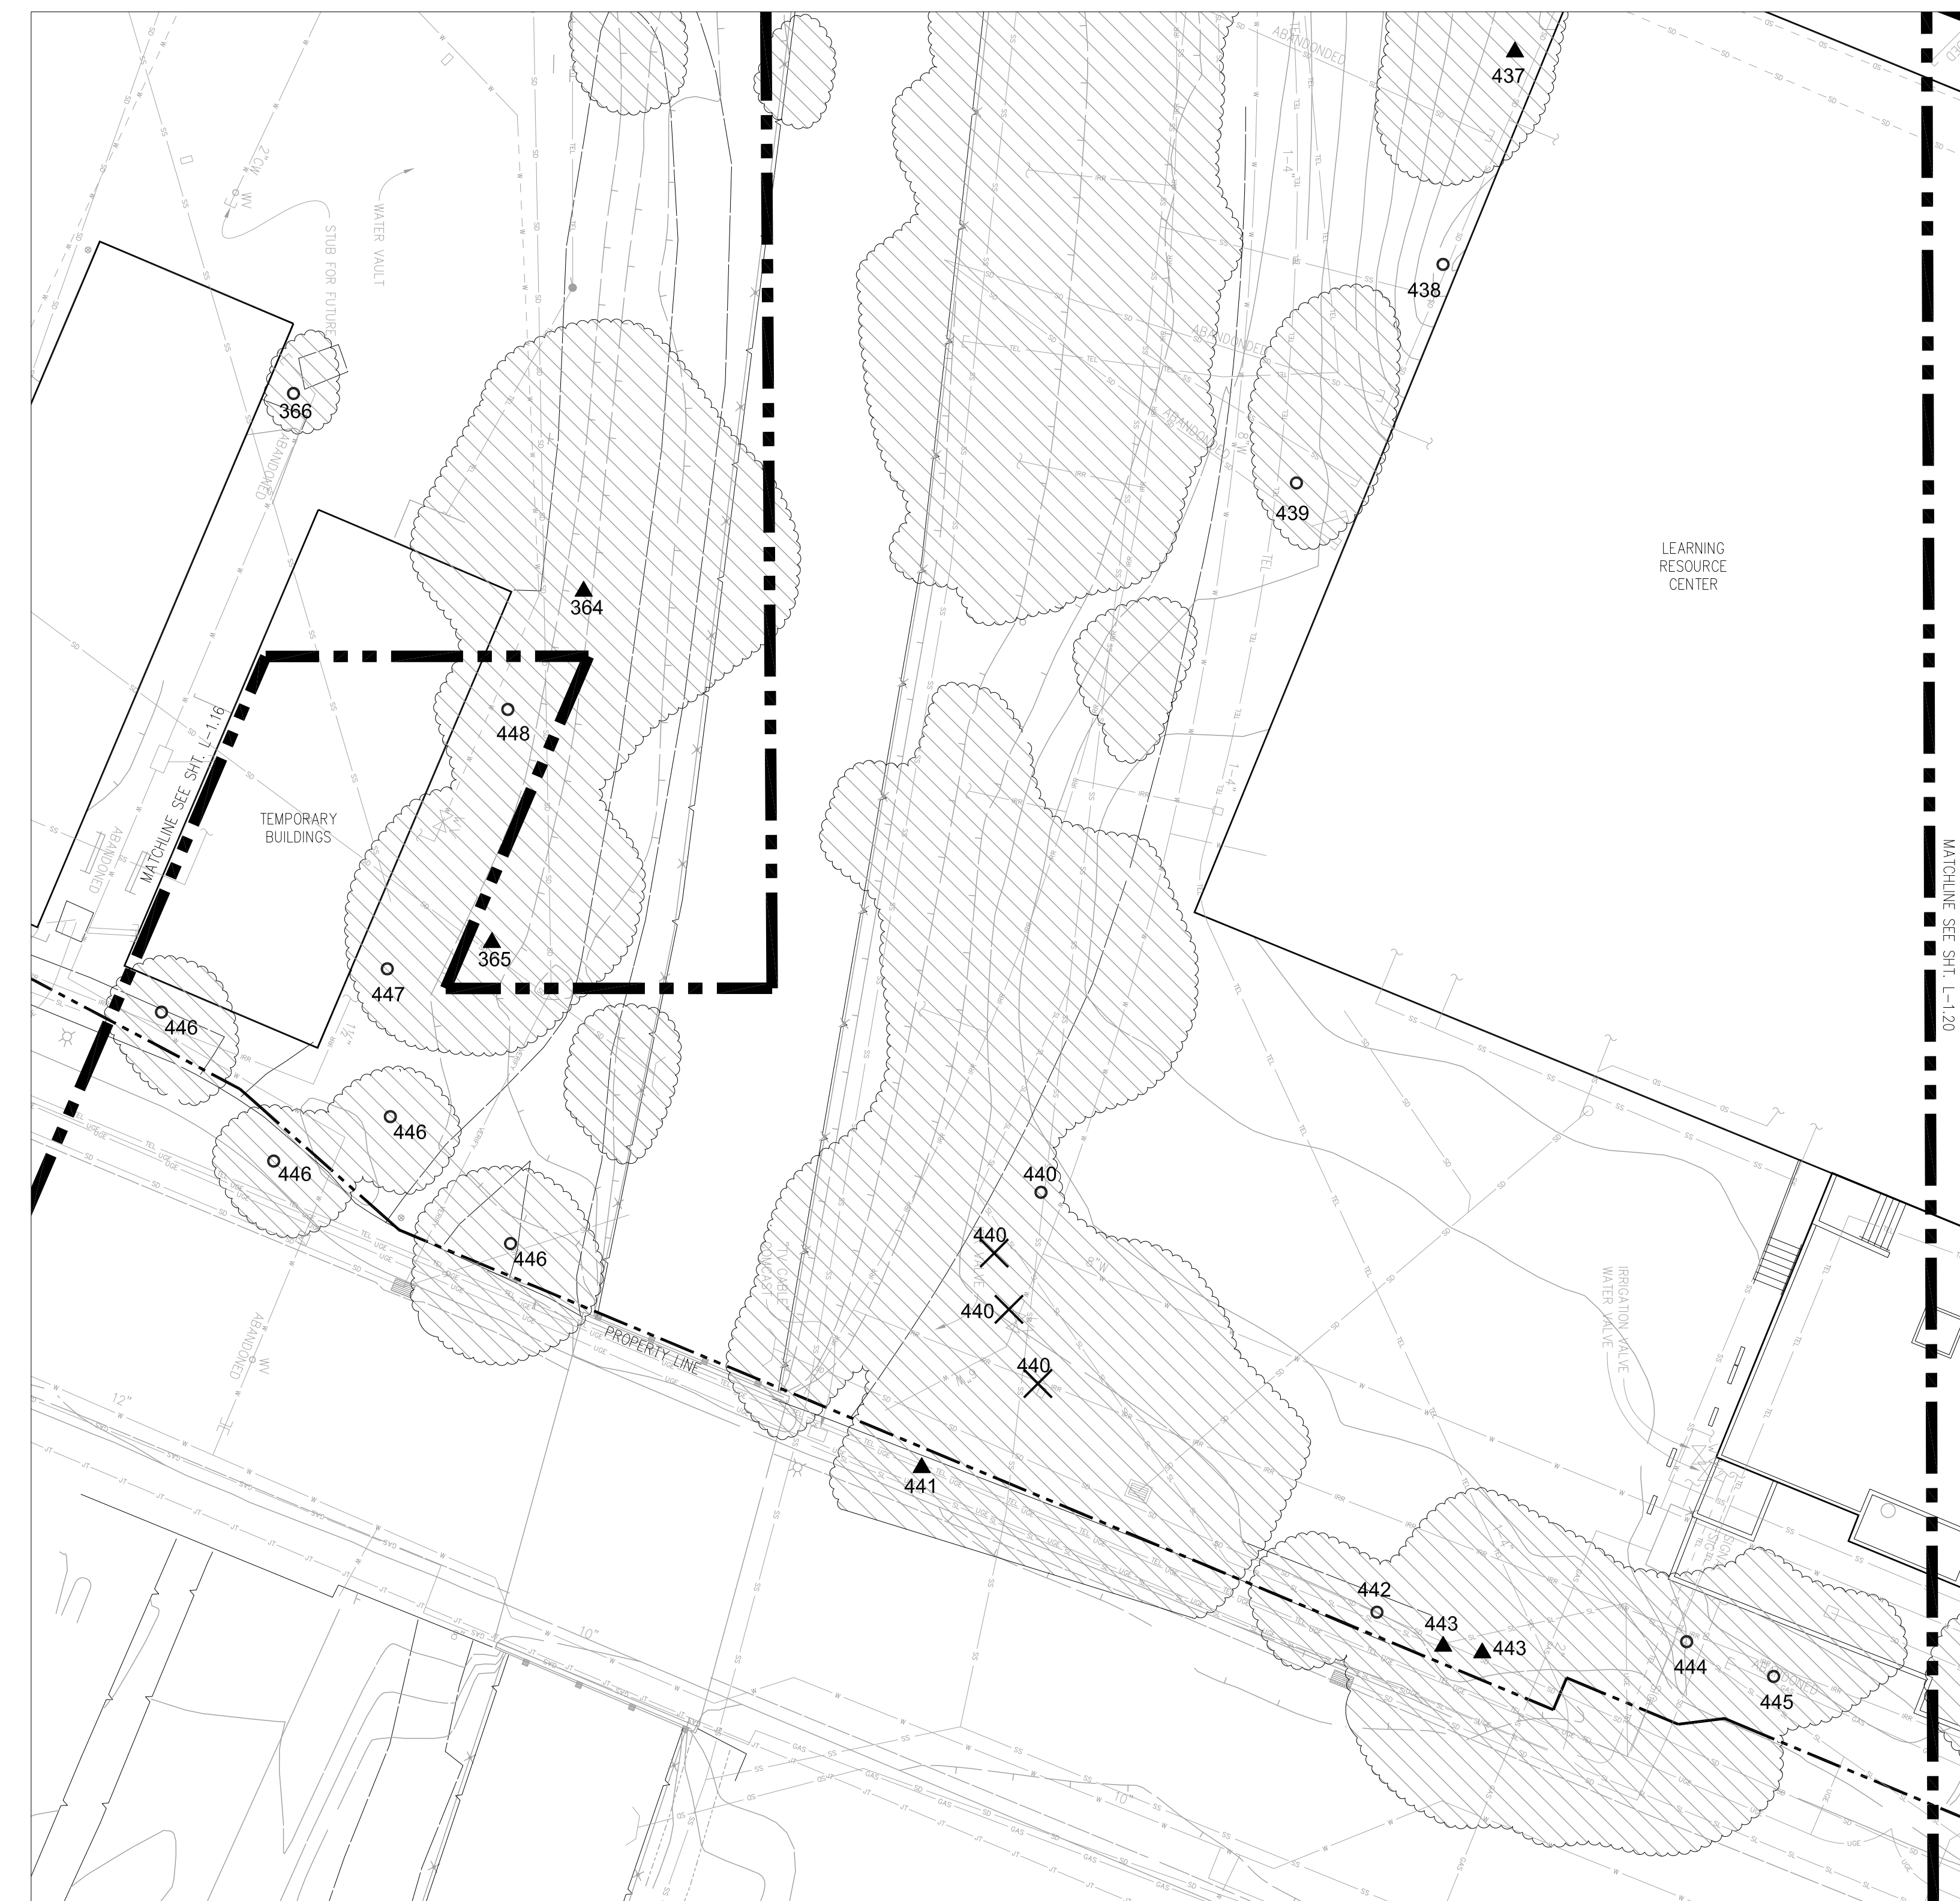
1 CORTE MADERA CREEK / COLLEGE AVENUE (TREES 437-448)
1" = 20', CONTOUR INTERVAL = 1'

TREE ASSESSMENT									SCHEDULE OF WORK	
Tree #	Species (common)	Species (scientific)	Location	Size	Health	Structural Condition	Impacts to infrastructure	Conclusion	Recommendations	Priority
437	Southern Magnolia	<i>Magnolia grandiflora</i> 'St. Mary's'	At the southwest corner of the Learning Resource Center	18"	Good; vines heavily constricting base of tree.	Good	None		Remove vines at base of tree to minimize competition for water and nutrients.	5
438	European White Birch	<i>Betula pendula</i>	Near the southwest corner of the Learning Resource Center; 15' to the east of the Magnolia (T-437)	18"	Good; minor dieback in crown	Good	None		None	5
439	Shantung Maple	<i>Acer truncatum</i>	On the west side of the south entrance to the Learning Resource Center	Multi stemmed at 6" a stem	Good	Good	None		None	5
440	English Elm	<i>Ulmus procera</i>	Located at the entrance to the parking area (Lot #5), on the east side of the Learning Resource Center	Three of seven trees were removed.	Fair to poor; largest of four remaining trees is in good health other than many water sprouts.	Fair; eastern most tree has strong lean over college Ave..	None	Trees are crowded; many crossing and rubbing branches	Remove three most easterly trees, leaving the largest tree to occupy the area.	2

441	English Elm	<i>Ulmus procera</i>	West and adjacent to the sidewalk on College Ave.; the north-most tree in the cluster of Elms near the entrance to parking lot #5	24"	Good; mature. Old wound with some decay at 10' on north side of tree.	Fair to good	None	Small tree growing underneath this tree will eventually conflict.	Remove understory tree to mitigate conflict or trim yearly.	4
442	C.F. Balkan Ash	<i>Fraxinus holotricha</i>	Along College Ave. in between the cluster of Elms and the mature trees near the main entrance to the college; in the middle of a Cherry Laurel hedge	12"	Good	Good	None		None	5
443	English Elm	<i>Ulmus procera</i>	North and south of the stairway entrance into Lot #5; northeast corner of the lot	24"	Fair; mature	Fair	Slight lifting of pavement	Deadwood present throughout crown on both trees.	Crown cleaning to remove deadwood.	2
444	Camphor	<i>Cinnamomum camphora</i>	East of the Learning Resource Center in the planting island between the east side of the building and the sidewalk along College Ave.	Multiple 6" stems	Fair; necrotic leaf tips throughout crown	Good	None		None	5

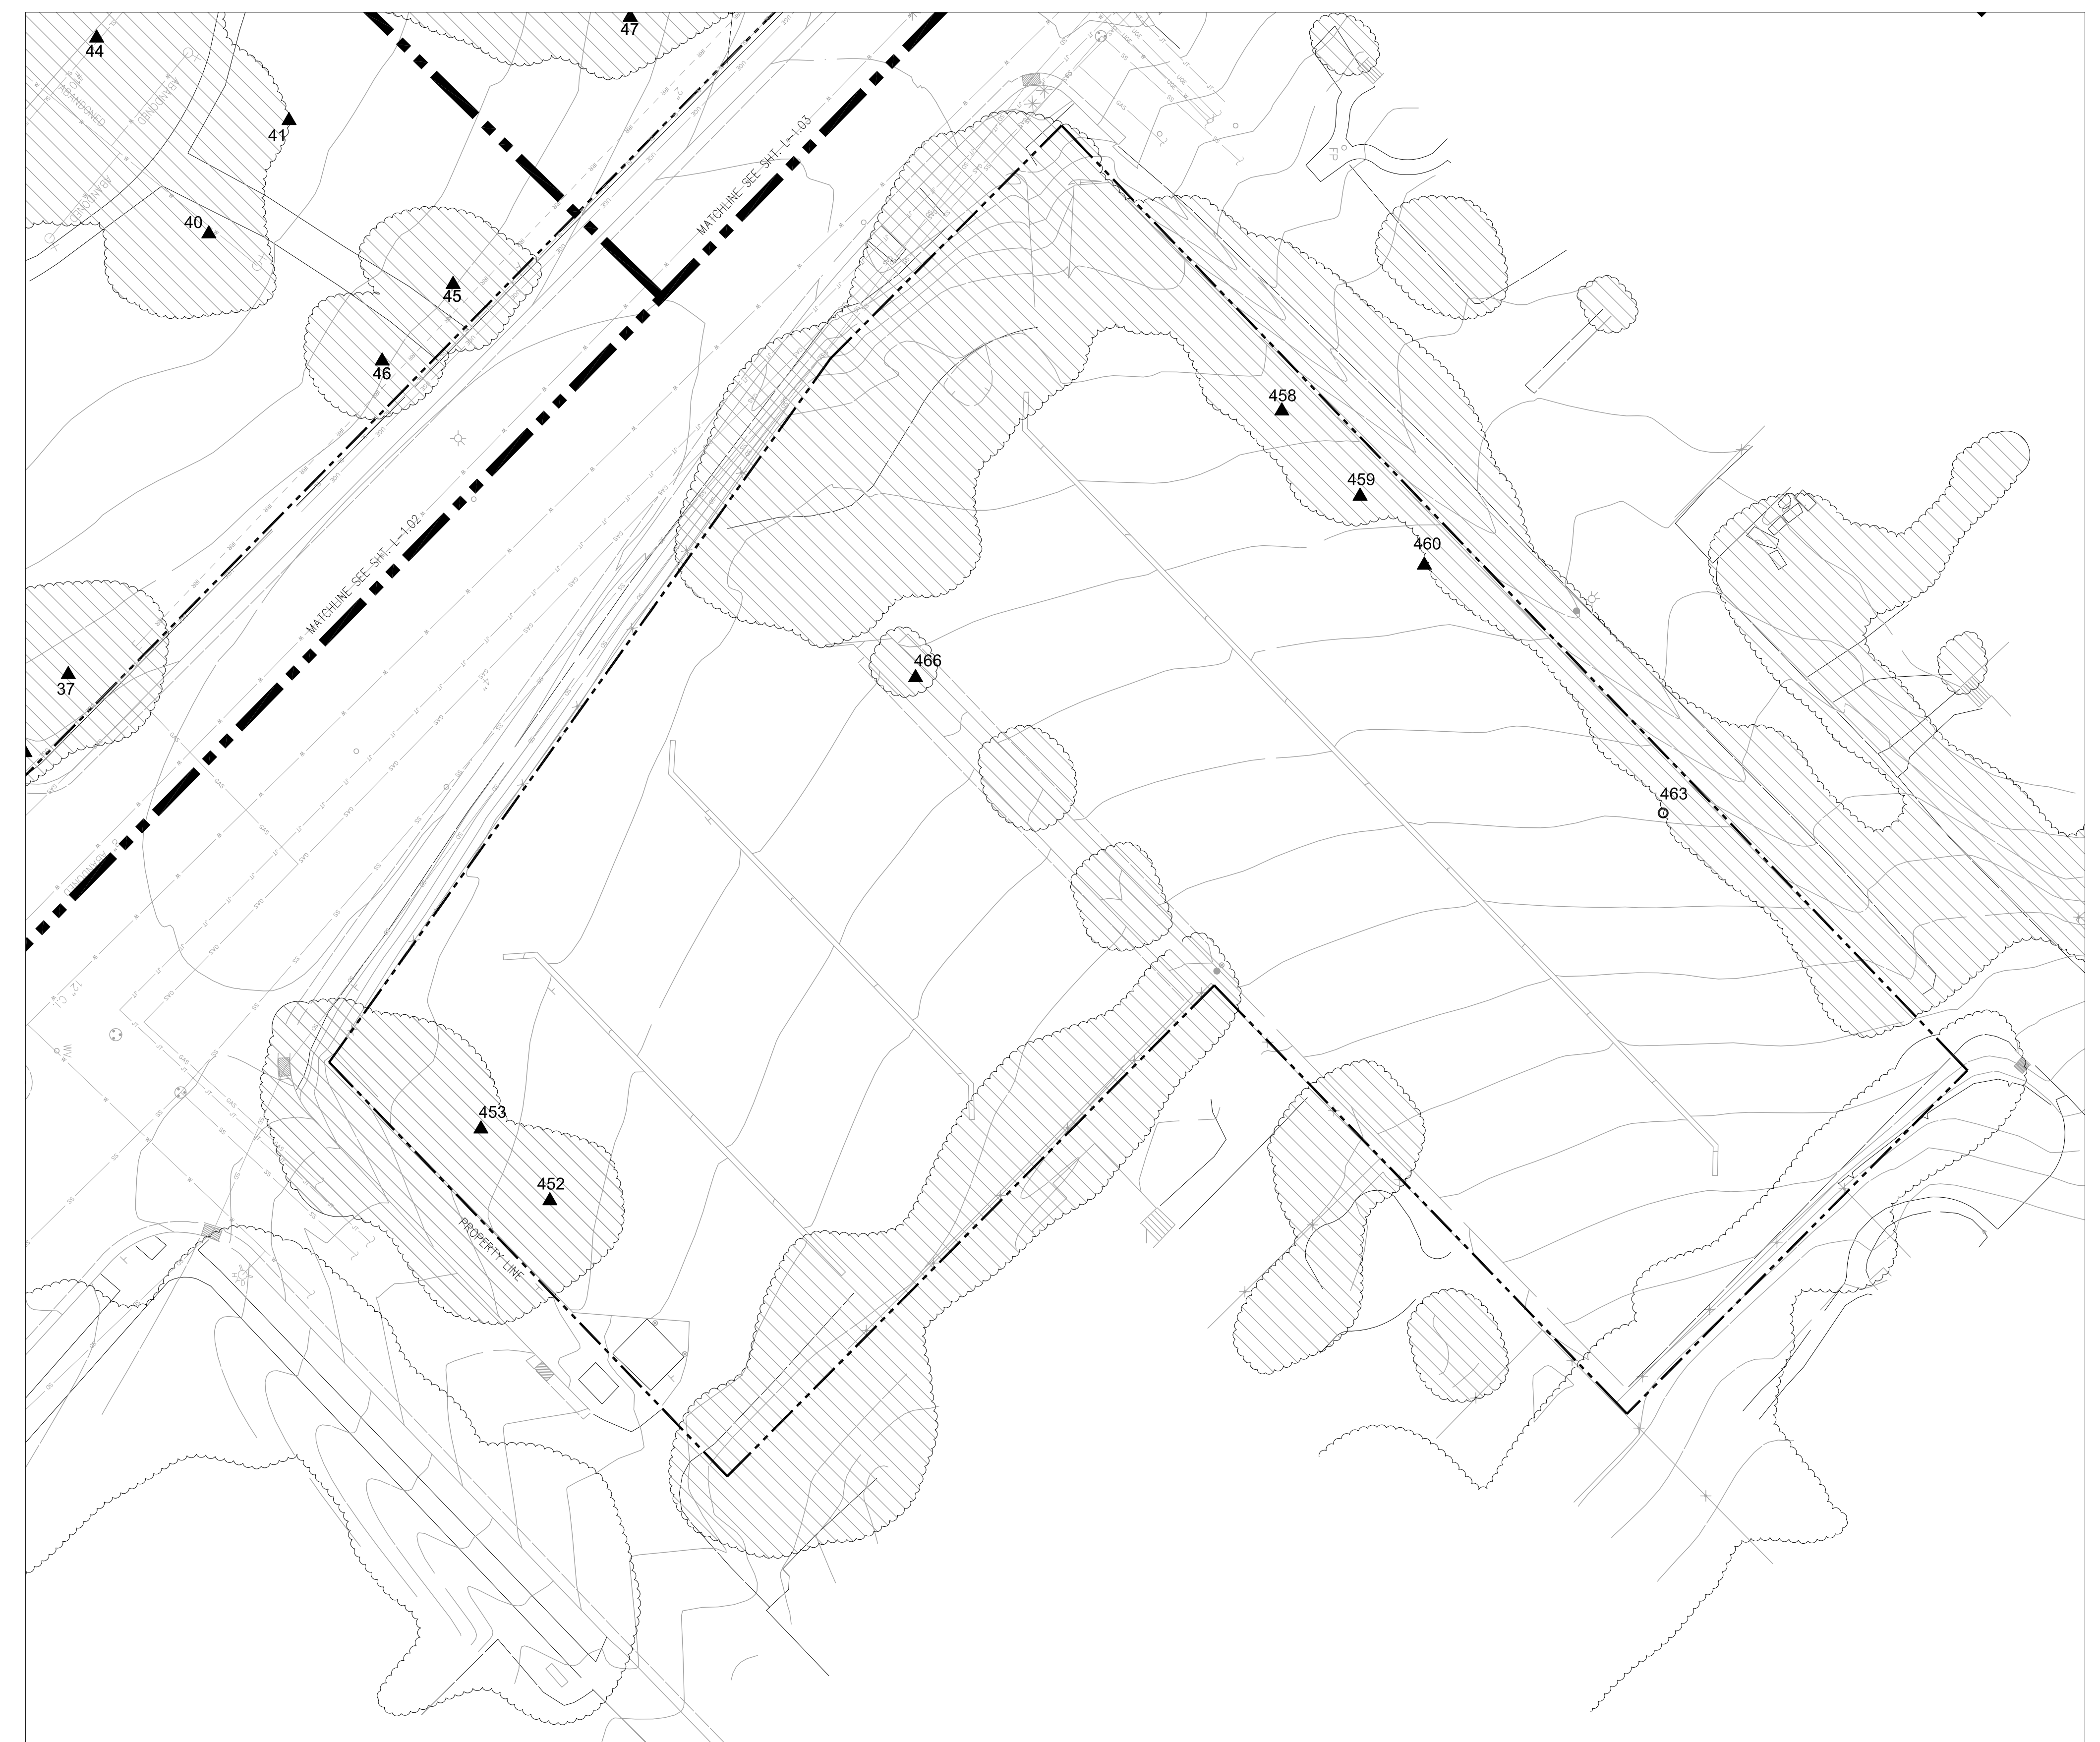
I PARKING LOT 2 (TREES 452-466)
1" = 20', CONTOUR INTERVAL = 1'

Tree #	Species (common)	Species (scientific)	Location	Size	Health	Structural Condition	Impacts to infrastructure	Conclusion	SCHEDULE OF WORK	
									Recommendations	Priority
452	English Elm*	<i>Ulmus campestris</i> *	Located in the planting island that is between Maple Ave. and the parking lot north of Sir Francis Drake; the north-most large tree in the planting strip	30"	Fair; mature	Fair; fair amount of deadwood hanging under canopy. Cavity at 7' on main trunk.	None		Crown cleaning. Remove sprout growth on main trunk.	3
453	a English Elm	<i>Ulmus campestris</i> *	10' southwest of T-453						Conflicting with infrastructure. Poorly located. Removal recommended.	2
453	English Elm*	<i>Ulmus campestris</i> *	Near the southeast corner of the parking lot north of Sir Francis Drake; in the planting island between Maple Ave. and the parking lot north of Sir Francis Drake	30"	Fair; mature	Fair; fair amount of deadwood hanging in canopy.	None		Crown cleaning. Remove sprout growth on main trunk. Remove understory brush for visual clearance.	1

458	English Elm	<i>Ulmus campestris</i> *	In the planting area along the west edge of the parking lot north of Sir Francis Drake; the south-most in the planting island and closest to the corner of Elm St. and Sir Francis Drake	18"	Fair; mature.	Fair; some larger deadwood.	None		Remove sprouts < 3" in diameter for vehicle clearance.	3
459	English Elm	<i>Ulmus campestris</i> *	North of T-459 in the west-most planting area between the parking lot and Elm Ave.	24"	Fair; mature	Fair	None	Understory oak sprouts present.	Preserve understory oak sprouts for possible replacement in future.	3
460	English Elm	<i>Ulmus campestris</i> *	North of T-459; in the planting area at the west edge of the parking area	24"	Fair; mature	Fair	None		Prune to un-weight branch reaching over Elm Ave.	3
463	Ash	<i>Fraxinus sp.</i>	North of T-459; in the planting area at the west edge of the parking area	18"	Fair to poor; over mature but stable.	Fair. Has been pruned back significantly to preserve the tree.	None		None	5

466		<i>Prunus sp.</i>	In center planting island in the parking lot north of Sir Francis Drake; south of T-465	N/A

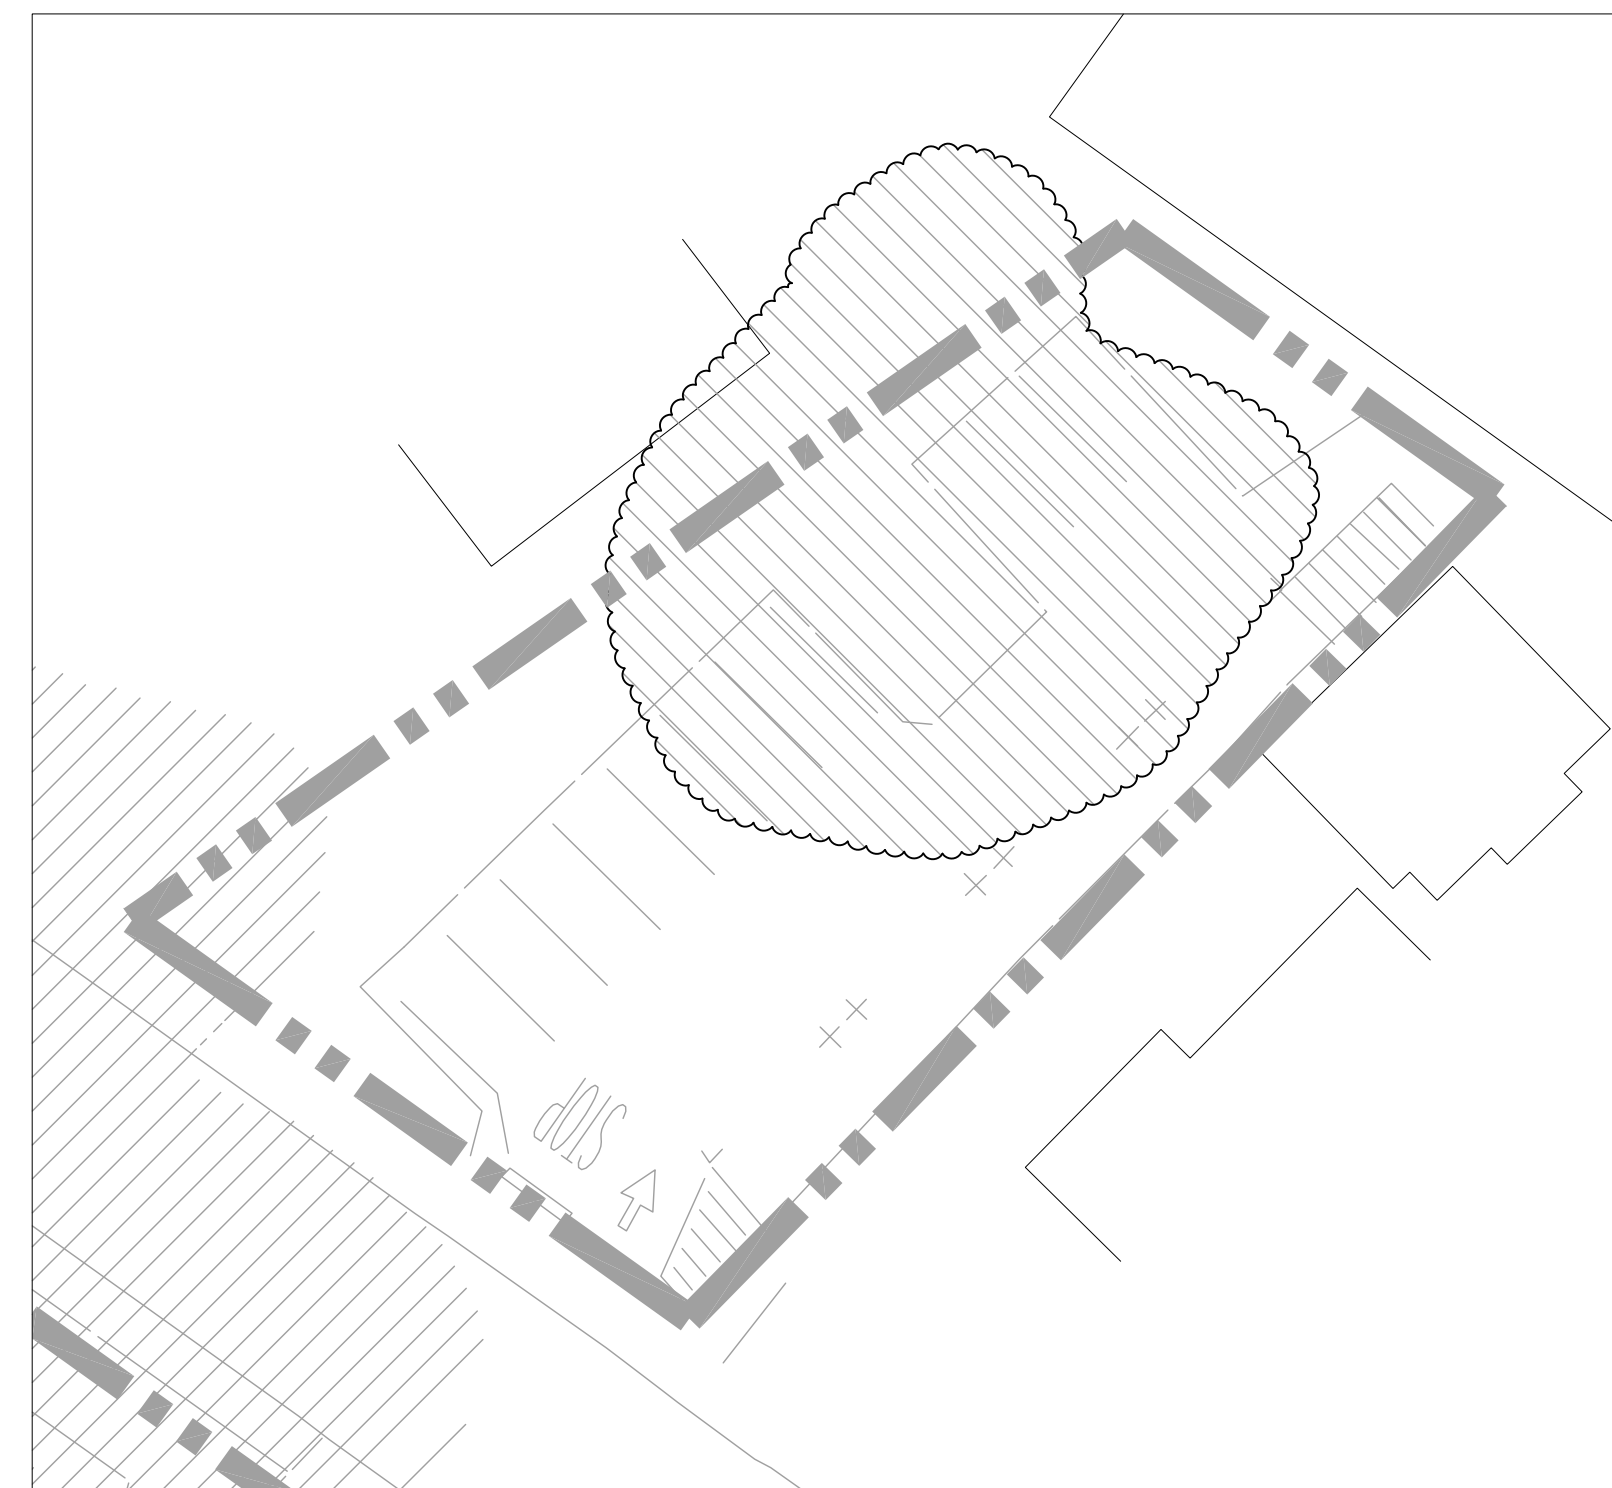
1 PARKING LOT 17 (TREES 467)
1" = 20', CONTOUR INTERVAL = 1'

TREE ASSESSMENT					SCHEDULE OF WORK			
TREE NUMBER	SPECIES	SIZE	LOCATION	CONDITION	OBSERVED INFRASTRUCTURE CONFLICTS	WORK DESCRIPTION	"Pruning class (1,2,3)"	"Stump grinding (Y/N)"
467	Black Walnut (Juglans nigra)	Mature to over mature.	Located in the parking area on the west side of Laurel Ave. It is northwest of the parking lot (P-3) and west of Dickson Hall.	Fair to guarded; tree was previously topped. There are old mechanical wounds on the north side of the trunk; there is good callus tissue formation. Decay was detected on the north side of the trunk. There is also a cable in this tree.	Tree. No significant construction impacts.	Contractor shall fell Black Walnut and cut into lengths to be approved by District's Representative. Provide 3 days notice to District's Representative prior to felling. Coordinate with District's Representative and return wood to College. Contractor shall deliver wood to an on campus location as determined by the District's Representative.	N/A	"Y Backfill w/ soil."

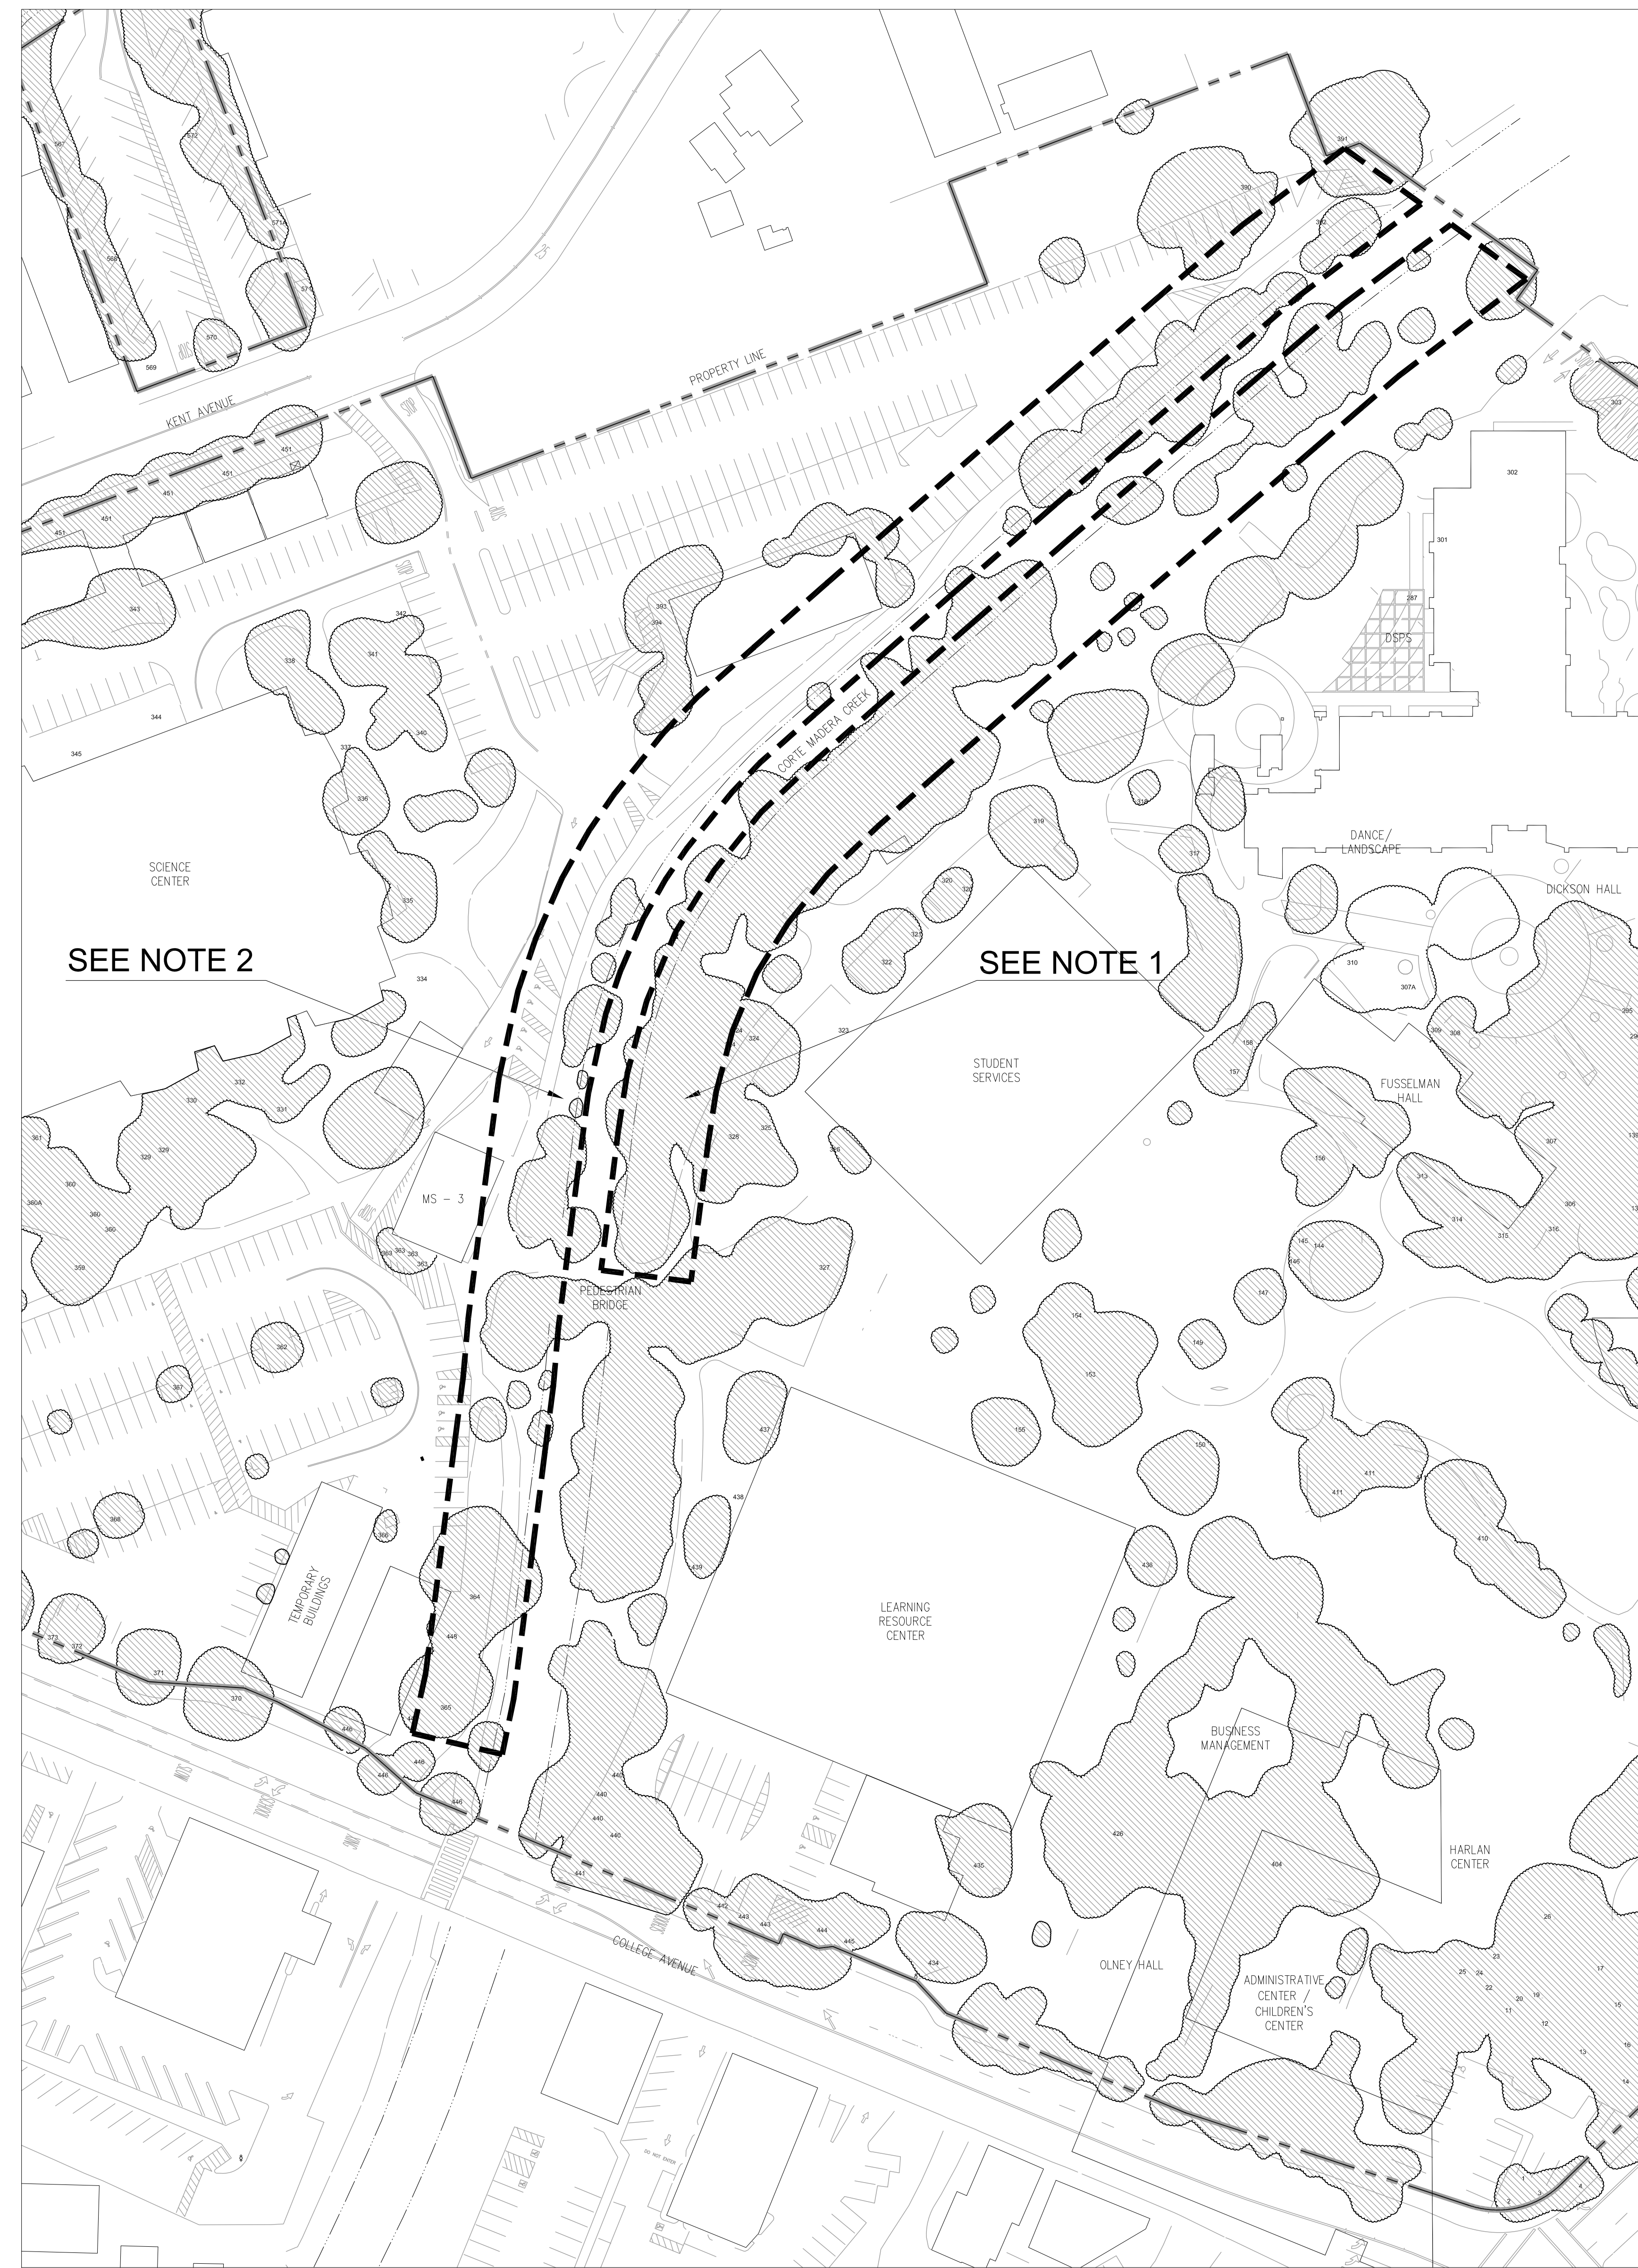
2 KENTFIELD CAMPUS - RIPARIAN ZONE
1" = 50'

2. On the northeast side of the riparian zone remove all of the acacia and eucalyptus trees. Work includes all trees from the edge of the creek wall to the maintenance roadway for a length of 740' (from the center of the pedestrian bridge to the edge of the college property). An approximate tally of acacia trees includes 55 medium sized and 80 small sized (< 3" diameter) trees. An approximate tally of the eucalyptus includes 2 small trees and 3 large trees. Where stump grinding is not feasible, immediate after the tree is cut, apply systemic herbicide to stump per the specifications Section 31 10 00.

3. Remove three box elders located near the planted Zelcova.
