COLLEGE OF MARIN

TREE HEALTH PROJECT

KENTFIELD CAMPUS

JULY 10, 2014

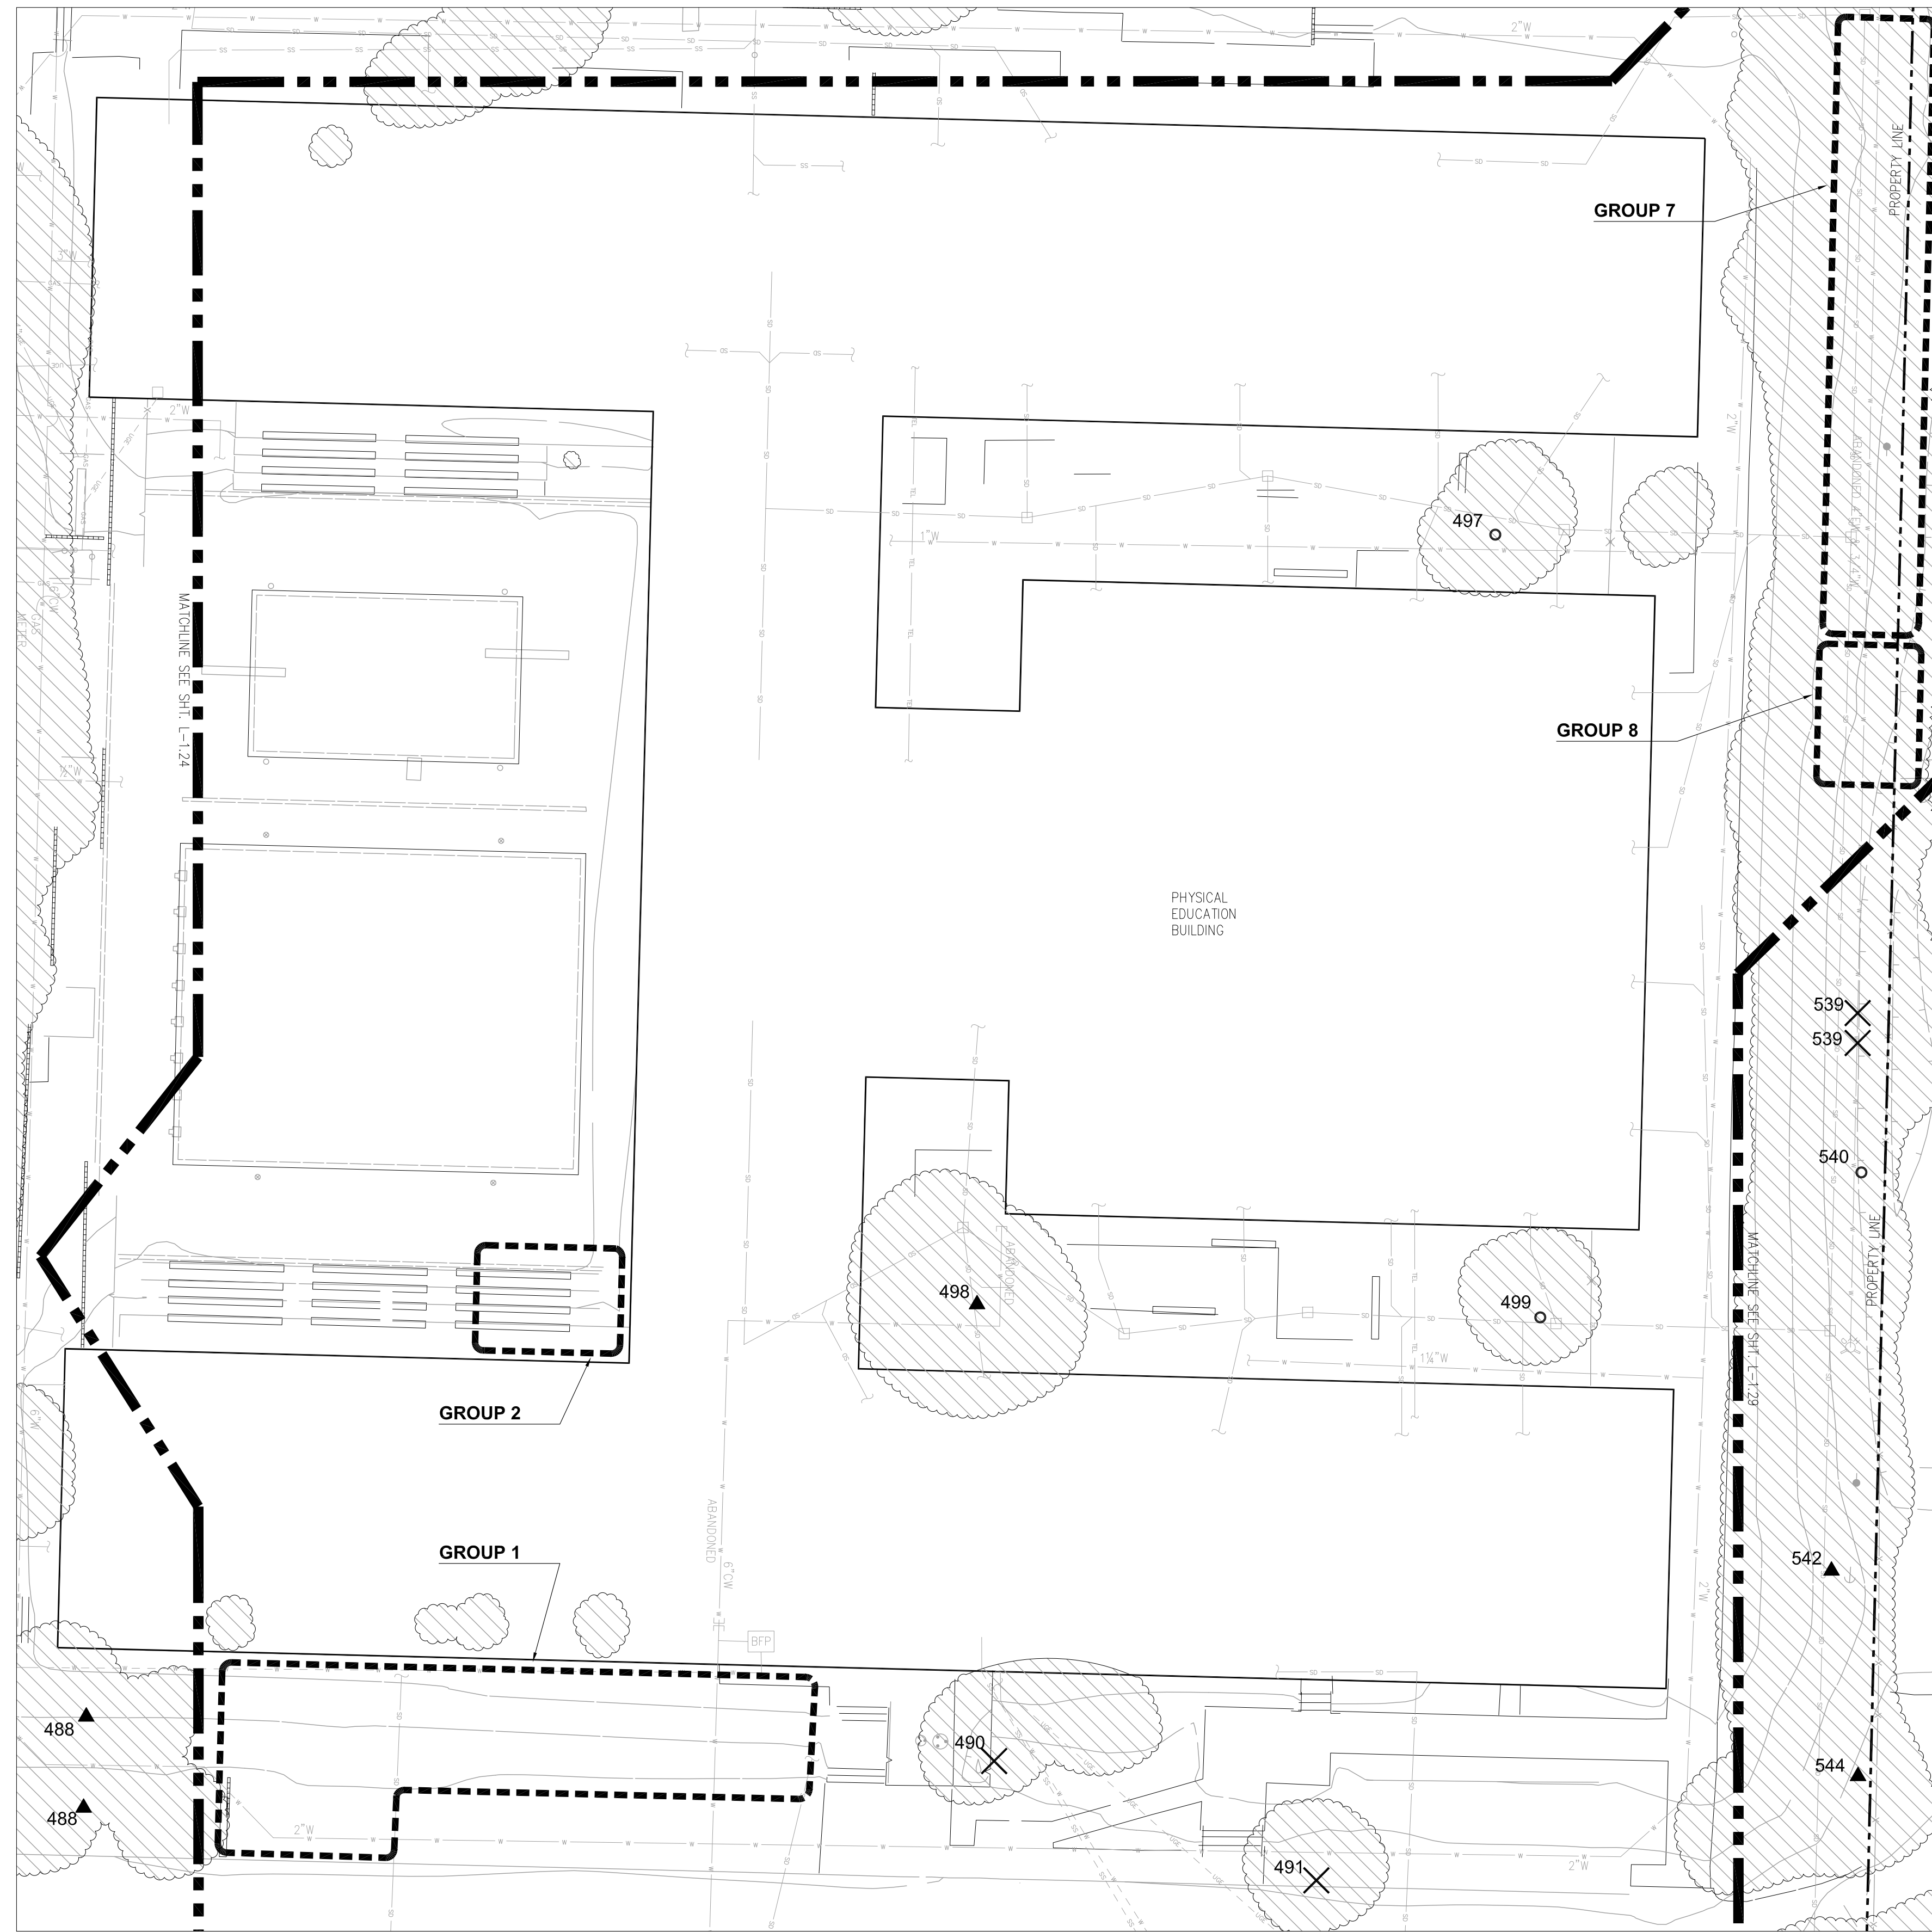
1 PHYSICAL EDUCATION BUILDING NORTHEAST (TREES 490-499)
1" = 20', CONTOUR INTERVAL = 1'

TREE ASSESSMENT									SCHEDULE OF WORK		
Tree #	Species (common)	Species (scientific)	Location	Size	Health	Structural Condition	Impacts to infrastructure	Conclusion	Recommendations	Priority	
490	Plum	<i>Prunus cerasifera 'Atropurpurea'</i>	Off of the east side of the PE building, near the laundry facilities	Removed and replaced by valley oak.					Poor tree choice to be growing with such vigorous ground cover. Suggest replacing tree with alternative species.	4	
491	Mayten	<i>Maytenus boaria</i>	Near the northeast corner of the building; 8' north of the stairway entrance near the northeast corner of the building; between the sidewalk and the parking lot	16"	Poor to fair; mature to over mature. Dieback in crown. Thick understorey grasses are choking the tree out.	Fair		Tree is in apparent decline. If tree is replaced at some point grass must be removed out from around the drip line of the tree.	Removal and replacement is an option.	4

497	Magnolia	<i>Magnolia veitchii</i>	15-20' south of T-494; inside the west patio area of the PE Building	12"	Trunk splits into two stems at 3". Tree is flowering nicely.	Good	None		None	5	
498	Magnolia	<i>Magnolia Grandiflora</i>	Within the east patio area inside the PE Building	24"	Fair, yellowing and slight die-back in crown.	Fair to good	None	May have been impacted by construction.	Clear ground cover around root crown	3	
499	Michelia	<i>Michelia doltsopa</i>	North end of the east patio area inside of the PE Building; 10 - 15' south of the junipers (T-492)	20" below split in to multiple stems	Fair to good	Good	None		None	5

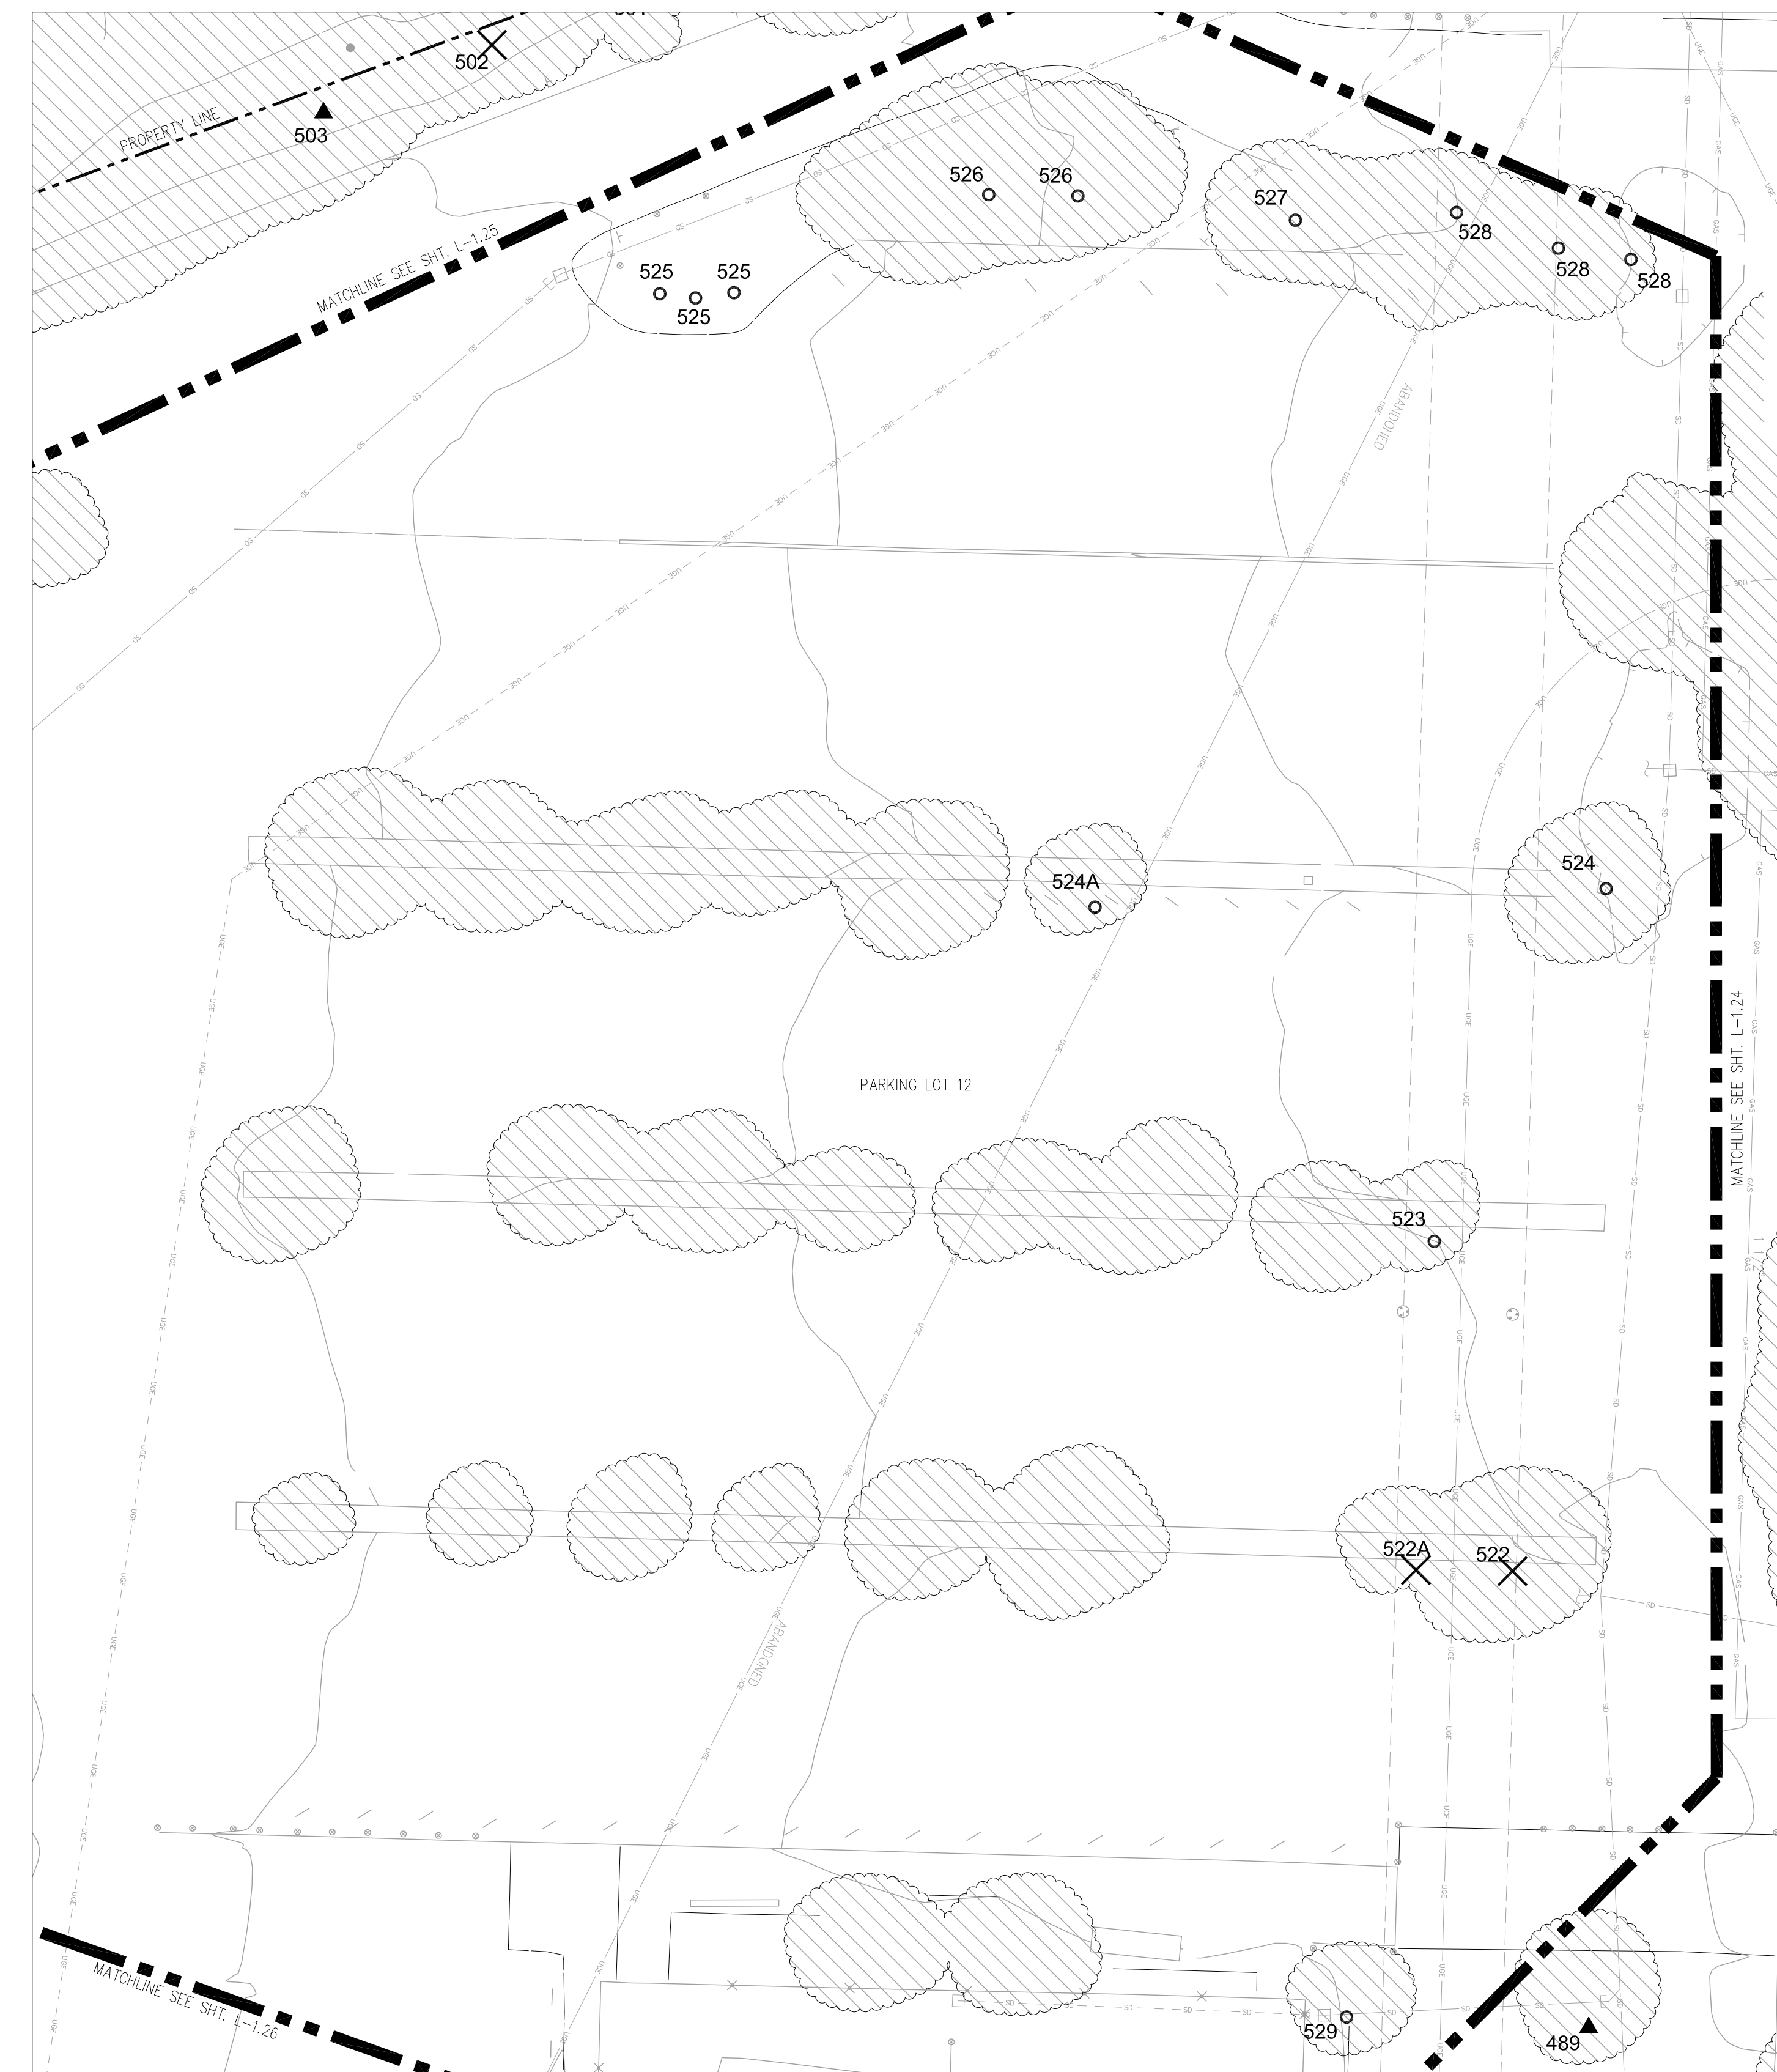
1 PHYSICAL EDUCATION BUILDING NORTHEAST (TREES 522-529)
1" = 20', CONTOUR INTERVAL = 1'

TREE ASSESSMENT									SCHEDULE OF WORK		
Tree #	Species (common)	Species (scientific)	Location	Size	Health	Structural Condition	Impacts to infrastructure	Conclusion	Recommendations	Priority	
522	a	Ash	<i>Fraxinus sp.</i>	In east-most planting island in the PE Building parking lot	4"	Poor	Poor	None	Deformed base. Will never become a well formed tree.	Remove and replace	4
522		Ash	<i>Fraxinus sp.</i>	In the east-most planting island in the PE building parking lot	12"	Fair; mature. Large deadwood present. Three sections of decayed bark on southwest facing side of trunk.	Fair	None		Remove deadwood	2
523		Ash	<i>Fraxinus sp.</i>	In a middle planting island in the PE building parking lot	12"	Fair	Fair	None		None	5
524	a	Ash	<i>Fraxinus sp.</i>	30' south of the PE complex in a circular planting island	10"	Fair	Fair; poor pruning. Tree has been lion's tailed	None		None	5
524		Ash	<i>Fraxinus sp.</i>	In the west-most planting island in the PE building parking lot	12"	Fair	Fair; decay column on southwest facing portion of trunk probably due to sun scald.	None		None	5

525		Bottlebrush	<i>Callistemon sp.</i>	West side of the PE Building parking lot; near the southwest corner of the parking lot	cluster of three; 8" each	Good	Good	None		None	5
526		Chinese Elm	<i>Ulmus parvifolia</i>	West side of the PE parking lot; in planting island between the entrance and the lot; north of T-525	Dual stem; 12" each	Fair; tree is crowded on both sides.	Fair	None		None	5
527		Olive	<i>Olea europea</i>	12' north of T-526; in the planting island between the entrance and the parking lot; immediately east of the parking lot entrance sign	Multiple 6" stems	Good	Fair	None		None	5
528		Ginko	<i>Ginkgo biloba</i>	North end of the planting island between the exit of the parking lot and the parking lot itself	cluster of three; 10" each	Good; topped in the past.	Fair	None		None	5
529		Coast Live Oak	<i>Quercus agrifolia</i>	Northwest corner of the tennis courts; between the planters with the Catalina Ironwood and the tennis courts	Co-dominant stems; 10" each	Fair to good.	Fair; co-dominant stems arising at	None.		None	5

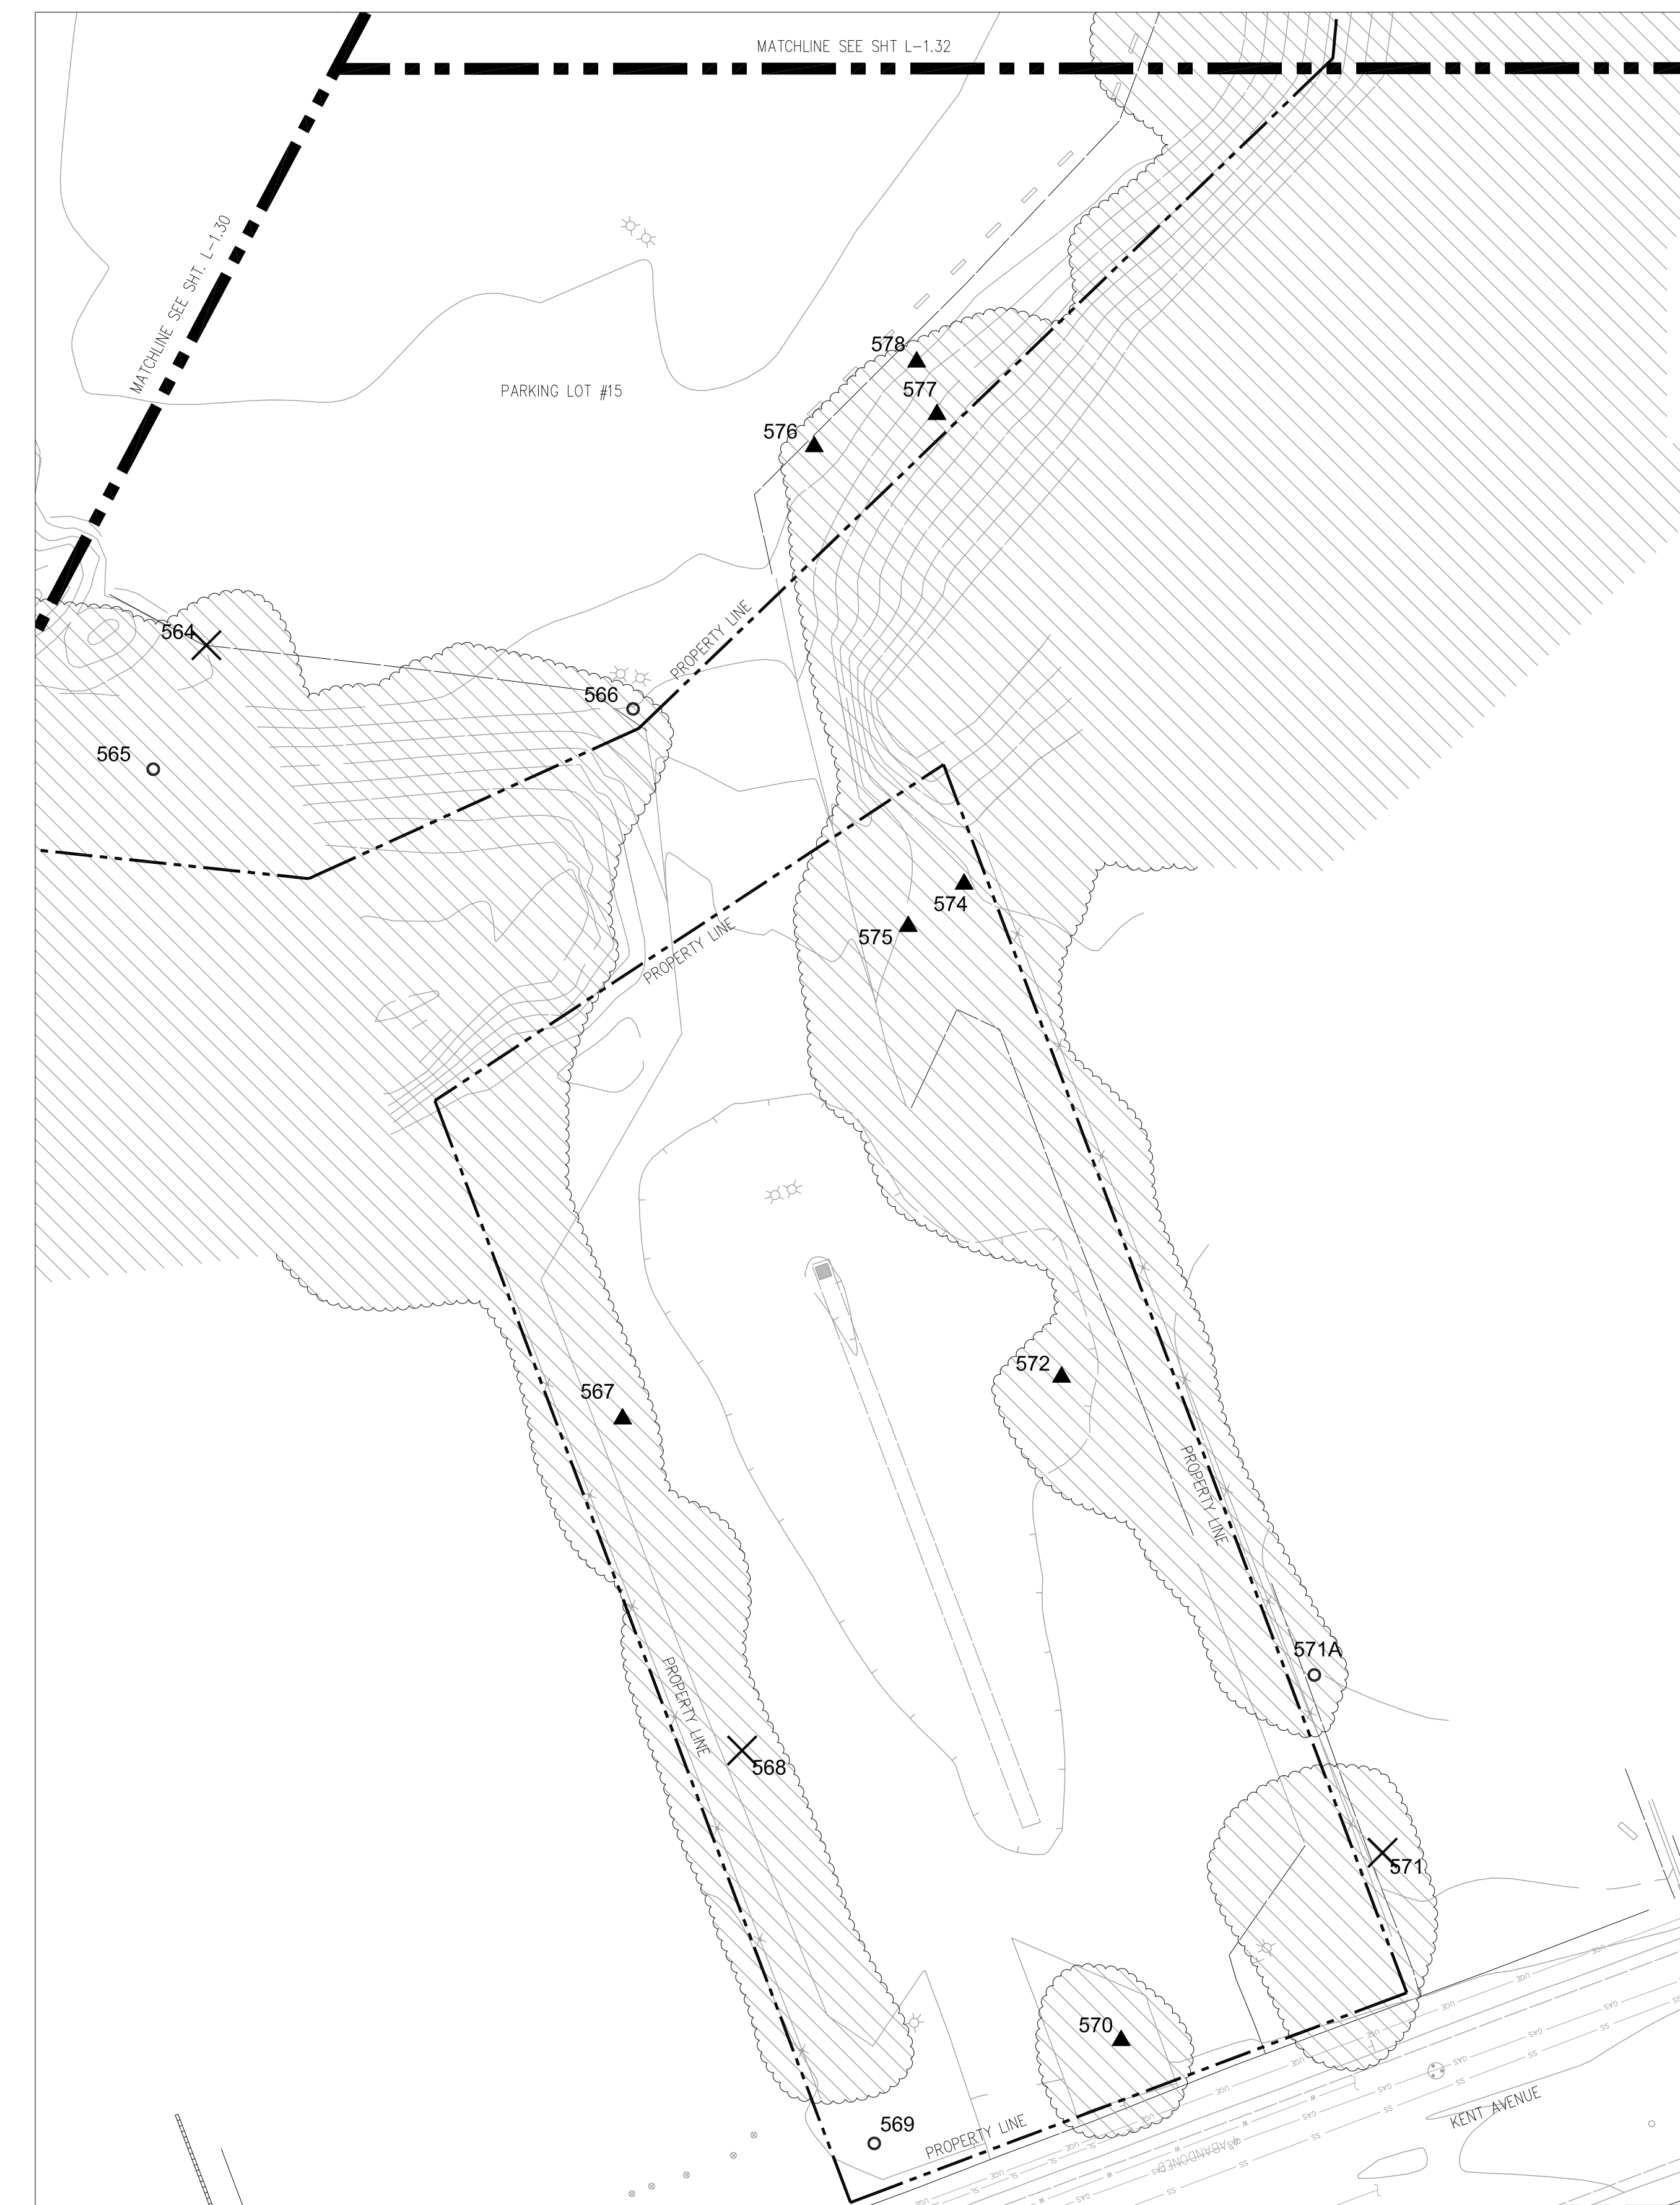
1 PARKING LOT #15 NORTHEAST (TREES 564-678)
1" = 20'. CONTOUR INTERVAL = 1'

TREE ASSESSMENT									SCHEDULE OF WORK	
Tree #	Species (common)	Species (scientific)	Location	Size	Health	Structural Condition	Impacts to infrastructure	Conclusion	Recommendations	Priority
564	Red Maple	<i>Acer rubrum</i>	Near the southeast corner of this parking area	12"	Poor to fair; mature to over mature.	Poor; decay in main leader.			Remove	2
565	Valley Oak	<i>Quercus kelloggii</i>	East/southeast of T-564	18"	Fair; mature. Being shaded out by neighboring valley oak.	Fair; moderate lean toward parking lot.			None	5
566	C.F. Valley Oak	<i>Quercus lobata</i>	At the intersection between the west and east portions of Parking Lot #15; at the southwest corner of the access road/bridge between the two lots; there is a culvert in this area	30"	Good; mature.	Fair; heavy lean toward creek.	None		None	5
567	Privet	<i>Ligustrum sp.</i>	Along the wood fence between the fence and the parking area asphalt; along the east portion of Parking Lot #15	18"	Good	Fair; v-crotch structure in main crotch.	Growing directly into neighboring fence. Lifting concrete on walkway by adjacent apt. complex.		Clear root crown of vines.	4

568	Evergreen Pear	<i>Pyrus kawakamii</i>	East of T-567	Dual stem; 6" each	Fair	Poor; v-crotch with included bark at tree base.	Encroaching parking lot light		Remove	2
569	Privet	<i>Ligustrum sp.</i>	At the southeast corner of the east portion of Parking Lot #15	3 stems at 12"	Fair; minor decay present at base.	Poor; three stems arising at ground level with included bark where they meet.			None	5
570	Catalina Cherry		Within the center planting isle between the entrance/exit of east portion Parking Lot #15; off of Kent Avenue	18"	Good; past branch failure on north side of tree, most likely from a vehicle.	Fair to good			Prune for vehicle clearance.	3
571	a Privet, Hawthorn, Plum	<i>Ligustrum, Crataegus, Prunus</i>	Along the north side of the east portion of Parking Lot #15, west from T-571	Multi-stem	Good	Good	None		None	5
571	Tree Of Heaven	<i>Ailanthus altissima</i>	Northeast corner of the east portion of Parking Lot #15 along Kent Ave.; between the sidewalk on Kent Ave. and the beginning of the asphalt parking spaces	Group of about 15	Poor; advanced decay on all trees. Very active termite presence.	Poor	None	Invasive exotic species. There is a pear tree growing in the middle of this cluster of trees that could take over after removal of Tree of Heaven.	Remove all tree of heaven	1

571	a		Dead tree located in between T-571 and 572						Remove	1
572	Ash	<i>Fraxinus sp.</i>	Southwest of the light post	Dual stem; 6" each	Fair	Poor to fair; large decay column along stem over parking lot.			Reduce to condense crown. Consider removal due to poor structure and decay.	1
574	California Bay Laurel	<i>Umbellularia californica</i>	South of the fence line between the parking area and the adjacent apartment complex	30"	Fair; mature. Was topped in past. Copious amounts of vines growing up tree.	Fair	Lifting pavement of pedestrian walkway.		Remove deadwood. Reduce canopy 15% to mitigate long reaching stems.	2
575	California Bay Laurel	<i>Umbellularia californica</i>	Along the north side of the entrance between the east and west portions of Parking Lot #15	Multi-stem; three 18" stems.	Fair; mature. Some dieback in crown. Decay at base which is typical in this species.	Fair; stems with moderate lean over parking lot.	Lifting pavement of pedestrian walkway.		Remove deadwood. Reduce canopy 15% to mitigate long reaching stems.	2

576	Coast Live Oak	<i>Quercus agrifolia</i>	At the intersection of the east and west parking lots; on the northeast corner of the west portion of Parking Lot #15	18"	Fair to poor; sparse crown; foliar dieback.	Good	None		Monitor decline.	3
577	California Bay Laurel	<i>Umbellularia californica</i>	Approximately 20' west of T-576; on north side of the west portion of Parking Lot #15; approx. 10' north of the asphalt	12"	Fair	Fair	None.		Remove vines.	4
578	Coast Live Oak	<i>Quercus agrifolia</i>	Southwest of T-577; approximately 7-8' north of the asphalt parking area	6"	Fair; vines are affecting the health of this tree.	Fair; leans over parking lot.	None		Remove vines	4

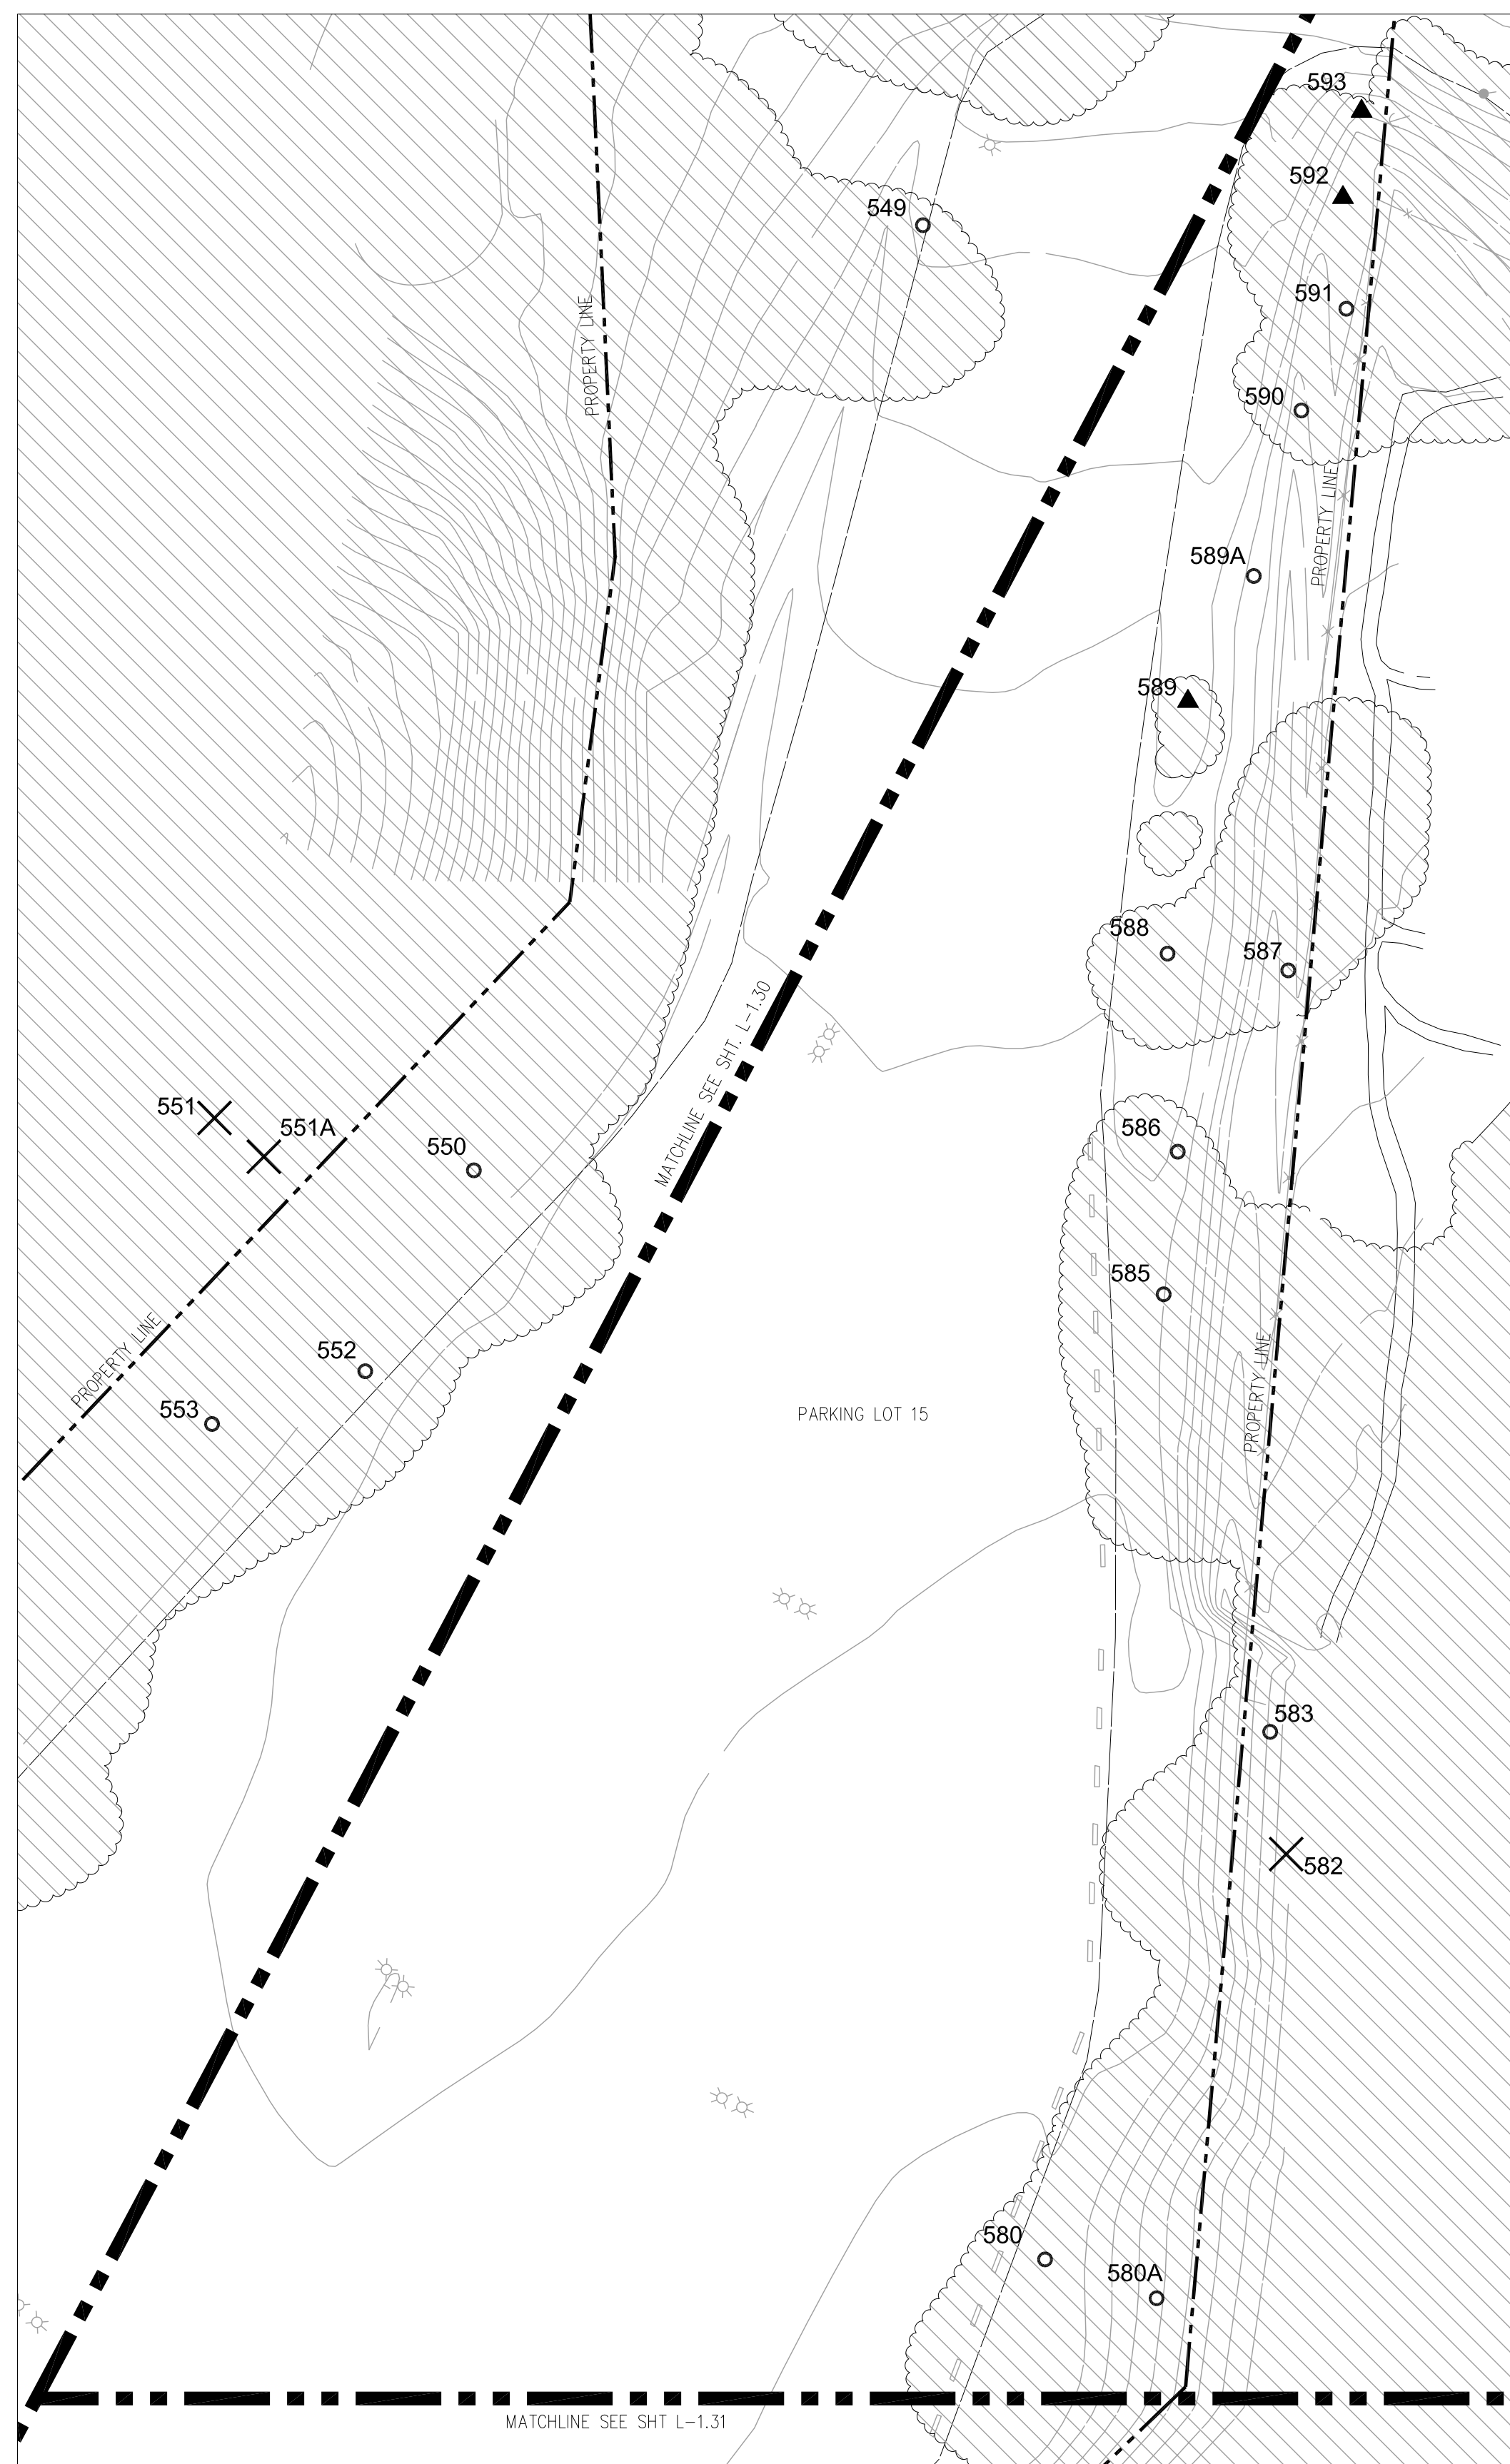
2 PARKING LOT #15 NORTHWEST (TREES 580-593)
1" = 20', CONTOUR INTERVAL = 1'

TREE ASSESSMENT										SCHEDULE OF WORK	
Tree #	Species (common)	Species (scientific)	Location	Size	Health	Structural Condition	Impacts to Infrastructure	Conclusion	Recommendations	Priority	
580	Privet	<i>Ligustrum sp.</i>		Multi-stem	Good	Good	None		None	5	
582	Coast Live Oak	<i>Quercus agrifolia</i>	Approximately 15' west of T-580	6"	Poor; advanced decay at root crown.	Fair to poor; Heavy lean toward parking lot.	None		Remove.	1	
583	Coast Live Oak	<i>Quercus agrifolia</i>	Approximately 10-15' northwest of T-582	12"	Good	Fair; slight lean.	None		None	5	
585	California Bay Laurel	<i>Umbellularia californica</i>	Northwest of T-584						None		
586	California Bay Laurel	<i>Umbellularia californica</i>	West of T-585						None		
587	California Bay Laurel	<i>Umbellularia californica</i>	Approximately 15-20' northwest of T-585						None		
588	California Bay Laurel	<i>Umbellularia californica</i>	Approximately 10' south of T-587						None

589	Coast Redwood	<i>Sequoia sempervirens</i>	West of a cleared opening (area without trees); approximately 4' north of the parking lot and consists of one major stem and a subordinate limb to the east	Dual stem; 18" and 6"	Good; remarkably healthy foliage. Wildlife has been impacting bark but not significant.	Fair to Good; dual stem.	None		Raise canopy to 10' for visual clearance.	2	
589	California Bay Laurel	<i>Umbellularia californica</i>	Southwest of T-587								
590	Italian Stone Pine	<i>Pinus pinea</i>	West/northwest of T-589	12"	Fair; tree experienced whole root ball failure in past but continues to display good vigor.	Fair	None		None.	5	
591	Douglas Fir	<i>Pseudotsuga menziesii</i>	Approximately 35-40' west of T-590	12"	Good	Good	None		None	5	
592	Deodar Cedar	<i>Cedrus deodrant</i>	Approximately 35-40' to the west of T-591; approx. 5' from the asphalt parking area	12"	Good	Good	None		Trim back branches from parking spot and raise canopy 5' for visual clearance.	4

593	Willow	<i>Salix sp.</i>	On the north side of the northwest exit from Parking Lot #15; on the north side of the drainage and approximately 35' northeast of the stop sign at parking lot exit	12"	Good	Good	None	Pine and oak saplings becoming established underneath this willow.	Raise canopy for vehicle clearance. Remove pine and oak saplings.	2
