Kentfield Learning Resource Center/ Student Center Programming

COLLEGE OF
MARIN

October 26, 2018

FACILITY CONDITION ASSESSMENT

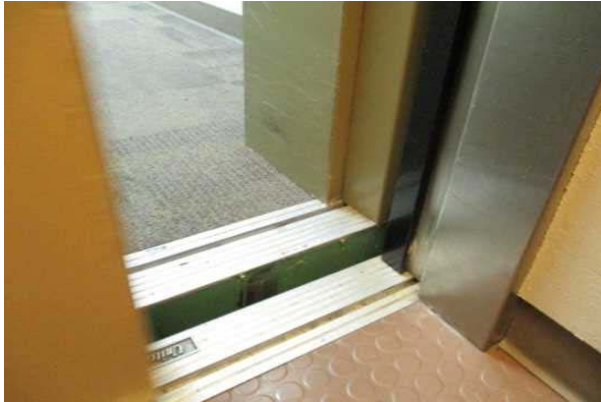
#19: ELEVATOR CONTROLS, DOOR OPENS BEFORE FLOORS ARE LEVEL

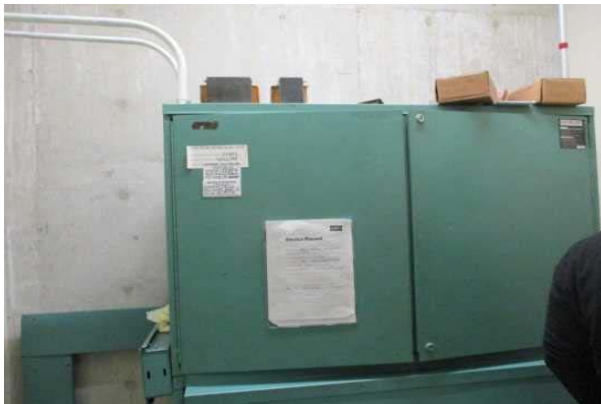
#21: ELEVATOR EQUIPMENT, HYDRAULIC

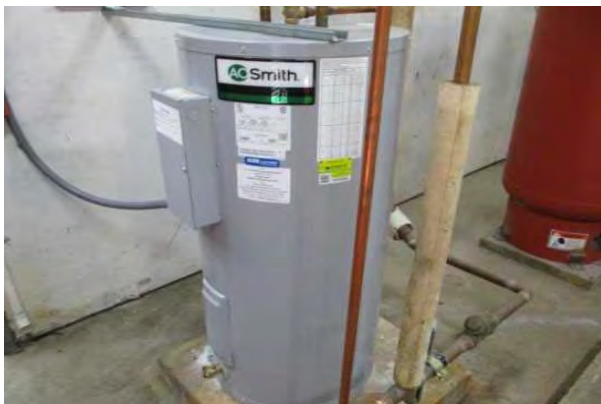
#23: WATER HEATER, ELECTRIC, COMMERCIAL

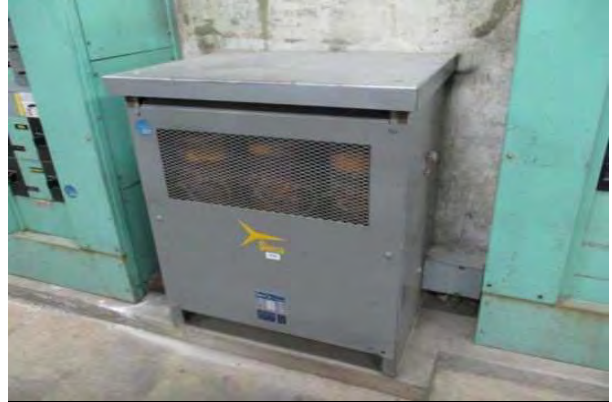
#38: SECONDARY TRANSFORMER, DRY

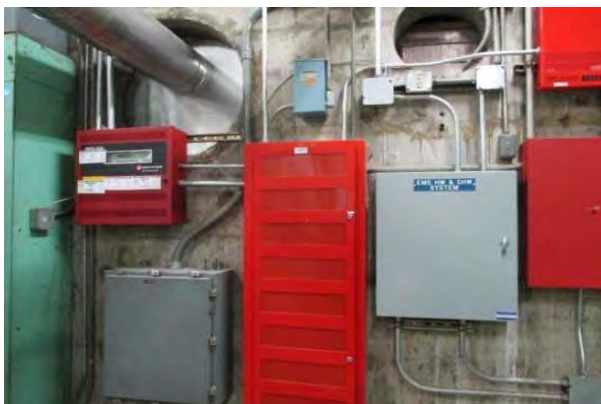
#41: FIRE ALARM CONTROL PANEL, ADDRESSABLE

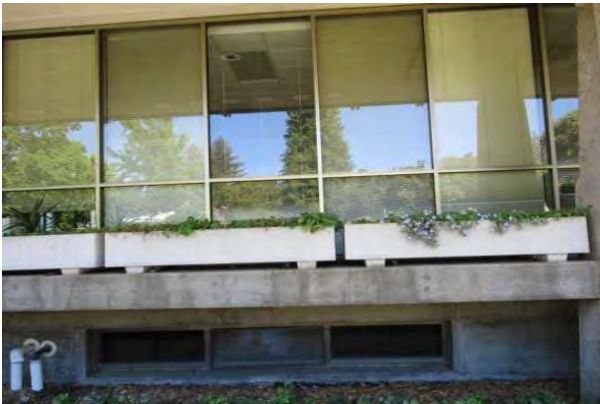
#9: EXISTING SINGLE GLAZED WINDOWS

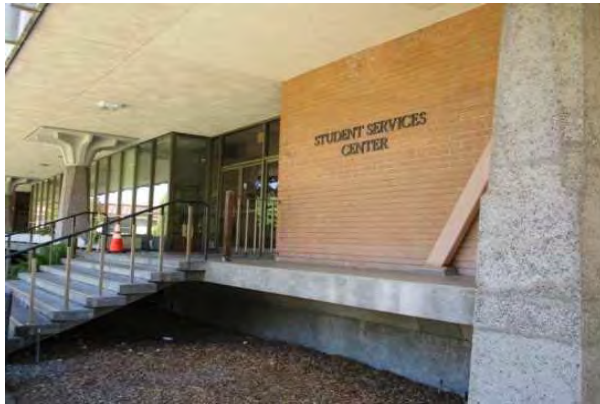
#10: EXTERIOR WALL, BRICK VENEER

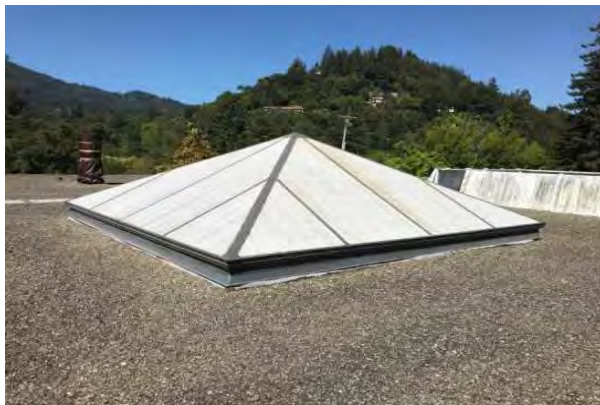
#12: ROOF SKYLIGHT, GLASS SINGLE UNIT

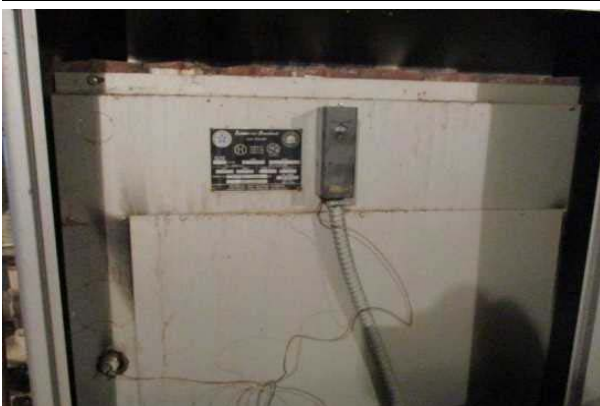
#29: BOILER, GAS, DOMESTIC & HEATING

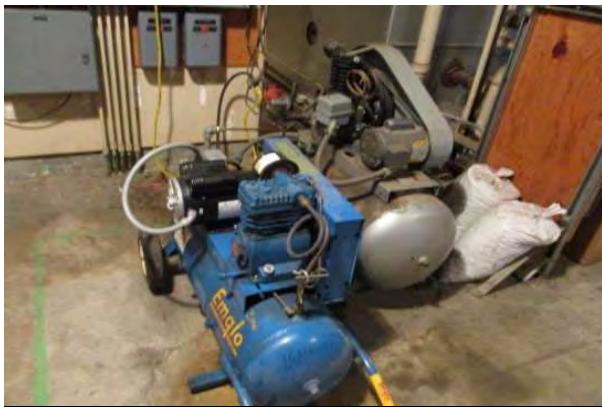
#33: HVAC CONTROLS, PART PNEUMATIC, AIR COMPRESSOR

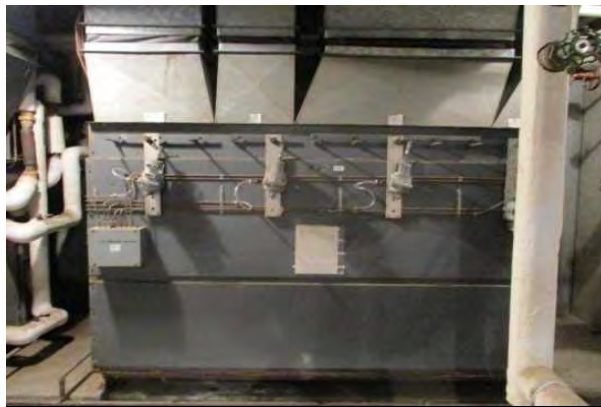
#34: AIR HANDLER, INTERIOR
