College of Marin

Kentfield Campus

Access Compliance Survey Report Update

August 2013

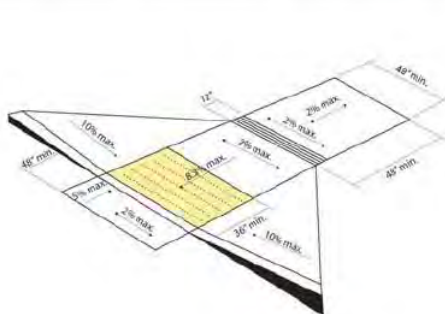
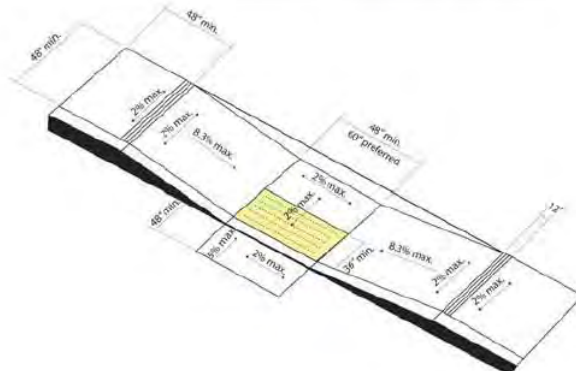
STANDARDS

PERPENDICULAR CURB RAMP	
Width of Ramp	48" wide min.
Slope of Ramp	8.3% max.
X Slope of the Ramp	2.0% max.
Top Landing Length	48" long min.
Top Landing Slope	2.0% max.
Top Landing X Slope	2.0% max.
Left Flare	10% max.
Right Flare	10% max.
Gutter Slope	5% max.
Gutter X Slope	2% max.
Gutter Lip	0" lip (Flush)
Grooved Borders	12" grooves
Truncated Domes	36" deep x width of ramp
Within Crosswalk	48" within crosswalk

PARALLEL CURB RAMP		
	LEFT	RIGHT
Width of Ramp	48" wide min.	48" wide min.
Slope of Ramp	8.3% max.	8.3% max.
X Slope of the Ramp	2.0% max.	2.0% max.
Top Landing X Slope	2.0% max.	2.0% max.
Bottom Landing Length	48" long x 48" wide	
Bottom Landing Slope	2.0% max.	
Bottom Landing X Slope	2.0% max.	
Gutter Slope	5% max.	
Gutter X Slope	2% max.	
Gutter Lip	0" lip (Flush)	
Grooved Border	12" grooves (on both sides)	
Truncated Domes	36" deep x width of ramp	
Within Crosswalk	48" within crosswalk
