Kentfield Learning Resource Center/ Student Center Programming

COLLEGE OF
MARIN

October 26, 2018

FACILITY CONDITION ASSESSMENT

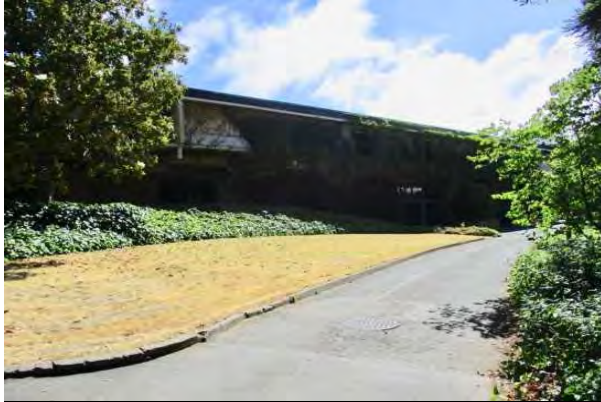
#1: WEST ELEVATION

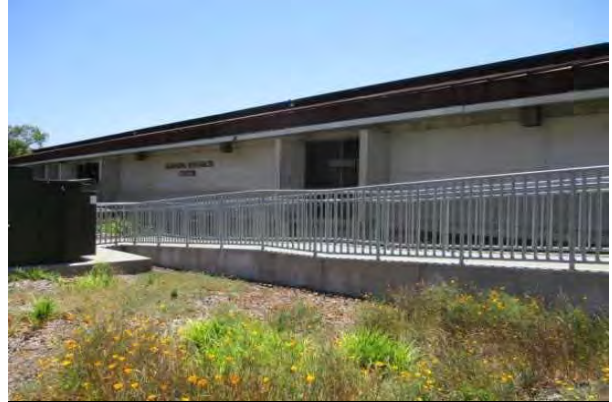
#2: NORTH ELEVATION

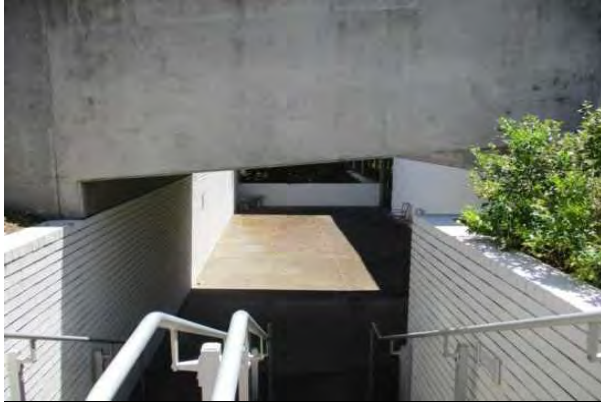
#7:

EXTERIOR WALLS

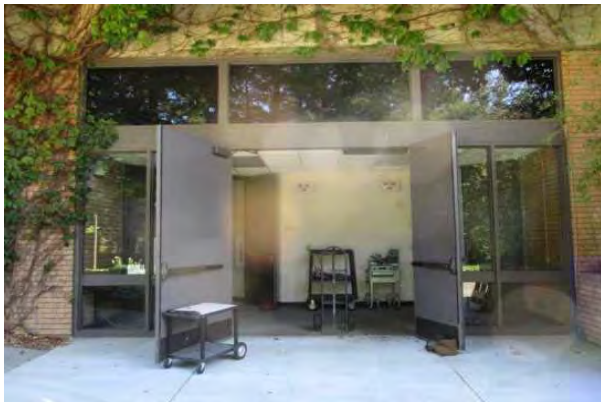
#9:

EXTERIOR DOORS

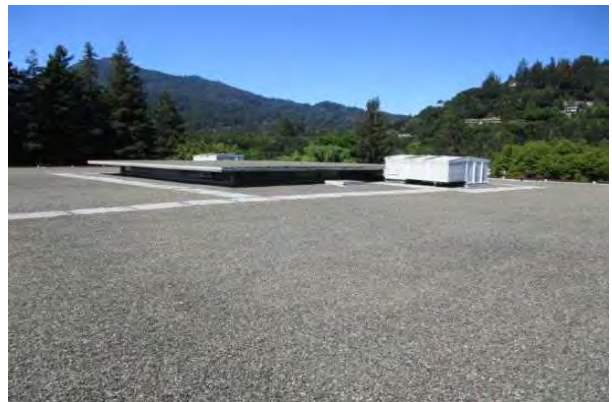
#12:

MAIN ROOF, MODIFIED BITUMINOUS

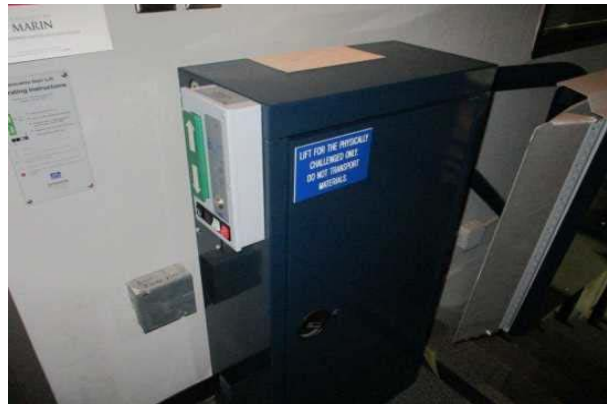
#22: WHEELCHAIR LIFT

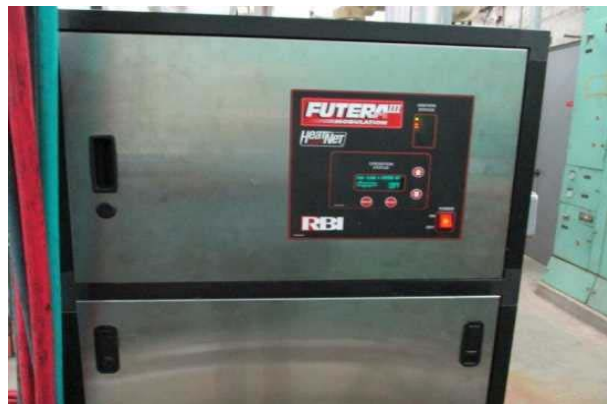
#24: DOMESTIC BOILER

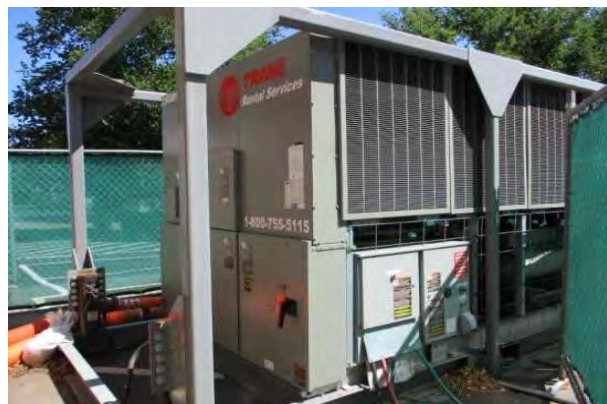
#30:

Mechanical, Electrical, Plumbing & Fire (MEPF): Much of the MEPF systems are original to the 1977 construction. The HVAC system is currently working on an temporary basis. The chiller failed in 2017 and a temporary unit is located in the parking lot. Permanent relocation of the chiller and replacement of HVAC componemts is anticipated. Much of the electrical infrastructure is original, modernization is anticipated. The plumbing system is generally in good working order with no major expenditures anticipated in the short term. The facility lacks a fire suppression system, and although the building is likely 'grandfathered', a full fire sprinkler system retrofit is highly recommended.

CHILLER, AIR-COOLED

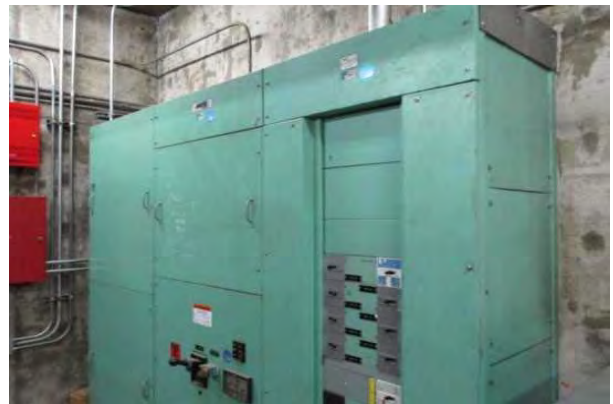
#36: SWITCHBOARD

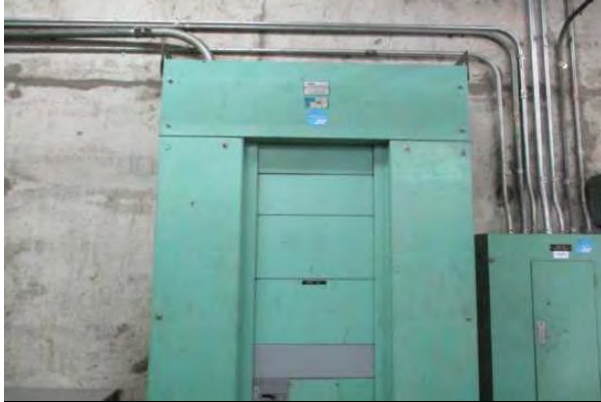
#37: SWITCHBOARD

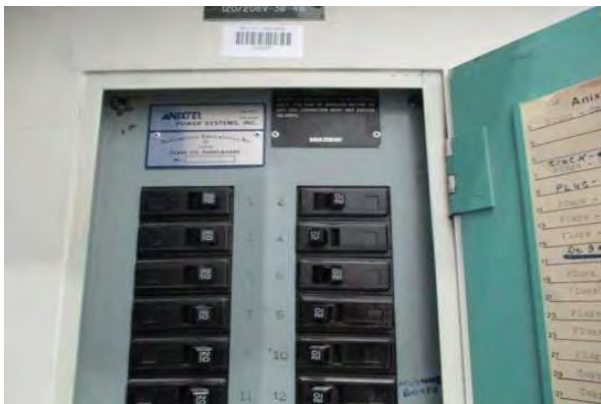
#39: DISTRIBUTION PANEL

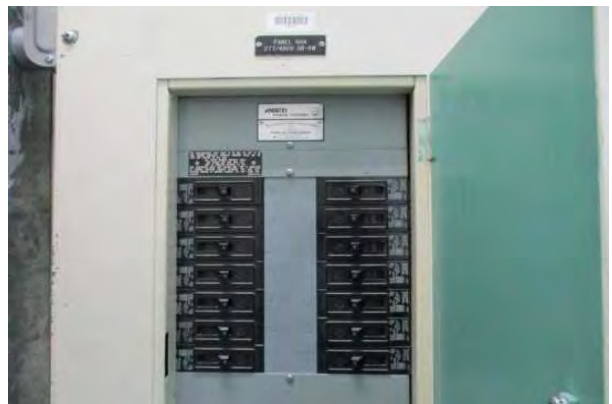
#40: DISTRIBUTION PANEL

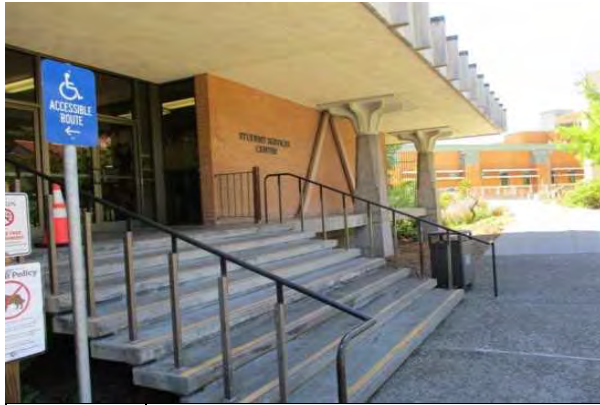
#8: EXTERIOR STAIRS

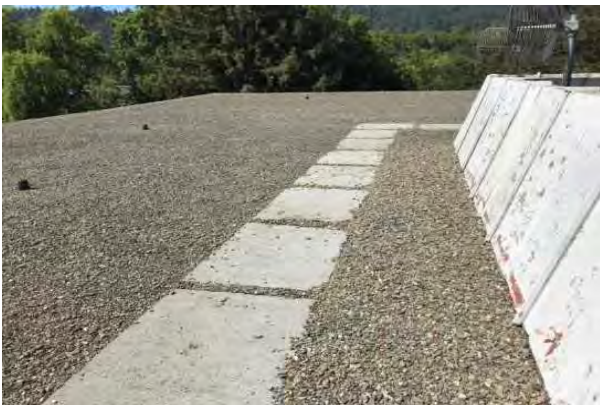
#11: ROOF

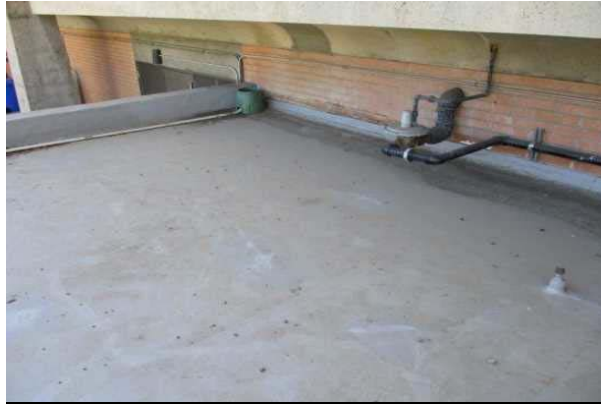
#14:	ELASTOMERIC COATING
------	---------------------

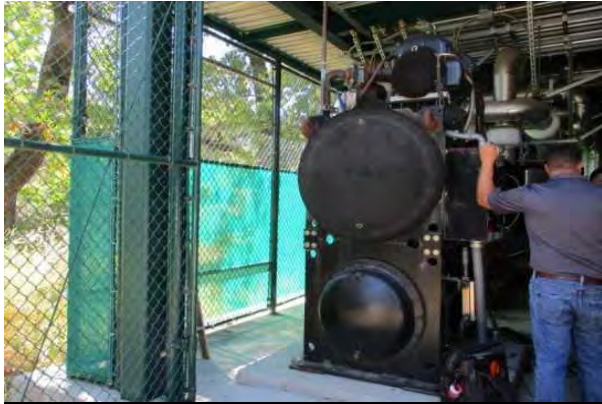
#31: CHILLER, CENTRIFUGAL
